DAMAGE OF SEFID RUD BUTTRESS DAM PROJECT IN IRAN CAUSED BY THE MAGNITUDE 7.4 MANJIL EARTHQUAKE OF JUNE 21, 1990

M. Wieland⁽¹⁾

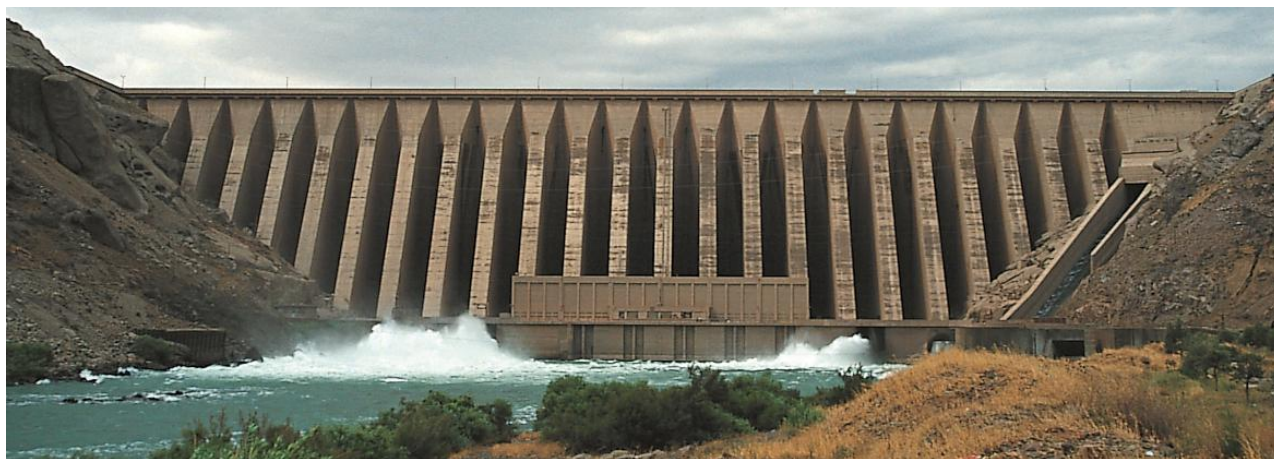
Sefid Rud buttress dam, located in the epicentral region of the Manjil earthquake, is the concrete dam, which up to now has experienced the strongest earthquake ground shaking of any concrete dam in the world (Fig. 1). This case is hardly known among dam and earthquake engineers, because in 1990, when the earthquake occurred, only few foreign engineers and earthquake experts were able to visit the devastated region. Sefid Rud dam and also hydraulic structures of the downstream irrigation scheme were among the main damaged infrastructure projects.

Fig. 1 – Sefid Rud buttress dam in Iran with irrigation outlets in operation for lowering the reservoir immediately after the 1990 Manjil earthquake; the powerhouse is at downstream foot of the dam.

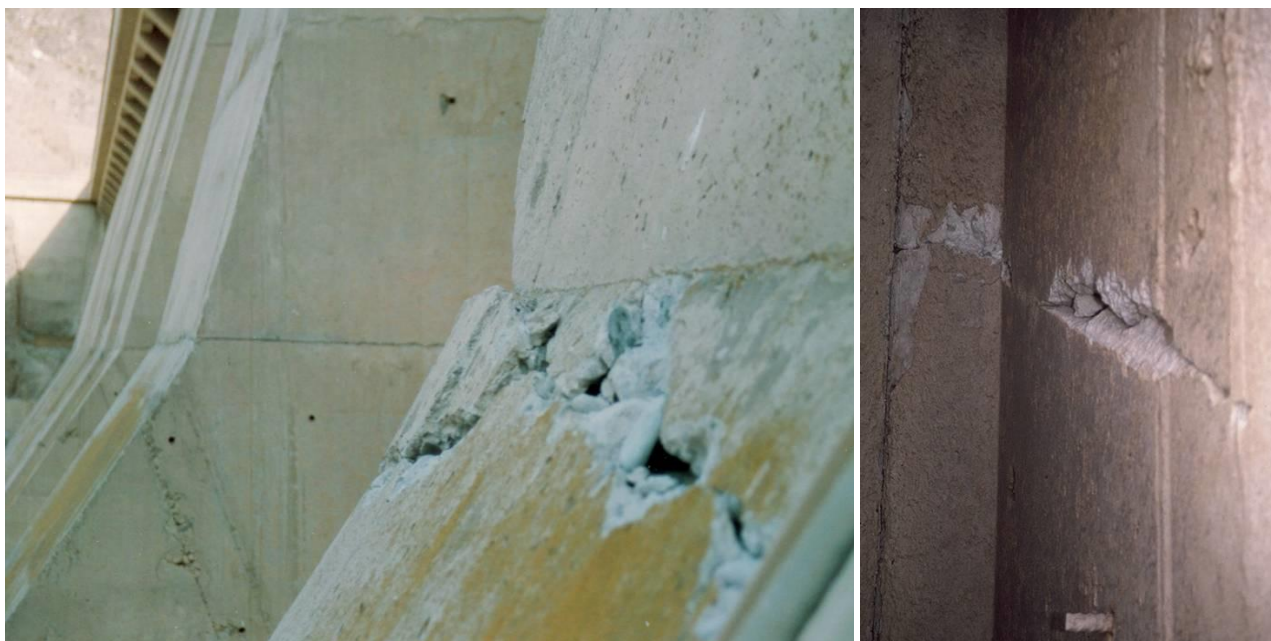
Damages to the dam structure consisted mainly of cracks along horizontal lift joints, which were spaced at 2 m (Figs. 3 and 4). Cracks appeared also in central buttresses that were located at the level of the kink in the slope of the downstream face. There was at least one major horizontal crack along working joints in all of the buttresses (Fig. 4). In one buttress, the cracks formed a wedge in the buttress web, which displaced by about 20 mm. On the dam crest, slabs of the carriageway suffered cracking and spalling (Fig. 5).

Fig. 3: Crack at kink location in buttress (left) and horizontal crack along lift joint (right)

- (i) Re-establishing watertightness of the cracked buttresses by epoxy resin grouting. Initial estimates based on water testing arrived at about 80 cracks that had to be treated by grouting.
- (ii) Re-establishing the shear strength of the cracked horizontal lift joints by post-tensioned rock anchors passing through the fractured joints (Figs. 16 and 17).

The objectives of the post-tensioned rock anchors were to increase the sliding resistance of the cracked surfaces, and to improve the sliding and overturning stability of the top portion of the dam. The design of the strengthening works called for a post-tensioning force of 100 MN per buttress for buttresses 8 to 23 and of 50 MPa for buttresses 5 to 7, and 24 to 27. With this normal force applied to the sheared lift joints, it was expected to restore the shear strength in the block joints that had moved during the earthquake [1, 2]. High capacity strand anchors of 8.4 MN working load were selected. Twelve anchors or six respectively were required per buttress to match the design force (Figs. 16 and 17).

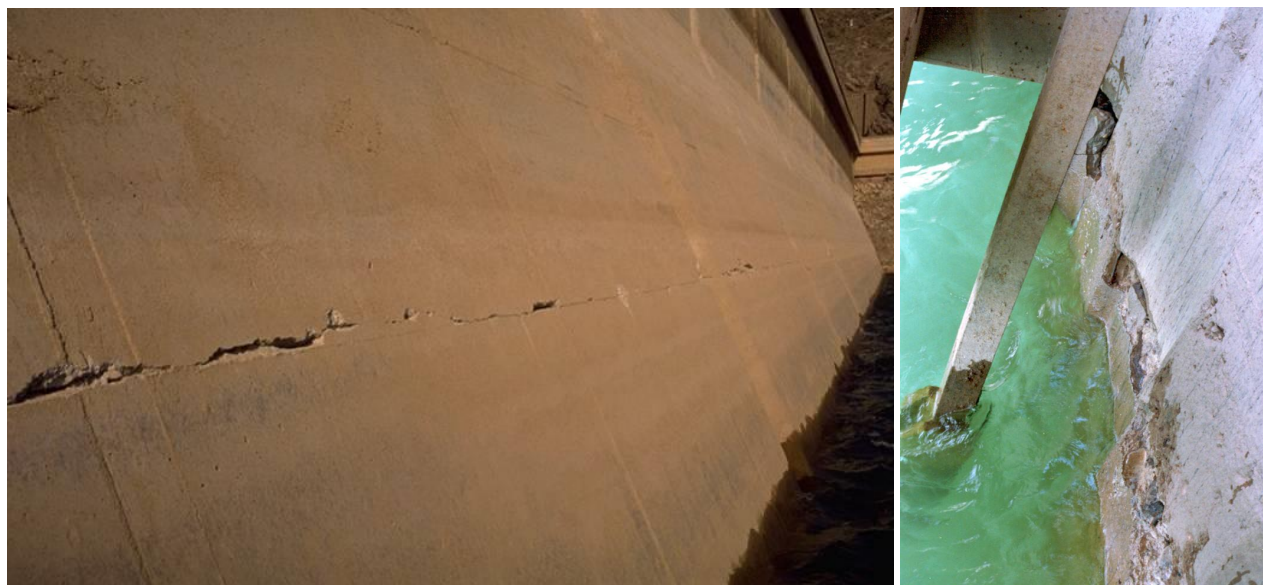
Fig. 4 – Horizontal crack at upstream dam face through several buttresses along lift joint (left) and horizontal crack and spalling of concrete above intake gates (right)

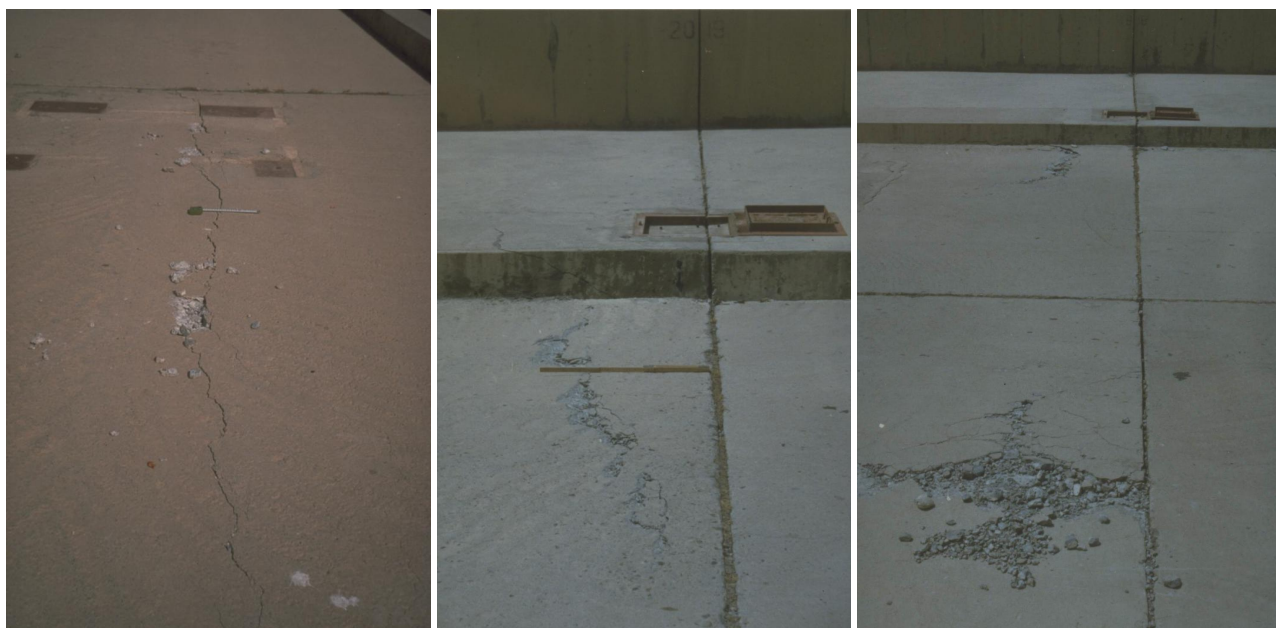
Fig. 5 – Cracks on dam crest due to high compressive stresses: Longitudinal crack (left) and compression-shear crack at block joints (centre and right) (Note: Relative movements occurred between some of the block joints)

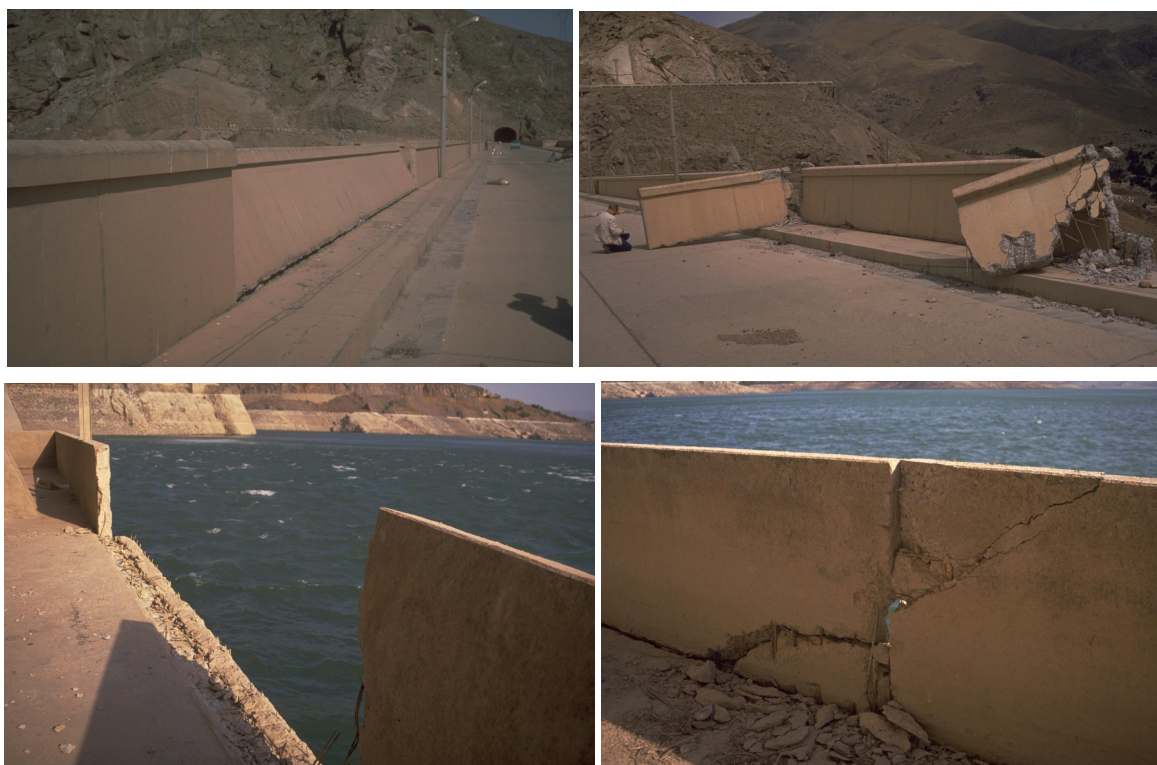
Typical damages of concrete parapet walls are shown in Fig. 6. The rockfall hazard above the intakes of the morning glory spillway can be seen from Fig. 7, and Fig. 8 shows the inelastic deformations of the arm of a radial gate of the intermediate level spillway, which was caused by high hydrodynamic pressures.

Fig. 6 – Tilting of concrete parapet wall on downstream crest (top left) and secured tilted wall after the earthquake to protect it from falling on the powerhouse (top right), damage at upstream face parapet walls above intake gates (bottom left and right)

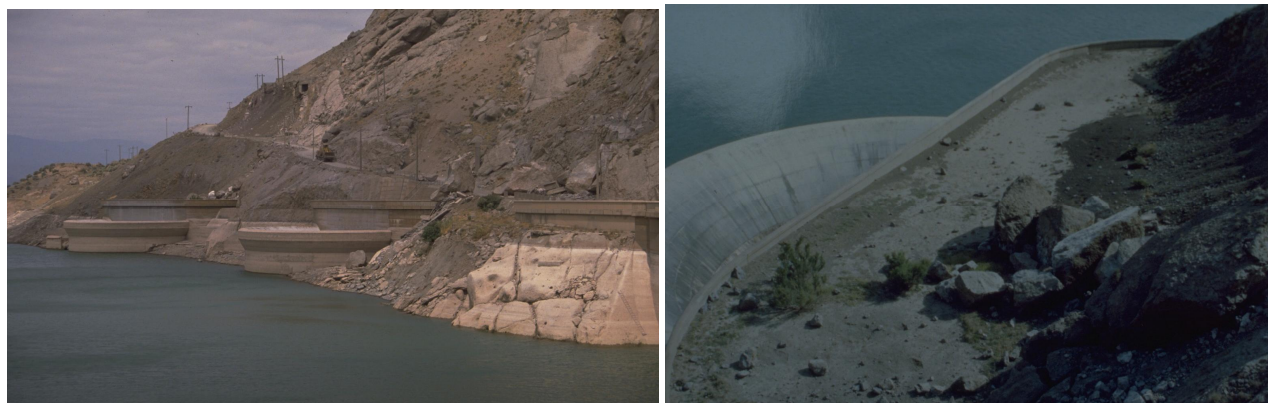
Fig. 7 – Rockfalls at intakes of morning glory spillways on left dam abutment: main rocks could be withheld by horizontal platform above intake (right)

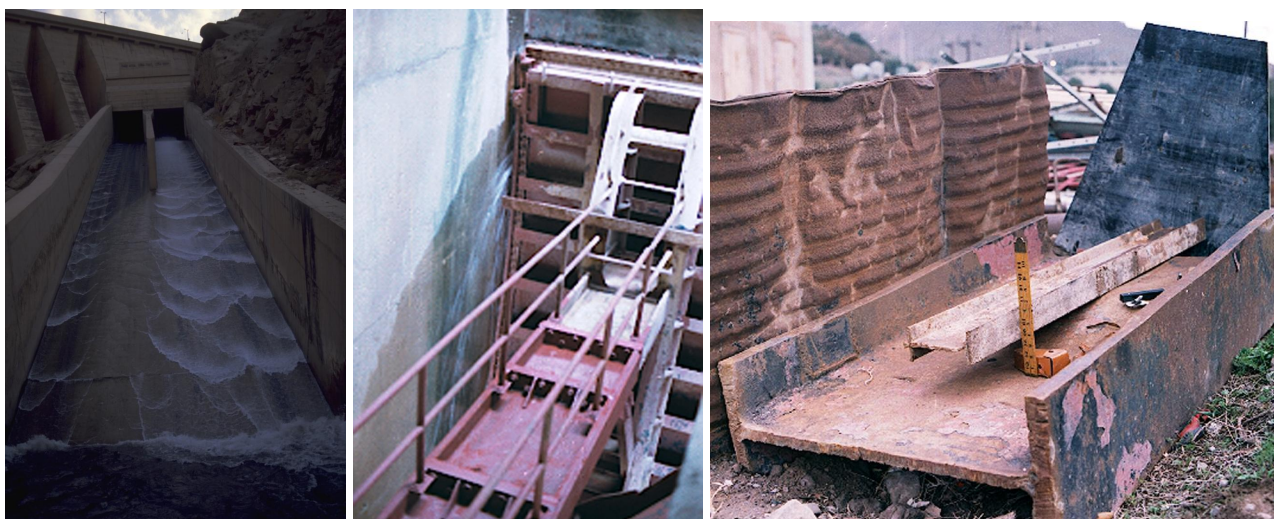
Fig. 8 – Damage of radial gate of intermediate level spillway causing leakage (left and centre) and deformed portion of spillway arm due to high hydrodynamic pressures (centre and right)

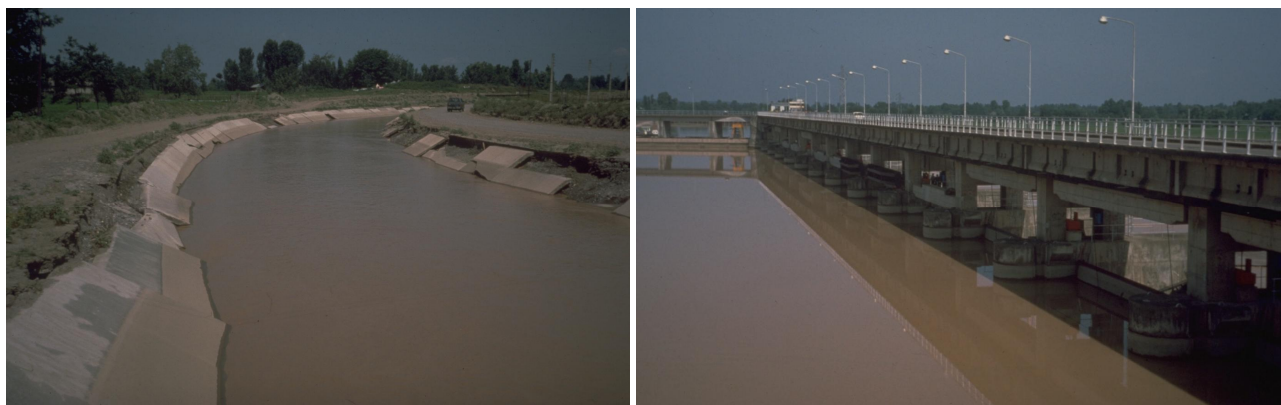
In Fig. 9 different types of damage to the downstream irrigation scheme is displayed. Multiple gates installed in long weirs are critical elements as all of them are of the same type. If one fails, the others are very likely to fail in the same way. The main seismic safety problem of gates of existing older projects is that they have been designed for seismic loads acting in river direction but not in cross-river direction.

Fig. 9 – Damage of lining of downstream irrigation canal (left) and several counterweights for gate lifting of diversion structure of irrigation scheme were falling down (right)

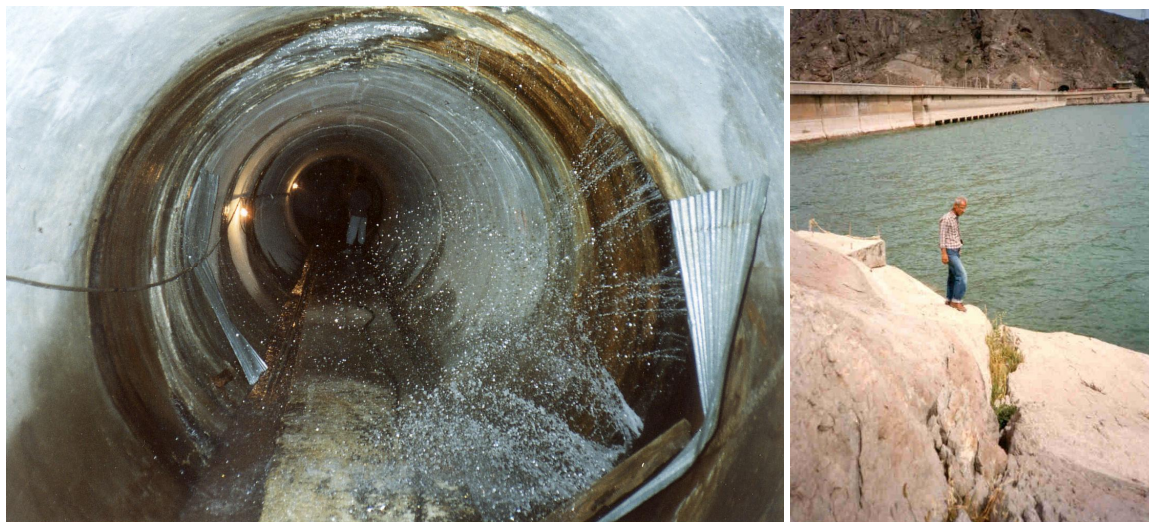
In Fig. 10 a reactivated old fissure in the foundation gallery is shown, which was leaking after the earthquake as fine material was washed out due to seismic fissure displacements. Cracks and fissures in concrete dams indicate that uplift pressures exist, which have a negative effect on the post-earthquake stability of concrete blocks. In the same figure a segment of the main fault of the Manjil earthquake can be seen, which passes through the footprint of the dam. The related movements were very small.

Fig. 10 – Leaking fissure in foundation gallery (left) and trace of fault of Manjil earthquake (right)

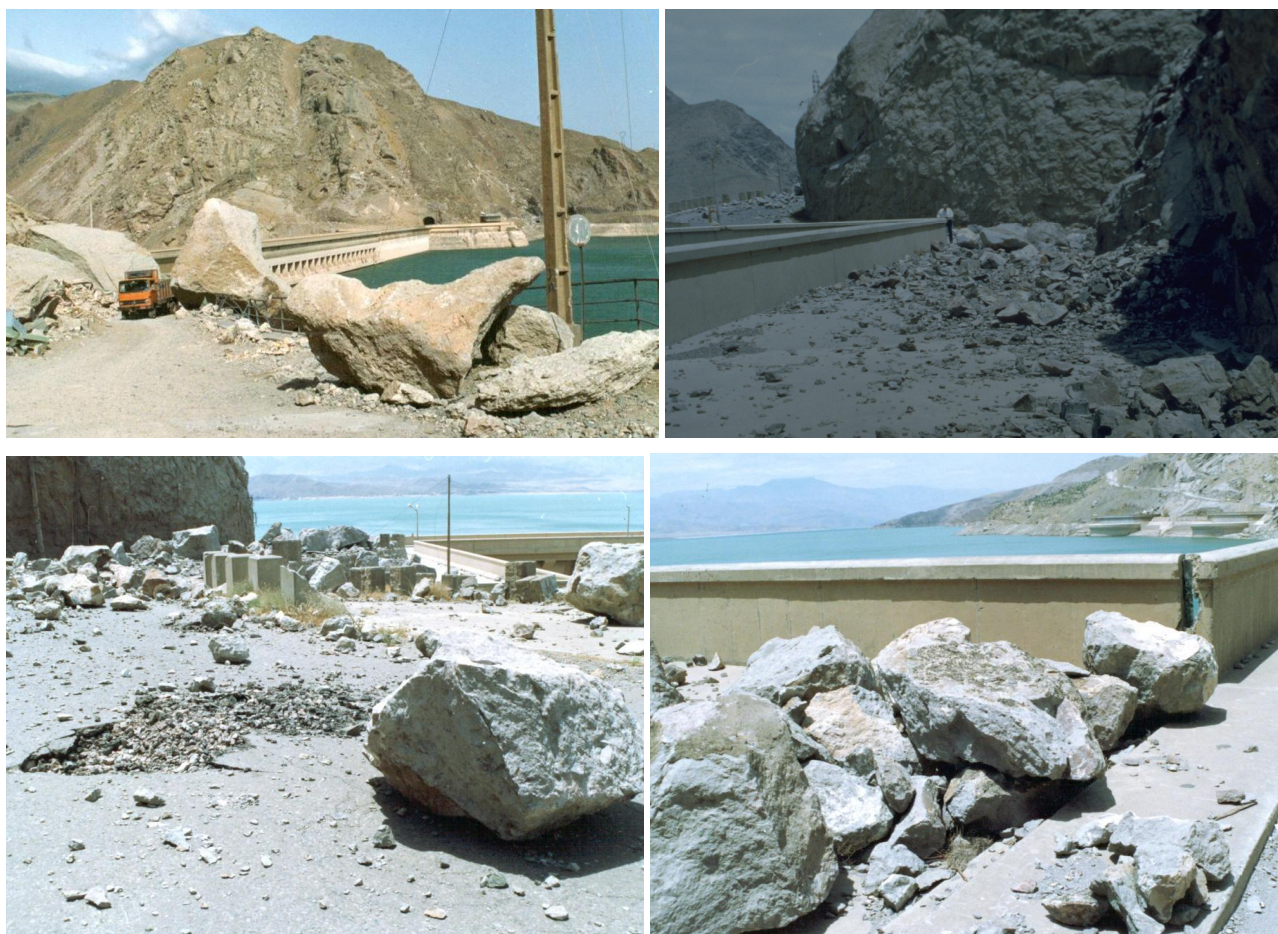
Fig. 11 – Rockfall at the dam site: Large displaced rocks above the spillway intake on left bank (top left)

In mountainous regions the seismic hazard is a multi-hazard, which besides ground shaking (Figs. 11 and 12), the hazard considered by all dam engineers, we must also taking into account faulting in the dam foundation and the reservoir, landslides, rockslides and rockfalls as well as ground movements (Fig. 13). During the Manjil earthquake, thousands of rockfalls could be observed; many of them were located very close to the dam site (Figs. 7 and 11).

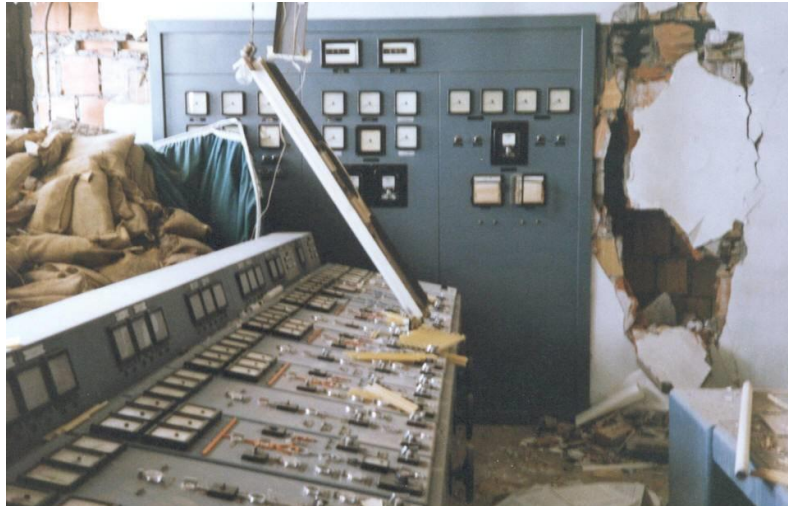
Fig. 12 – Damage in the control room of the hydropower plant caused by ground shaking (Note: The sandbags at the left were placed as protection from missiles as the dam and power plant were attacked by fighter planes during the Iran-Iraq war of 1980-1988)

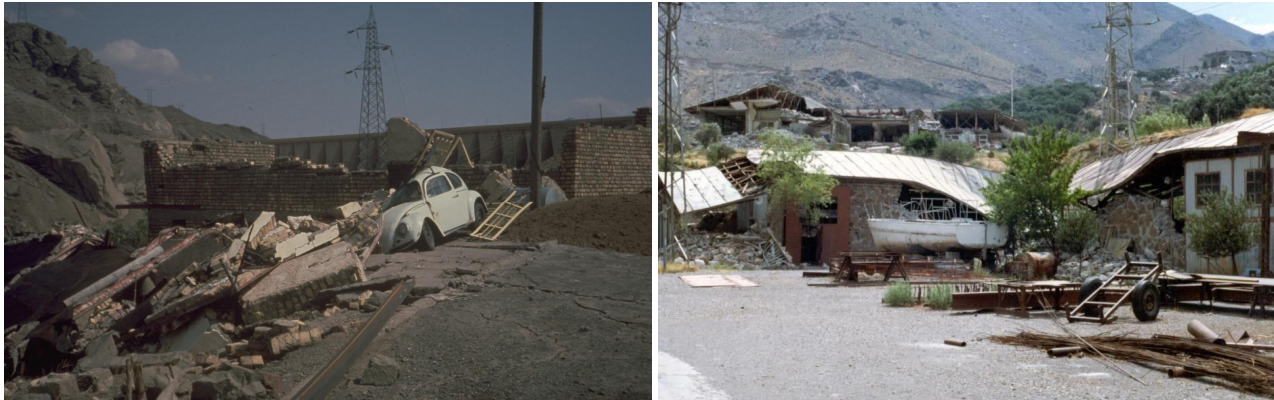
Fig. 13 – Collapsed buildings at dam site caused by strong ground shaking

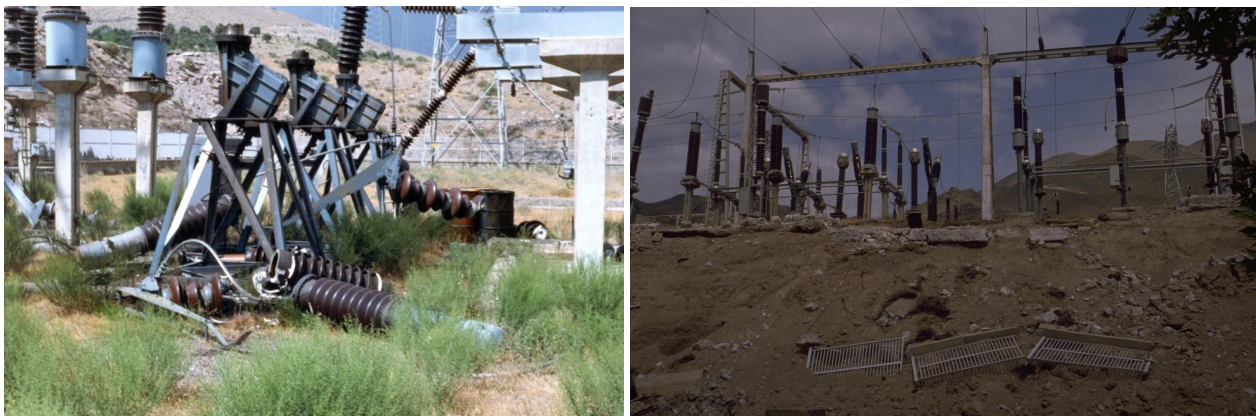
Fig. 14 – Damage of switchyard equipment due to ground shaking and ground movements

Electro-mechanical equipment installed in the powerhouse and switchyard are vulnerable to ground shaking, because some have high centres of gravity and are not properly anchored to the foundation or structural walls and, therefore, are vulnerable to overturning (Figs. 14 and 15). But more important is the fact that electrical and mechanical engineers are often not familiar with the overall seismic safety concept used for large dam projects and some of the design guidelines may have to be revised. Furthermore, transmission towers can easily be destroyed by rockfalls. This has also happened with the first transmission tower in Sefid Rud, which caused the shut-down of the power plant.

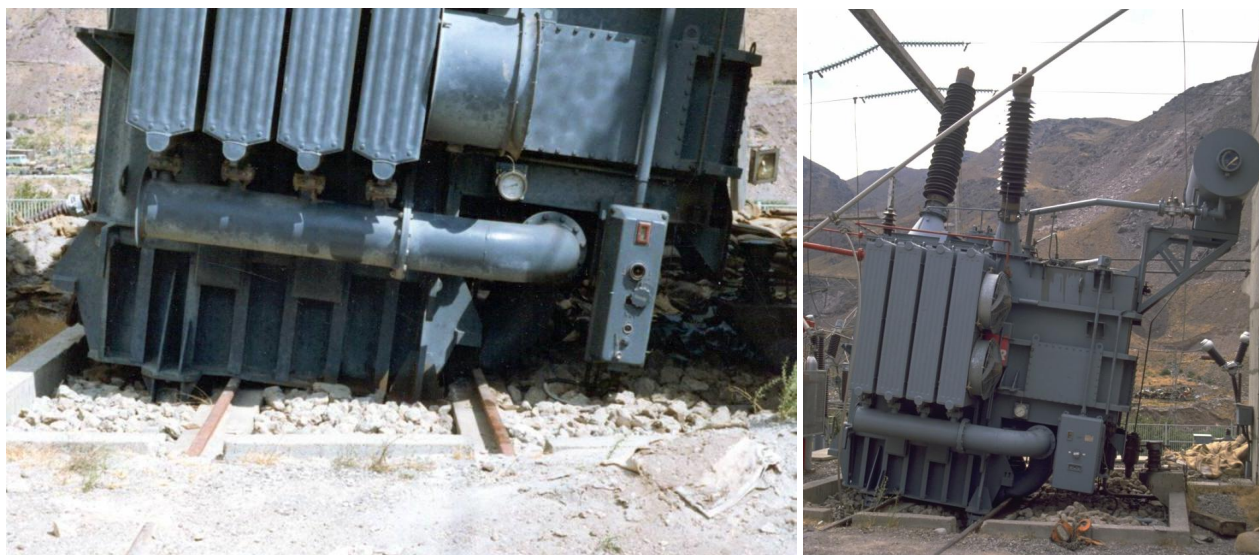
Fig. 15 – Derailed transformers that were not properly anchored

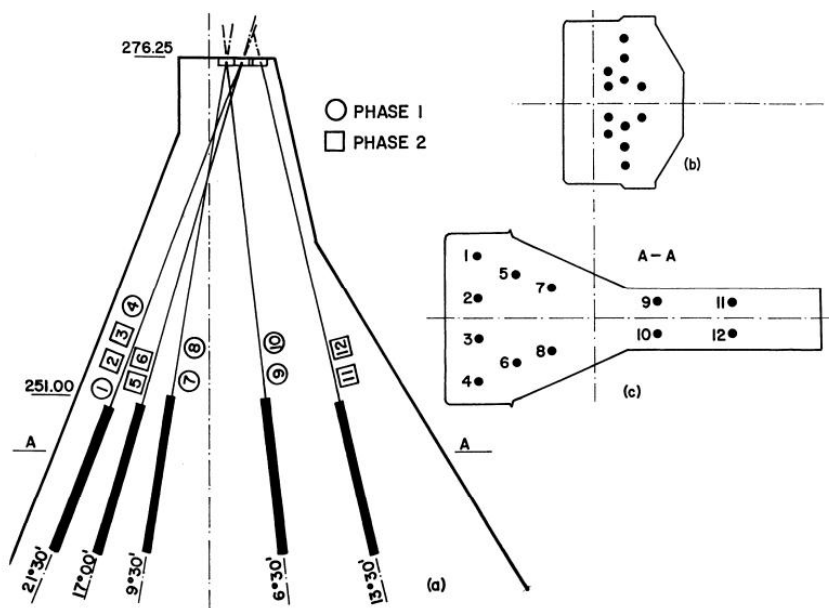
Fig. 16 - Arrangement of post-tensioned anchors in damaged buttresses: (a) cross-section of buttress, (b) top elevation, (c) Section A-A [1]

In the region of the downstream kink, the post-tensioned anchors cause an additional vertical stress of approximately 0.8 MPa. This amount of prestress is not sufficient to prevent future cracking during similar earthquakes. However, the dynamic stability of the detached upper portion of the dam is improved substantially.

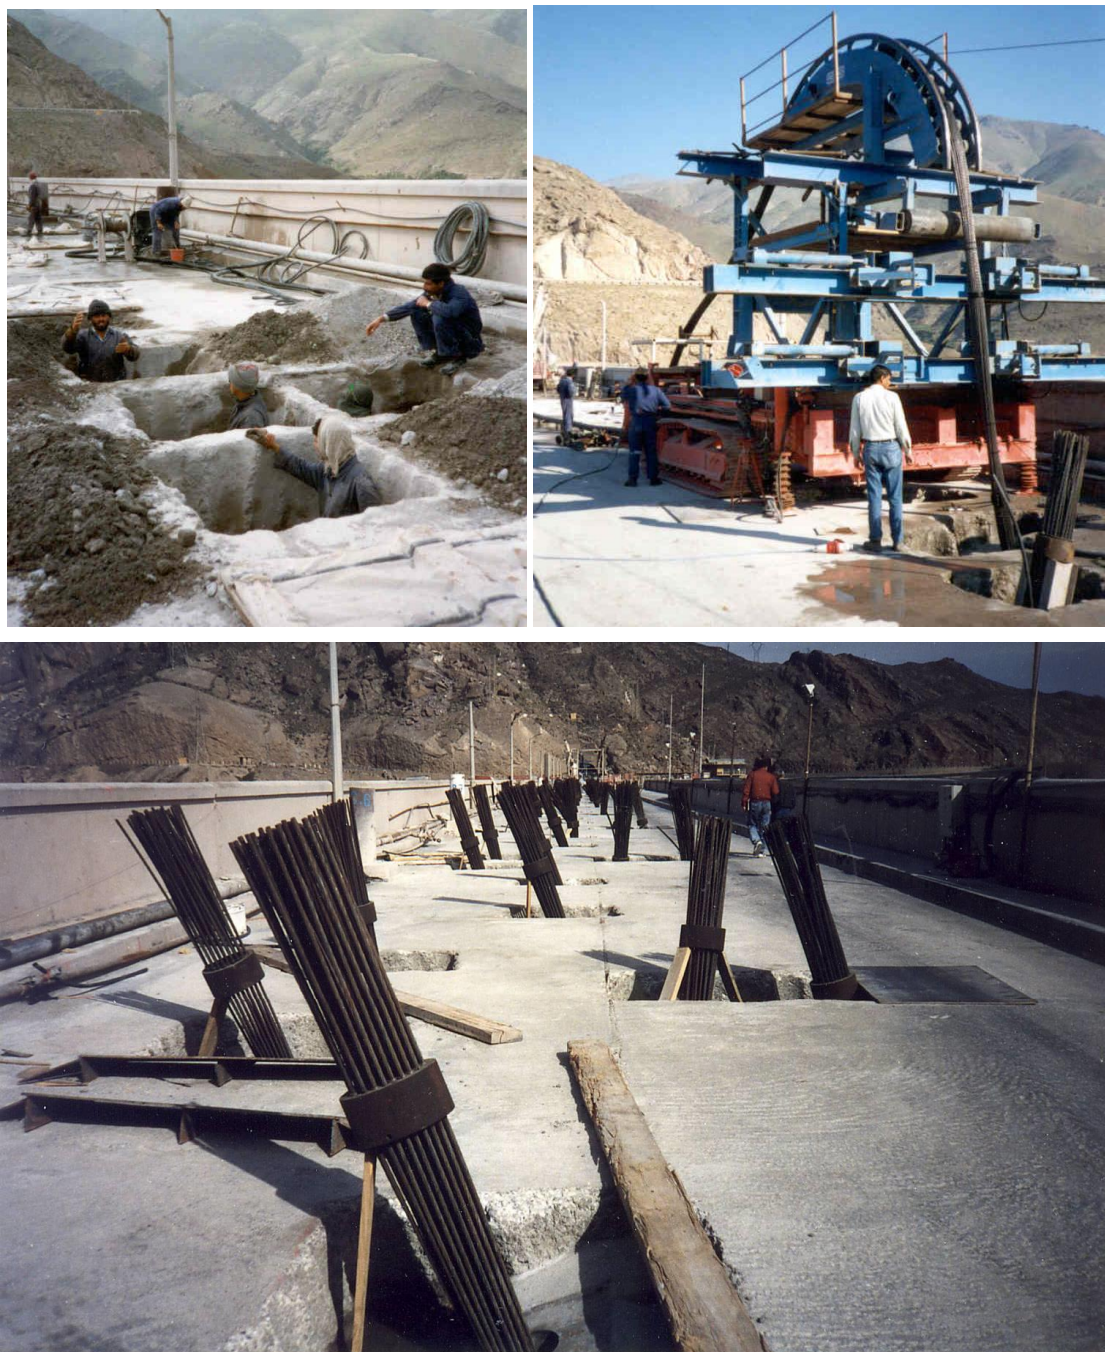
Fig. 17 - Repair work at Sefid Rud dam: Excavation for placement of anchor heads (top left), placement of anchor by homing device mounted on a crawler chassis (top right) and installed rock anchors before stressing (working load of each tendon: 8.4 MN) and final placement of anchor heads (bottom)
