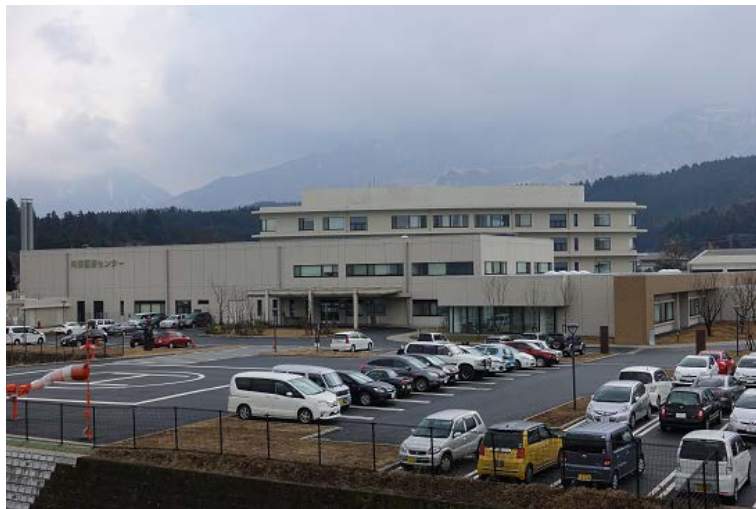
Fig. 4 Photo of Medical Facility M

The seismograph station K-NET Ichinomiya, located close to Medical Facility **M** in Aso City, measured a seismic intensity of 6-lower during the main shock. The record on the scratch plate in the isolation level of Medical Facility **M** immediately after the foreshock showed a locus smaller than 5 mm in diameter. A single amplitude of 46 cm was recorded during the main shock, which indicates its severity. Also, the dominant period of the seismic motion measured at K-NET Ichinomiya was 3 seconds as shown in Figure 7. The seismic isolation period of the Medical Facility **M** is about 3 seconds, which is almost the same as the dominant period of the observation wave. From Figure 7, it is estimated that the maximum response deformation for a period of 3 seconds exceeds 1 m. The large difference between this and the observed deformation by the scratch plate requires investigation.

In an interview with the building manager, it was confirmed that the seismically isolated buildings were undamaged, and normal business continued without even any furniture or medical equipment falling over. Patients were not evacuated from the Medical Facility **M**. And this hospital accepted a total number of around 70,000 patients from 13 damaged hospitals with seismic-resistant structure.

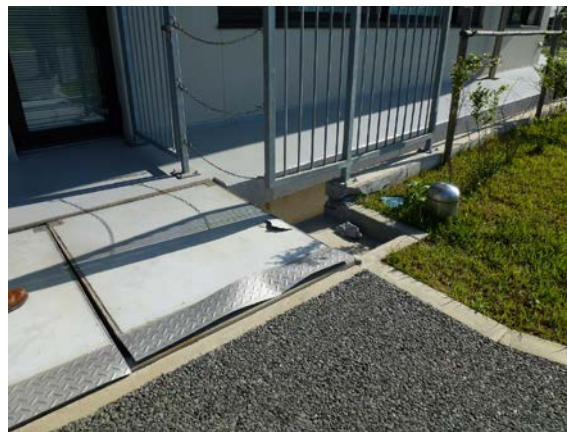
Fig. 8 A deformed gap cover

The Kumamoto earthquakes revealed several problems. In almost all of the buildings, we found that the expansion joints and gap covers connecting the seismically isolated building with seismic-resistant buildings were deformed. Figure 8 shows a deformed gap cover. During an earthquake, the expansion joints move without interfering with the movement of the seismically isolated building. However, when they are subject to large forces or move more than expected, the expansion joints and the gap covers may become deformed, although this does not impair the performance of the seismically isolated building. During the Kumamoto

earthquakes, some of the joints showed greater deformation than expected, but there were no problems in terms of use.

Compared to when seismically isolated structures first started to be employed in buildings, the gap covers installed near building entrances have become more sophisticated. They allow completely barrier-free access, and recently many are designed to make it look as though the building is not seismically isolated at all. However, some of the expansion joints and gap covers appeared to have suffered excessive deformation due to a lack of consideration by the designers, who appeared to have forgotten that “during an earthquake, there will be relative movement between the seismically isolated building and the ground surface or the seismic-resistant building.”

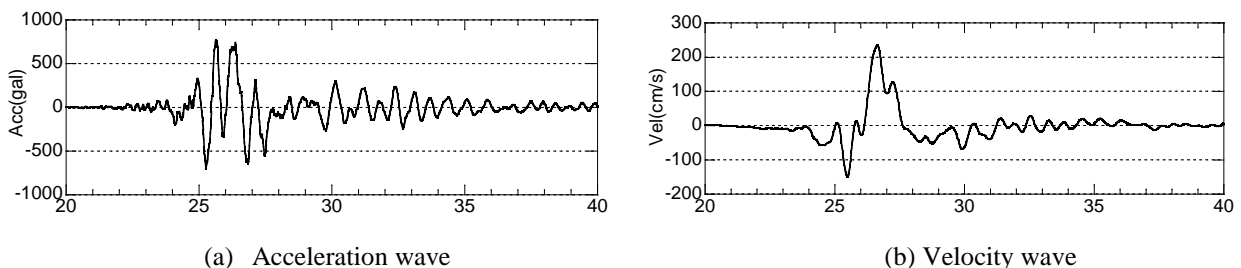
Fig.9 Observed earthquake records (EW-dir.) at Nishihara Village

In the Kumamoto earthquake, long-period ground motion was observed in Nishihara Village. Figure 9 shows the recorded waveform. Looking at the velocity waveform, a pulse-like waveform with a period of 3 seconds can be seen. The maximum velocity is over 200cm/s. Recently, the response evaluation of long-period ground motions in high-rise buildings and seismically isolated buildings has become an issue in Japan. In general, large subduction zone earthquake and moderate to large crustal earthquake can generate far-source long-period ground motions in distant sedimentary basins. However, in the Kumamoto earthquake near-fault long-period ground motions [4] are generated. When such ground motion is input to a seismically isolated building, the response deformation of the isolation layer becomes very large. Measures for that are also required. Research on the generation mechanism of long-period ground motions and suppression of response of seismically isolated buildings is also needed.
