OBSERVED PERFORMANCE OF SEISMICALLY ISOLATED BUILDINGS DURING 2016 KUMAMOTO EARTHQUAKE IN JAPAN

M. Takayama⁽¹⁾, K. Morita⁽²⁾

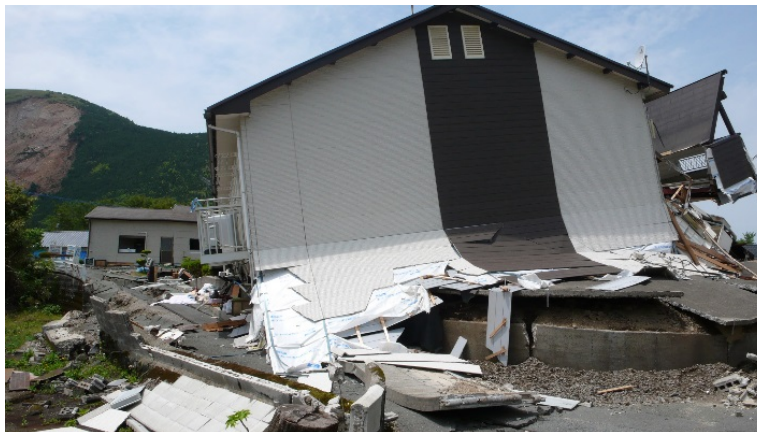
(a) 2 stories wooden apartment in Minamiaso Village

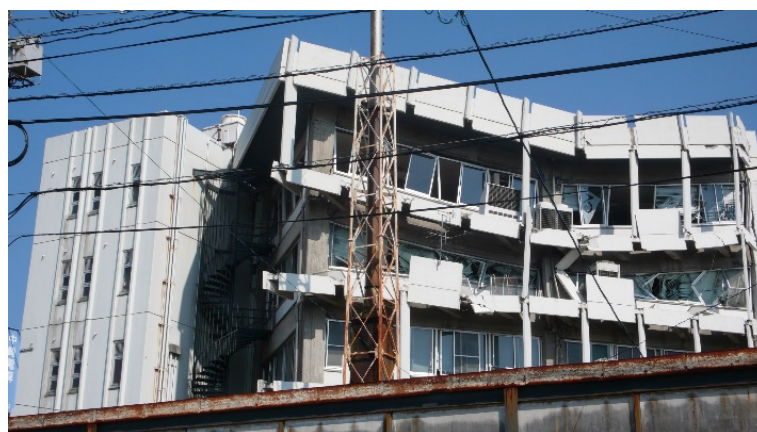
(b) 5 stories city hall

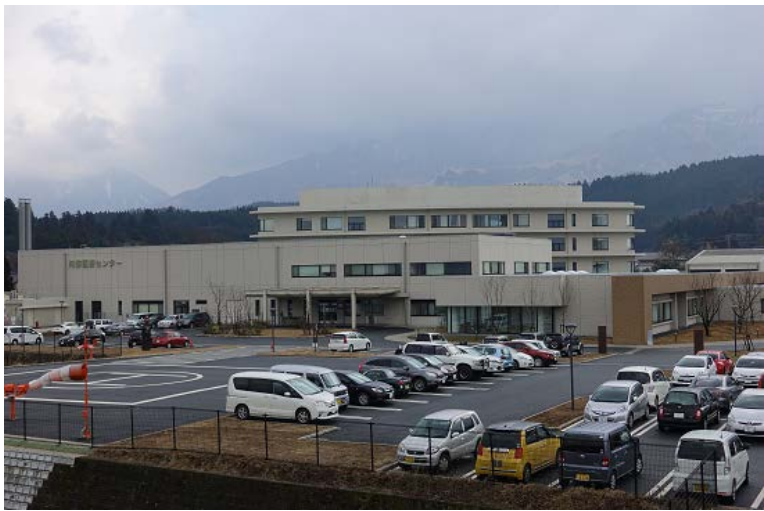
Fig. 4 Photo of Medical Facility M

A maximum double amplitude of 90 cm and a maximum single amplitude of 46 cm were recorded at Medical Facility **M** in Aso City (25 km away from epicenter) as shown in Figure 4. Figure 6 show the orbit recorded by mainshock of the earthquake. The amount of deformation recorded at Medical Facility **M** is the largest for a seismically isolated building so far. There was almost no residual deformation in any of the buildings, and no defects were identified in the seismic isolation devices.

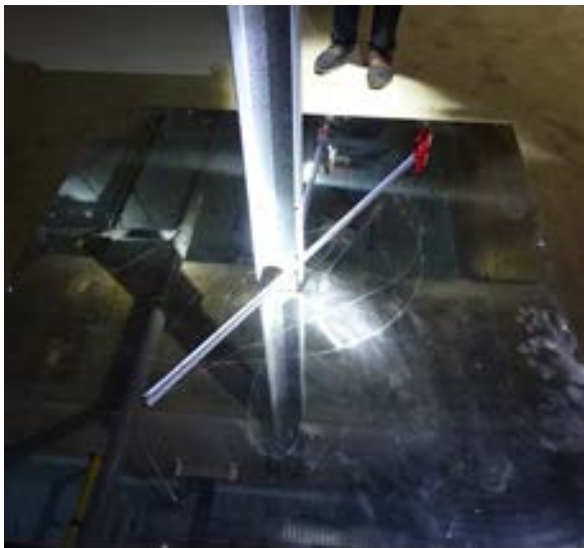
“A scratch plate”, like a Figure 5, which allow the movements of a building to be recorded by marking scratches on a metal plate, had been installed in 8 of the hospitals and offices, and this made it possible to confirm the movements of these buildings during the earthquakes. Table 3 shows the maximum amplitudes recorded on the scratch plates. A maximum single amplitude of 41 cm was recorded at the clinic building of Medical Facility **A** in Kumamoto City, and a single amplitude of 40 cm was recorded at Office **B** nearby. A maximum single amplitude of approximately 10 cm was recorded at Medical Facility **H** in Yamaga City, and a single amplitude of 33 cm was recorded at Warehouse **L** in the district of Kikuchi Gun.

Fig. 5 Photo of scratch plate

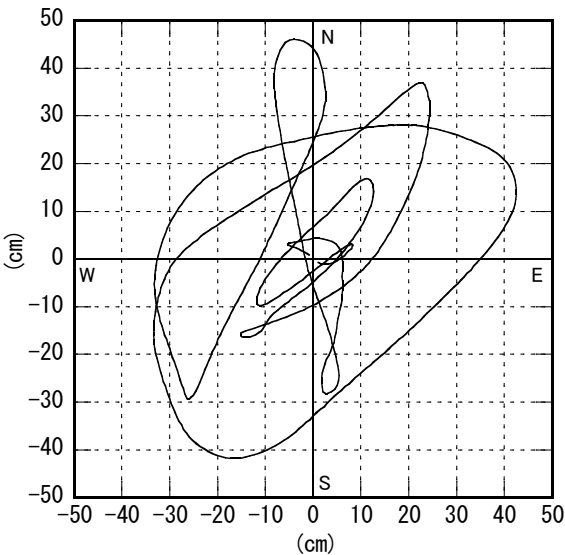
Fig. 6 Orbit recorded at Medical Facility M

The seismograph station K-NET Ichinomiya, located close to Medical Facility **M** in Aso City, measured a seismic intensity of 6-lower during the main shock. The record on the scratch plate in the isolation level of Medical Facility **M** immediately after the foreshock showed a locus smaller than 5 mm in diameter. A single amplitude of 46 cm was recorded during the main shock, which indicates its severity. Also, the dominant period of the seismic motion measured at K-NET Ichinomiya was 3 seconds as shown in Figure 7. The seismic isolation period of the Medical Facility **M** is about 3 seconds, which is almost the same as the dominant period of the observation wave. From Figure 7, it is estimated that the maximum response deformation for a period of 3 seconds exceeds 1 m. The large difference between this and the observed deformation by the scratch plate requires investigation.

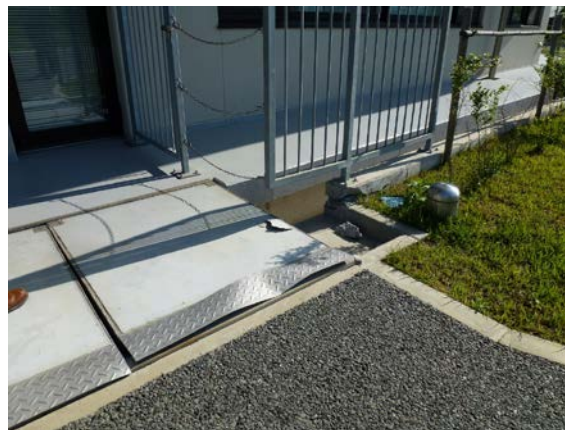
The Kumamoto earthquakes revealed several problems. In almost all of the buildings, we found that the expansion joints and gap covers connecting the seismically isolated building with seismic-resistant buildings were deformed. Figure 8 shows a deformed gap cover. During an earthquake, the expansion joints move without interfering with the movement of the seismically isolated building. However, when they are subject to large forces or move more than expected, the expansion joints and the gap covers may become deformed, although this does not impair the performance of the seismically isolated building. During the Kumamoto

earthquakes, some of the joints showed greater deformation than expected, but there were no problems in terms of use.

Fig. 8 A deformed gap cover

Compared to when seismically isolated structures first started to be employed in buildings, the gap covers installed near building entrances have become more sophisticated. They allow completely barrier-free access, and recently many are designed to make it look as though the building is not seismically isolated at all. However, some of the expansion joints and gap covers appeared to have suffered excessive deformation due to a lack of consideration by the designers, who appeared to have forgotten that “during an earthquake, there will be relative movement between the seismically isolated building and the ground surface or the seismic-resistant building.”
