OBSERVED DAMAGE AT SCHOOLS AFTER THE ILLAPEL EARTHQUAKE (CHILE, 2015)

F. López-Almansa⁽¹⁾, G. Valdebenito⁽²⁾, S. Bustos⁽³⁾

Most of the damage caused by the Illapel earthquake concentrated in poorly designed school and hospital buildings; this paper presents a study of the observed damage in the school buildings. Four representative schools are particularly discussed: “El Ingenio” school in Ovalle, children school in Coquimbo, “Maritima” school in Tongoy, and, mainly, “San Rafael de Rozas” school in Illapel. Their damage is comprehensively described; it is understood in terms of poor design, site effects and other relevant issues. Regarding the seismic design, the role of short columns is thoroughly investigated, among other structural deficiencies. Concerning the site effects, the soil fundamental period is identified after by two types of ambient vibration field tests: Nakamura, and soil profile analysis by using geophones. The natural periods of the damaged buildings were identified after operational modal analysis using triaxial seismometers. Then, the proximity between and the soil and the structure fundamental period is investigated as a main potential source of response amp

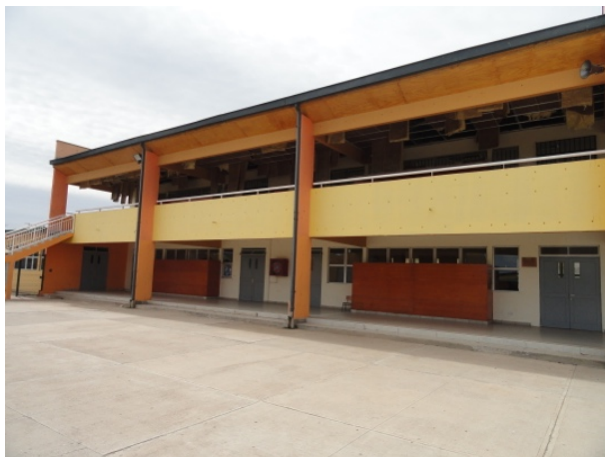
This building was only moderately damaged. The school has two stories and the structure is made of concrete, consisting in a combination of shear walls and moment-resisting frames. The earthquake caused a slight settlement in the west wing; non-structural damage of the ceilings was also observed. Figure 3.a presents a general view of such west wing, and Figure 3.a depicts the aforementioned damage of the ceilings.

(a) General view of the west wing

Apparently, plan symmetry and regularity in elevation plaid a relevant role in the rather good seismic performance of this building.

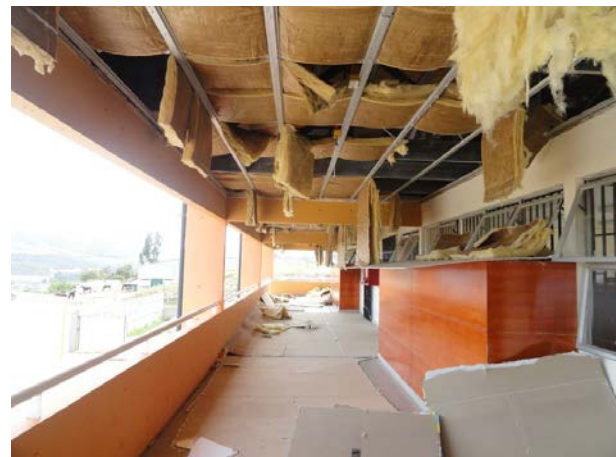
(b) Nonstructural damage of the ceilings

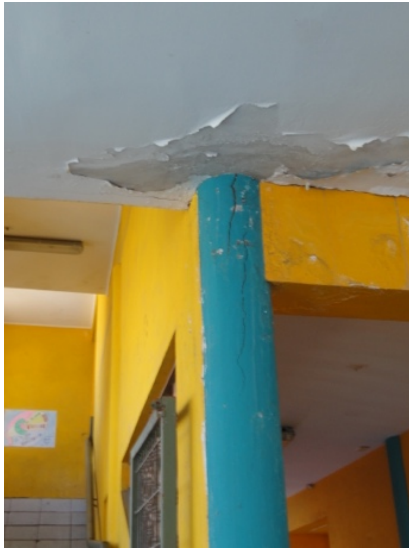
Although very slight damage was observed in this 2-story building, it is interesting to expose a typical masonry Chilean school building being located in an area where the Illapel earthquake notably affected masonry housing buildings. Figure 4.a shows the damage on a wall originated by bending rotation of the beam-wall connection; as well, probably, the slab experienced also some pounding. Additionally, Figure 4.b describes part of the performed geophysical surveys.

(a) Cracking originated by rotation of the wall-beam connection

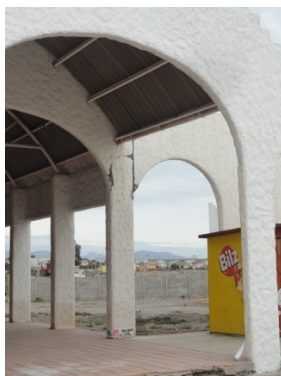
The complex consists of several connected masonry and RC frame buildings. The observed damage was only slight; Figure 6.a presents some damage in column-beam joints and Figure 6.b describes the damage of a connecting bridge. Apparently, this last damage was caused by incorrect design of the bridge supports.

(a) Slight damage in some connections

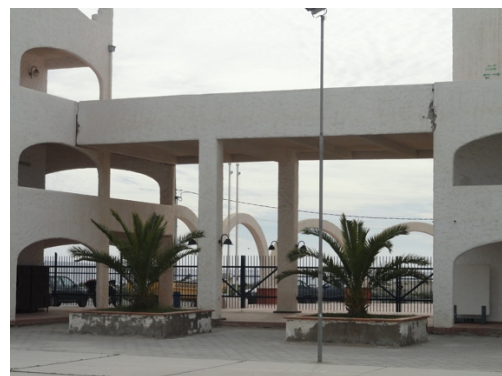
(b) Damage in the bridge connection

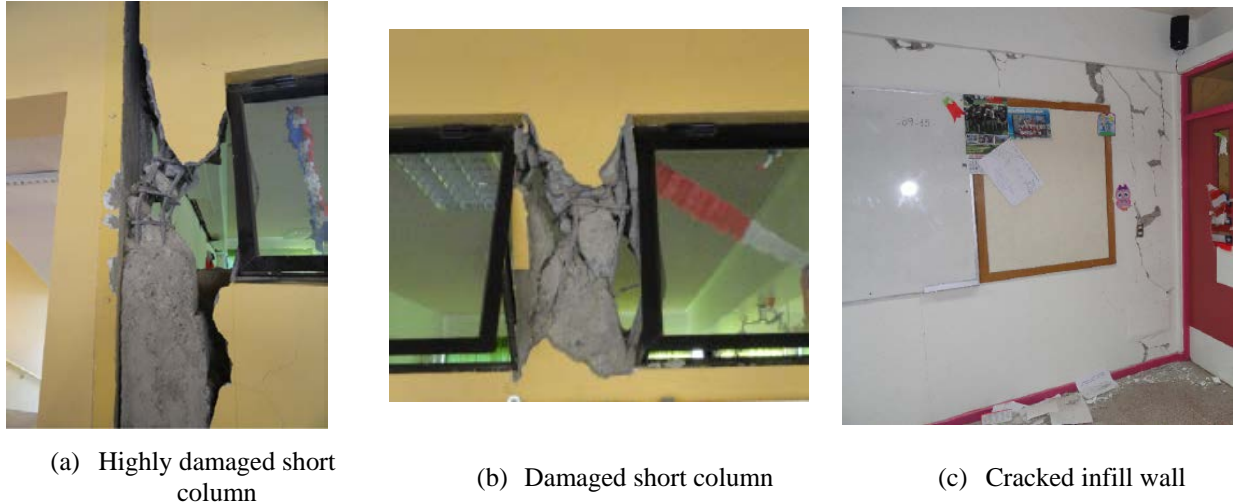
Figure 9. Observed damage in the analyzed wing

Two types of damage were observed: brittle shear failure of short columns, and extended cracking of confined masonry walls. Figure 9 displays representative examples of such failure types.

Figure 9.a represents the failure of a short column that is adjacent to a column belonging to an external wing (Figure 7.b); this explains the apparent asymmetry of the damage, as left (counterclockwise) shear strain was prevented by such column. Figure 9.b depicts the shear failure of a short column. Noticeably, the transverse reinforcement (6 mm diameter hoops separated 17 cm) proved totally insufficient. Figure 9.c illustrates the crushing of the top corner of an infill wall; this type of failure corresponds to the classical diagonal compression strut mechanism [11].
