SHAKE TABLE TESTING OF A FULL-SCALE WOOD FRAME BUILDING CONSIDERING THE GROUND MOTION DURATION

M. Motamedi⁽¹⁾, C. E. Ventura⁽²⁾, G. Taylor⁽³⁾, A. Bebamzadeh⁽⁴⁾

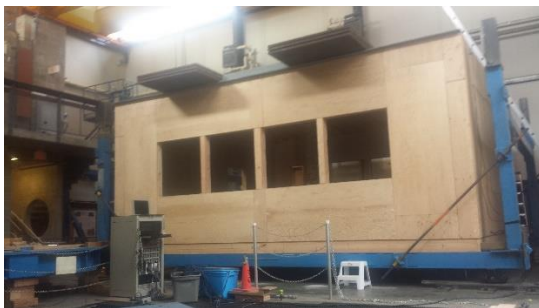
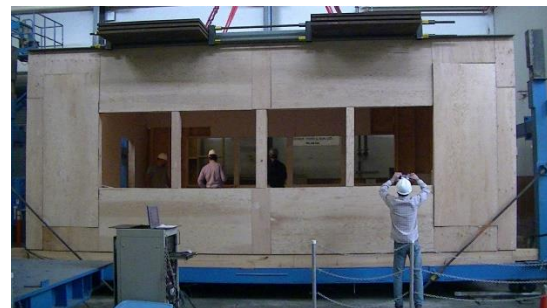
Figure 5 illustrates the general view of the Specimen Sp-1 (with Pattern “A”) before Test #1 and after Test #3. The deformed shear wall in south-west of the specimen and failure of the connections are shown in Figure 6(a). Figure 6(b) shows the internal damage after the third test run. The result of testing of Specimen Sp-1 confirmed that the shear wall panel reached a near-collapse state at least in 6% drift. The specimen sustained large inelastic deformation. However, it was still standing vertical and supporting the inertial loads. Typical damage in shear wall, nail pull through and separation of the plywood panels from studs are shown in Figure 7(a). Shear deformation and breaking of the nails are illustrated in Figure 7(b).

Fig. 5 - Specimen Sp-1: a) Before test #1, b) After test #3 [1]

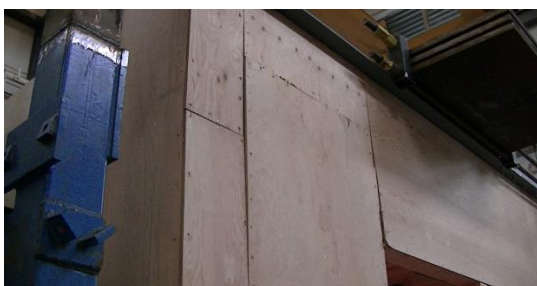
(a)

Fig. 6 - Damage in Specimen Sp-1 after test # 3: a) South-west shear wall, b) Internal view of drywall [1]

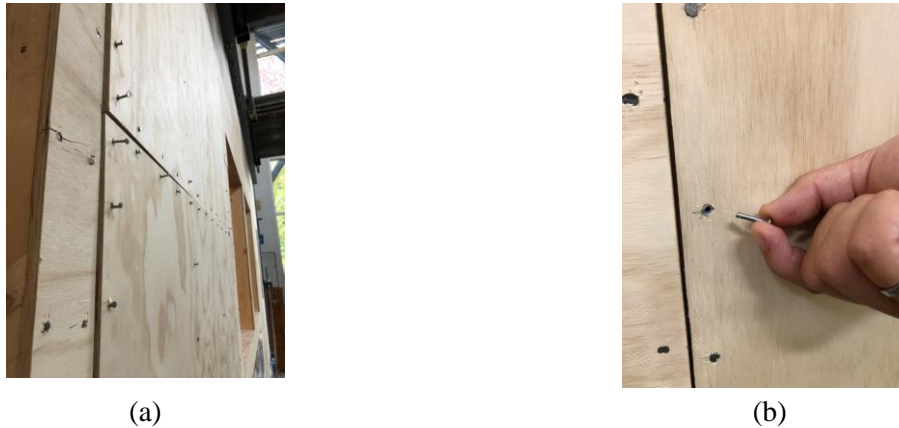
Fig. 7 - Damage in Specimen Sp-10 after test #2: a) South-west shear wall, b) Shear off nail

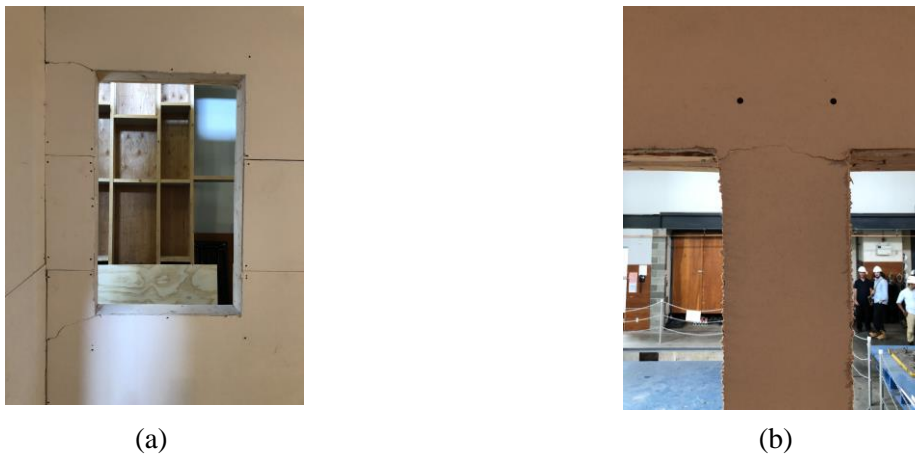
For internal gypsum wall board the failure mode was also found to be independent of the ground motion. The dominant failure mode was found to be tear-through as shown in Figure 8. It was observed to have occurred as the nail pushed laterally through the gypsum board resulting in a slotted hole around the nail and no resistance provided by the connection along the gap. Damage was observed to have occurred at both the top and bottom drywall panels. After testing, with only a small push by hand applied out of plane the plywood panels were easily detached from the wood frame.

Fig. 8 - Specimen Sp-9: a) After test #2, b) After test #3
