VERIFICATION OF THE FRACTURE MECHANISM OF A WOODEN BRACING BEARING WALL WITH CROSS-SECTIONAL DEFECTS

H. Funatsu⁽¹⁾, Y. Wakabayashi⁽²⁾, X. Chen⁽³⁾, N. Takiyama⁽⁴⁾

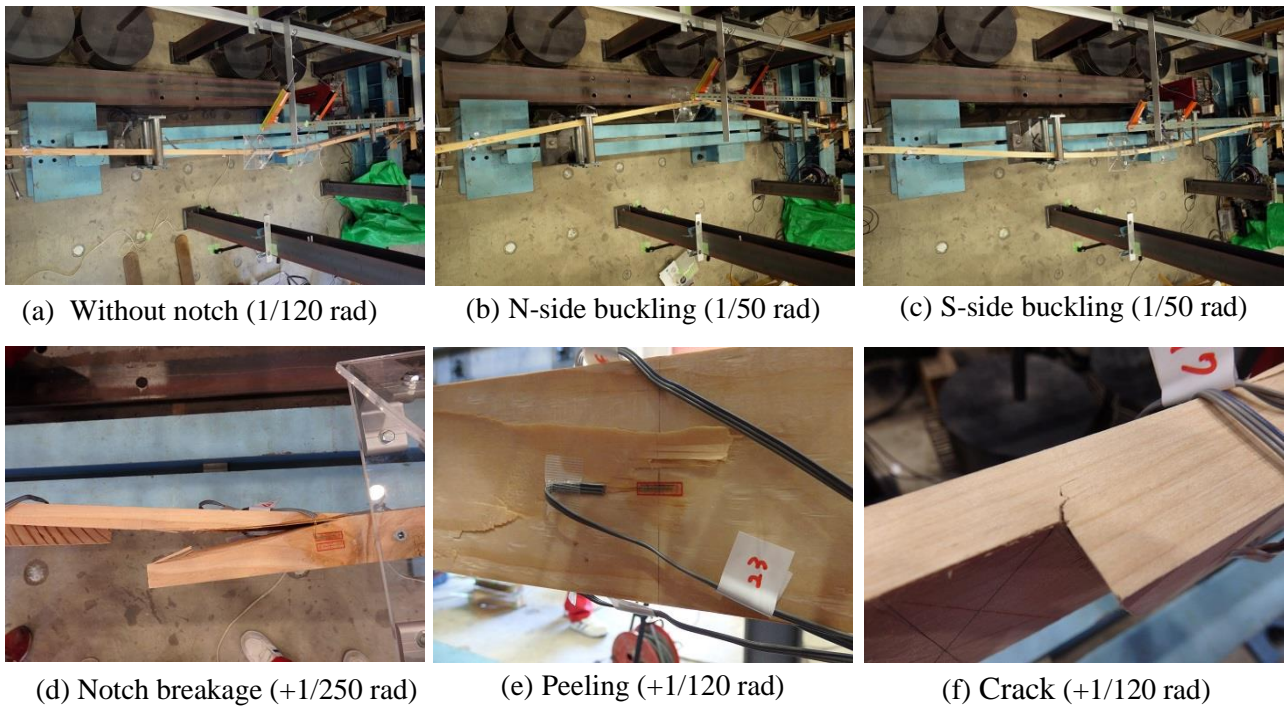
Fig. 3 – Typical damage of specimens

[S1] After exhibiting a maximum load of 6.4 kN on the compression side of 10.1 mm (1/150 rad), the material buckled and its resistance dropped rapidly. The maximum out-of-plane displacement was 128.7 mm on the W-side and 123.3 mm on the E-side. The bending moment in the out-of-plane direction was a maximum at the center of the bracing when compressed. When a tensile force of 12.6 mm (1/120 rad) was applied, the edge was ‘cut off’, but no other noticeable damage was observed.

[S2] After exhibiting a maximum load of 4.2 kN on the compression side of 6.0 mm (1/250 rad), the material buckled, and its resistance dropped rapidly. The maximum out-of-plane displacement was 184.3 mm on the W-side and 185.6 mm on the E-side. The bending moment in the out-of-plane direction was a maximum around the notch when compressed. It buckled to the N-side due to the compression-side force, referred to as N-side buckling. At 12.6 mm (1/120 rad) on the compression side, the surface of the notch portion was ‘peeled off’ at the N-side, and at 30.4 mm (1/50 rad) on the compression side, the notch segment was cracked.

[S3] After exhibiting a maximum load of 1.3 kN on the compression side of 6.0 mm (1/250 rad), the material broke immediately after buckling. The maximum out-of-plane displacement was 188.9 mm on the W-side and 213.6 mm on the E-side. It buckled to the notched S-side, referred to as S-side buckling, and was damaged in the notch at 6.0 mm (1/250 rad) on the compression side.

[S4] After exhibiting a maximum load of 3.2 kN on the compression side of 6.0 mm (1/250 rad), the material buckled and its resistance gradually decreased. The maximum out-of-plane displacement was 201.9 mm on

the W-side and 202.9 mm on the E-side. The bending moment in the out-of-plane direction was a maximum around the notch when compressed. Buckling occurred on the N-side, peeling started on the N-surface of the cutout at 12.6 mm (1/120 rad) on the compression side, and cracked significantly at 30.4 mm (1/50 rad) on the compression side.

[S5] After exhibiting a maximum load of 5.8 kN on the compression side of 6.0 mm (1/250 rad), the material buckled and its resistance dropped rapidly. The maximum out-of-plane displacement was 189.0 mm on the W-side and 184.4 mm on the E-side. The bending moment in the out-of-plane direction was a maximum around the notch when compressed. Buckling occurred on the N-side, cracks occurred in the notch at 12.6 mm (1/120 rad) on the compression side, and a relatively small amount of peeling occurred on the N-surface of the notch at 30.4 mm (1/50 rad) on the compression side.

The bracing without a notch was not damaged by buckling, and the bracing with a notch generally resulted in damage to the notch. Regarding the buckling load, the bracing S1 without a notch exhibited the largest buckling load, followed by the bracing S5 with a notch. The bending moment in the out-of-plane direction of the compression side of the bracing showed a maximum at the center of the bracing (around the notch for the bracing with a notch).

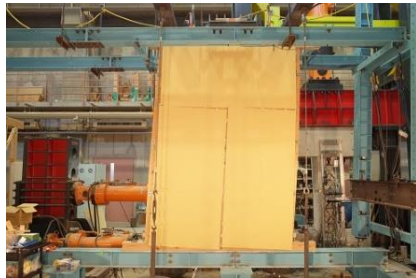
[F1] The maximum strength of the specimen was 33.8 kN on the positive side and 38.5 kN on the negative side, and the deformation angles at the break were 0.020 rad on the positive side and 0.013 rad on the negative side.

The damage became audible at $1/100$ rad on the positive side, and louder at $1/50$ rad on the positive side. At approximately $1/150$ rad, the corners where the gypsum boards were in contact with each other began to get damaged, and the screws from the W-side rows on both sides of the W-side gypsum board attached to the lower section of the frame gradually became detached. Before reaching the negative $1/50$ rad, the N-side compression brace broke through the gypsum board. Furthermore, before reaching the second $1/50$ rad on the positive side, the lower part of the S-side compression bracing broke, penetrating the gypsum board. The pedestal did not show any noticeable damage. At the time of dismantling, it was confirmed that a screw had broken and a split had occurred where the bracings of the studs on the W and E-sides were in contact.

(a) Before reaching (-1/50 rad)

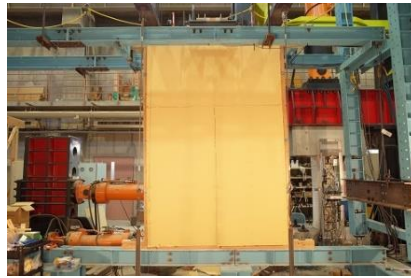
(b) Before reaching (+1/50 rad)

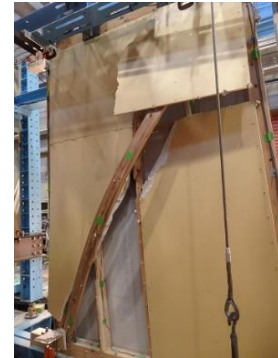
(c) N-side damage

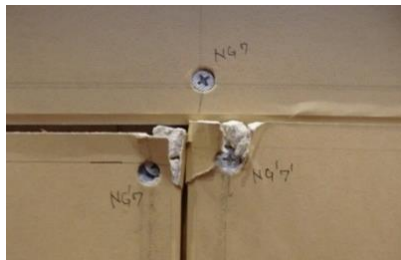
(d) Gypsum board joint damage (1/50 rad)

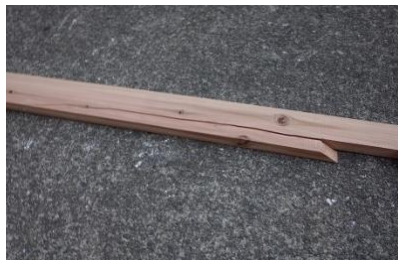
(e) W-side stud splitting when dismantling

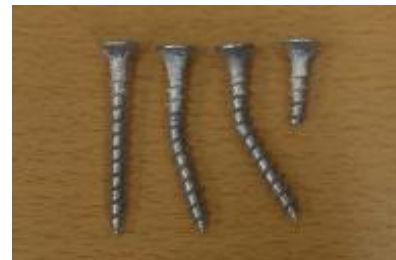
(f) Screw break

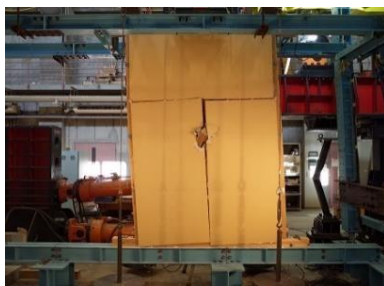
[F2] The maximum strength of the specimen was 28.2 kN on the positive side and 29.2 kN on the negative side, and the deformation angles at the break were 0.023 rad on the positive side and 0.010 rad on the negative side.

At $1/180$ rad on the positive side, the corner of the gypsum board started to get damaged, and at $1/120$ rad on the negative side, the damage became audible. After arriving at the $1/50$ rad on the positive side, the compression bracing on the S-side broke at the notch and pierced the gypsum board. Furthermore, before reaching the negative $1/50$ rad, the N-side compression bracing also broke. The pedestal did not show any noticeable damage. At the time of dismantling, it was confirmed that a split had occurred at the lower end of the S-side bracing.

(a) Reaching (+1/50 rad)

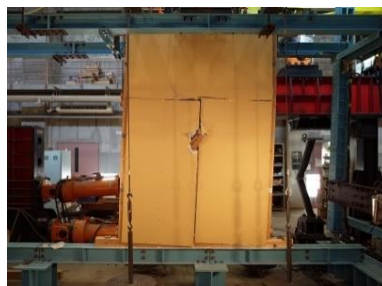
(b) Before reaching (+1/50 rad)

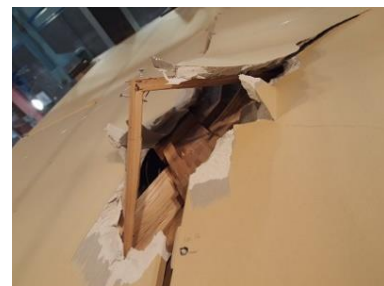
(c) Bracing damage (1/50 rad)

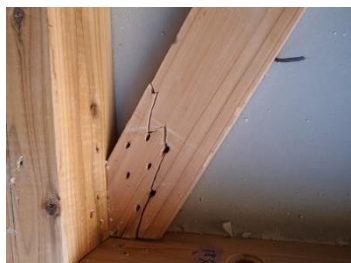
(d) Lower end of N side bracing when dismantling

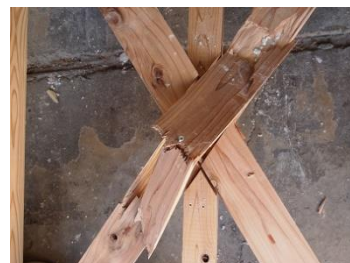
(e) Bracing damage when dismantling
