DAMAGE MECHANISM OF PVC DRAINAGE PIPE CONNECTED TO HOUSE WITH HIGH SEISMIC PERFORMANCE

Abstract

Keywords: Shaking table test; wood house; functionality; PVC drainage pipe

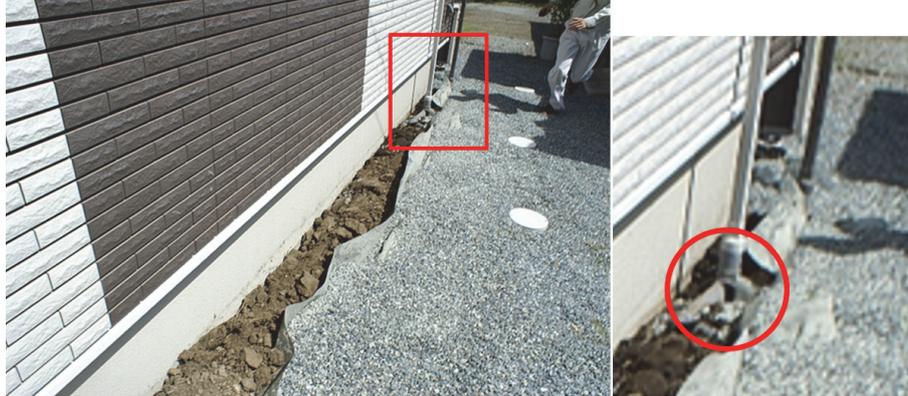
due to the house slippage. In this figure, a pipe for rainwater drainage was disconnected. It probably resulted from relative displacement between the house and the ground induced by the slippage.

Fig. 1 – Evidence of house slippage (courtesy of Ichijo Co.,Ltd.)

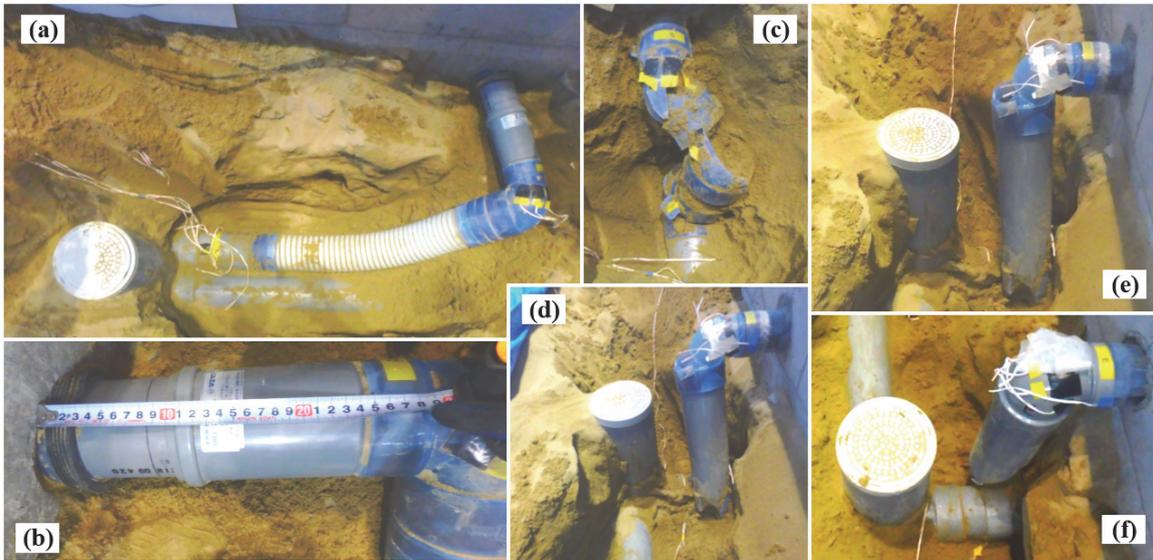
Fig. 8 – Damage inspection of specimens

Damage inspection of PVC pipes was performed during shaking through video cameras. It was observed that the reducing elbow in Section D was fatally ruptured in JMA Kobe 100%. Damage conditions of Sections A to C could not be captured from the videos because these pipes were fully embedded in the surrounding soil. Section E with VP pipes had minor damage in the 100A socket of the reducing elbow, but the reducing elbow itself showed no rupture.

After all the shaking, another damage inspection was performed by excavating soil around the PVC drainage pipes. Fig. 8a shows Section A with insignificant damage. As shown in Fig. 8b, the expansion joint was contracted approximately 45 mm and a rubber packing was pulled out from the foundation. The rubber packing can be easily returned to original position by hand, and Section A was still functional even though the house slippage was quite large. The house slippage was about 140 mm in the negative Y-direction and approximately 110 mm in the positive Y-direction in JMA Kobe and JR Takatori 100 %, respectively, and therefore, the residual slippage of the house was approximately 30 mm (Fig. 7). So, 45 mm contraction of the expansion joint implies this 15 mm difference induced pull-out of the packing. Because 140 mm slippage was beyond the capacity of the expansion, ± 60 mm, it was absorbed by the embedded flexible pipe as well as the expansion joint. In JMA Kobe 100 % motion, the soil around the flexible pipe was pushed in the negative Y-direction by the house slippage, the flexible pipe could be deformed with the surrounding soil easily. However, the soil around the flexible pipe stayed in JR Takatori motion because the house slipped in the positive Y-direction, and therefore, flexibility of the flexible pipe may be reduced by reaction from the surrounding soil. It may result in 15 mm difference between the residual slippage of the house and the contraction of the expansion. So, the combination of the expansion joint and the flexible pipe worked quite well in this test, but more modification is probably necessary against house slippage in pulling direction.

Figs. 8c to 8f show damage condition of Sections B to E, respectively. The lower elbows as well as the reducing elbows were fatally ruptured in Sections B to D. The reducing elbow in Section E had only minor damage as mentioned above, but the bottom portion of the vertical pipe was totally failed. Based on the inspection, it is obvious that Sections B to E completely lost their function. It is noticeable that the fatal rupture in Sections B to E was not happen at instrumented area.

- 2) As a possible seismic reinforcement approach of PVC drainage pipe, a combination of a flexible pipe and expansion joints was applied in the shaking table test. Based on damage inspection, the reinforced pipe had considerable contraction along one of the expansion joints and pull-out of rubber packing, but it could avoid functional disorder. More modifications are necessary, especially against house slippage in pulling direction for the pipes.

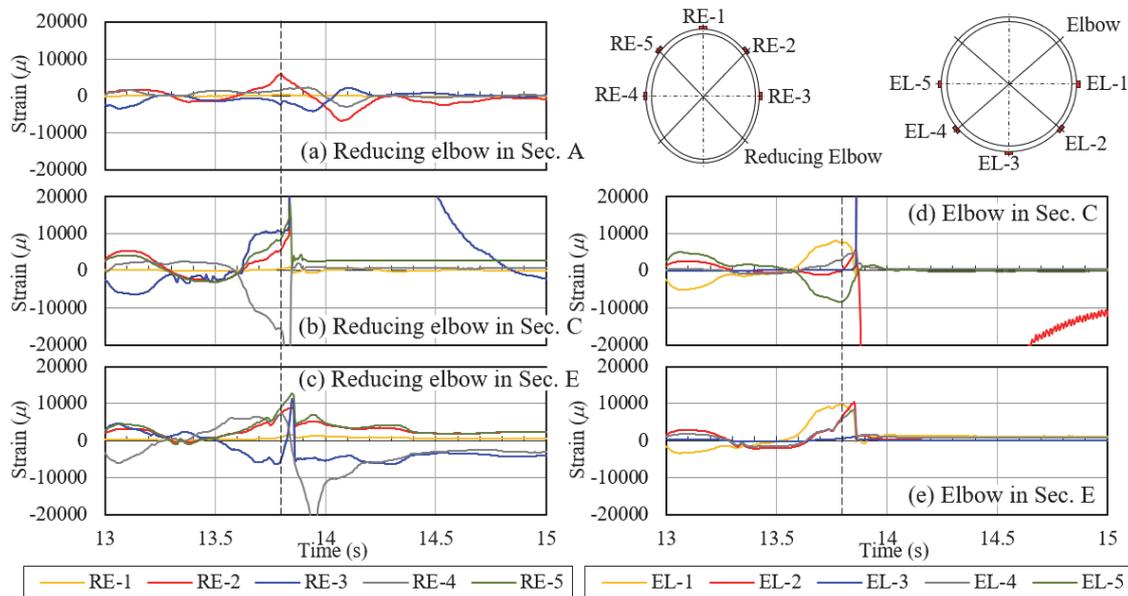
Fig. 12 – Time histories of axial strain around elbows at input of JMA Kobe 100 %

Time histories of axial strain around the reducing elbows in Sections A, C and E in JMA Kobe 100% are shown in Figs. 12a, 12b and 12c, and ones around the lower elbows in Sections C and E are plotted in Figs. 12d and 12e. It is noted that the strain in this figure is not strain at failure because the gages were not

placed at the ruptured portions. So, it is assumed herein that the PVC pipe was collapsed near the gage when discontinuity of strain time histories appeared at that gage. Based on Fig. 12a, the maximum strain reached at approximately 6000 micro strain, but there was no jump observed in Section A. On the other hands, significant jumps of strain records were recorded at 13.85 s in Sections C as shown in Fig. 12b. These jumps may correspond to the fatal rupture of the reducing elbows in Section C as observed in Fig. 8d. Again, considerable strain jumps appeared in some of the gages in Fig. 12c, but they are less significant than in Fig. 12b. These relatively small jumps may imply minor damage of the pipe, such as the 100A socket failure. Also, significant discontinuity of strain appeared in the lower elbow in Section C at 13.87 s, slightly after the strain jumps in the reducing elbow as shown in Fig. 12d. It may correspond to the fatal damage of the lower elbow in Section C. Relatively minor strain jumps were observed in Fig. 12e at 13.85 s in Section E. It may be when the vertical pipe was fatally collapsed and accumulated strain in the lower elbow was released.

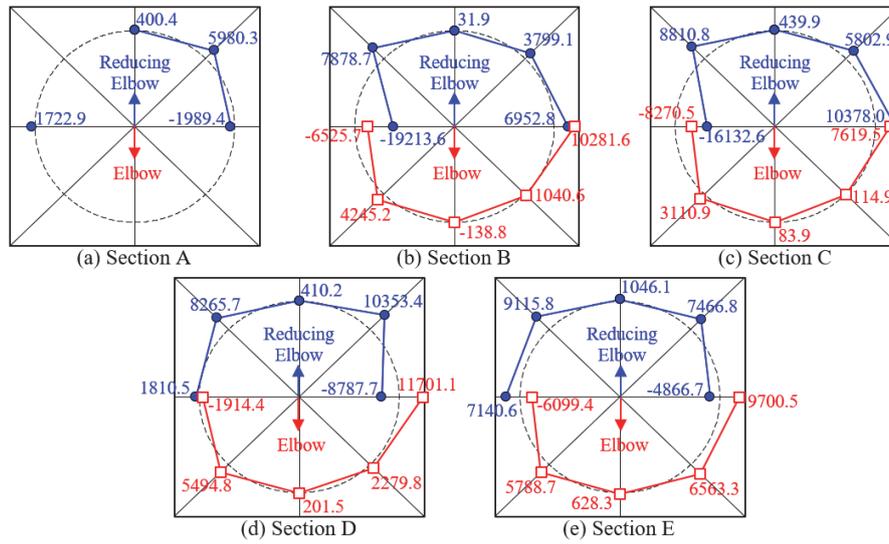
Fig. 13 – Distribution of axial strain around elbow portions at 13.8 s in JMA Kobe 100 %

Fig. 13 shows distribution of axial strain around the reducing and lower elbows at 13.8 s in JMA Kobe 100%, right before the significant strain jumps. This figure shows different tendency from Fig. 10; that is, significant strains appeared on the sides of the reducing and lower elbows. RE-3 and RE-4 in the reducing elbow, and EL-1 and EL-5 in the lower elbow show different sign of axial strain. It indicates that the elbows were significantly bent. In Sections B and C, the reducing and the lower elbows were bent in the same direction, however, these elbows deformed in the opposite direction in Sections D and E.

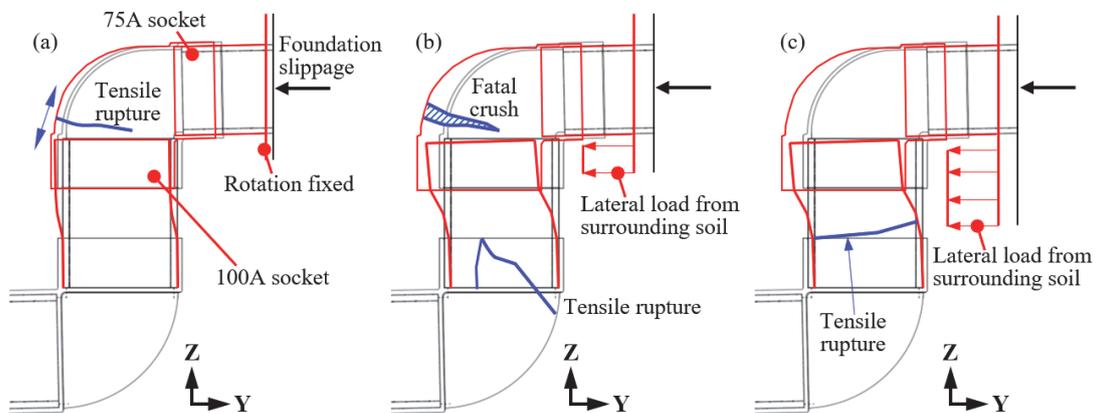
Fig. 15 – Possible failure mechanism due to house slippage in Y-axis

Based on the above results from the inspection and data analysis, a possible failure mechanism of the drainage pipes is illustrated in Fig. 15. At the first stage, rotational deformation around the reducing elbows was partially restricted because of rotationally fixed boundary connection at the surface of the house foundation, and therefore, tensile rupture was generated around the 100A socket in the reducing elbow as shown in Fig. 15a. If the PVC drainage pipes were in the air without the surrounding soil, all the strain along the pipes were released and no more failure appeared. However, large displacement of the surrounding soil was induced due to embedded portion of the house foundation, and pushed the pipes. In Sections B and C, because the depth of the embedment of the pipes was large relative to one of the house foundation, the lower elbows may be fatally failed around the socket to the vertical pipes by bending deformation (Fig. 15b). On

the other hand, in a case if the depth of embedment of the pipe was relatively small comparing with one of the foundation like Section E, the bottom portion of the vertical pipe may be failed by shear deformation as shown in Fig. 15c. In addition, deformation development mechanism due to the house slippage in X-direction is shown in Fig. 16. Sections A, B and C bent in the opposite direction to Sections D and E as mentioned above. It probably resulted from different fixity in rotation around the vertical axis; that is, the void tubes in Sections D and E provided less rotational restriction than in the other sections. Based on the

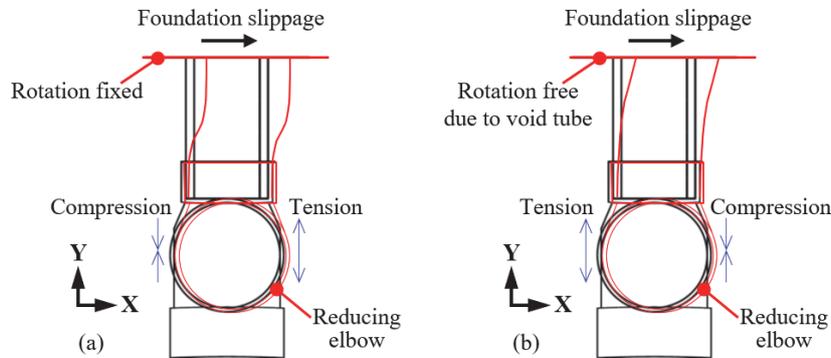
Fig. 16 – Deformation development due to house slippage in X-axis

discussion herein, it can be reasonably hypothesized that deformation and failure mechanism of the PVC drainage pipes are highly dependent on fixity at the surface of the house foundation, relative depth of embedment of the pipes to the house foundation, and the surrounding soil as well as the amount and direction of the house slippage.
