RAPID DAMAGE ASSESSMENT PROCEDURE TO COLLECT, PROCESS, AND ANALYZE DATA FOR MONITORING OF FULL-SCALE TESTS

Abstract

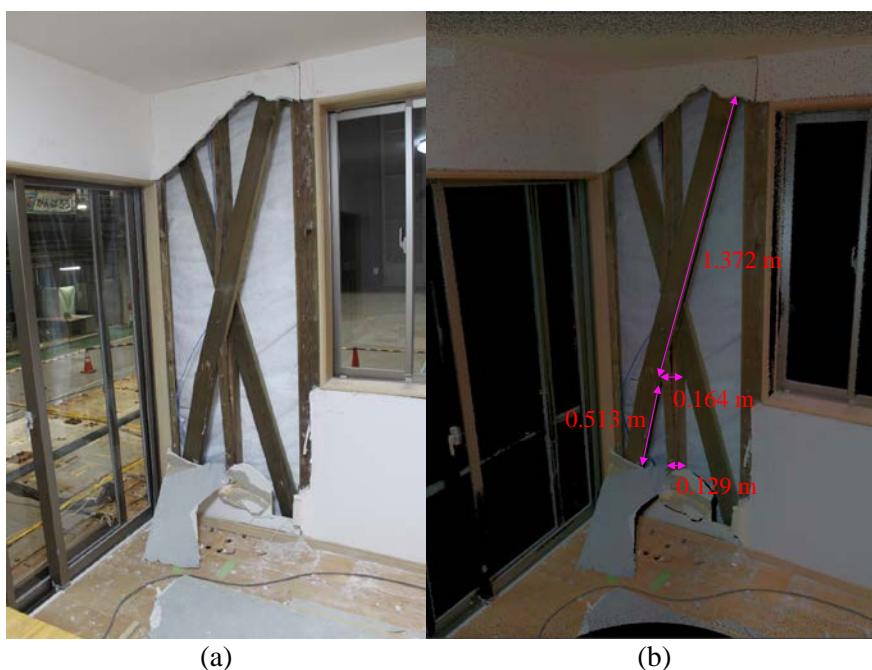
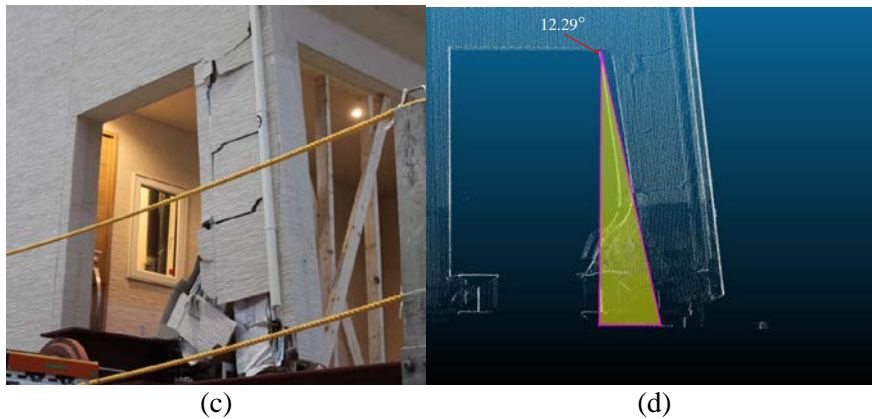
No major structural damage was observed in the first two days of testing, and hence, neither the LiDAR scans nor the visual inspections revealed any structural damage. During the next two test days, structural damage occurred, while during Test Day 4 damaged structural components were exposed due to the severity of the damage. Fig. 5 presents two examples of the structural damage in Building A (Fig. 5a and 5b) and Building B (Fig. 5c and 5d) on Test Day 4. Fig. 5a shows a photo taken from a damaged diagonal wood bracing in Building A using a camera, while Fig. 5b shows a screenshot of the LiDAR point cloud of this element with a number of measurements. The comparisons illustrate the advantage of LiDAR point clouds over ordinary visual inspections to store perishable data and allow researchers to perform post-mortem measurements. In a similar manner, Fig. 5c and 5d, respectively, present the photo and LiDAR point cloud of a distorted column in Building B and the rotation angle measured through the point cloud.

Fig. 5: Camera photos and LiDAR point cloud screenshots of ((a) and (b)) a damaged bracing in Building A and ((c) and (d)) a distorted column in Building B.

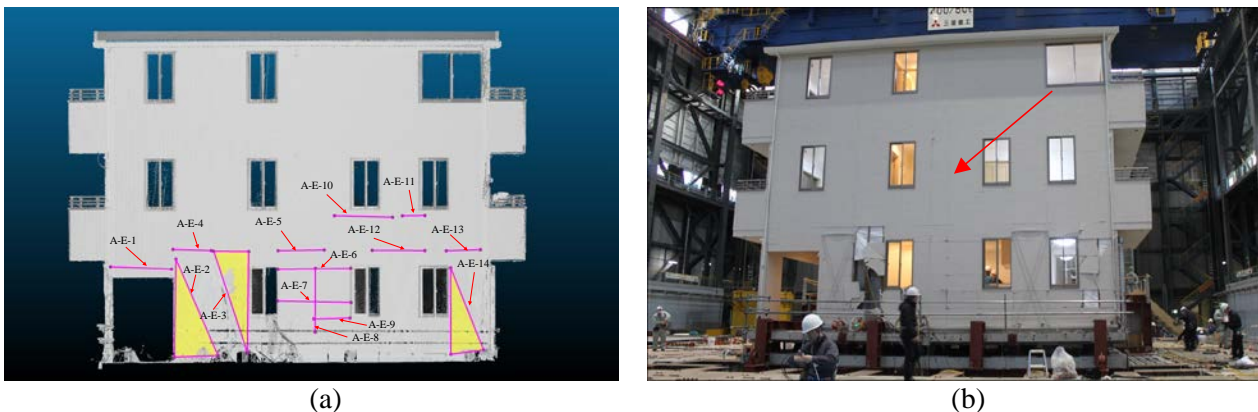
During the first two days of testing, when Building A was located on base isolation, very minor nonstructural damage was observed, while Building B experienced nonstructural damage from the first day of testing. Both buildings experienced severe structural damage in the last two days of testing. As an example of the nonstructural damage, Fig. 6 presents the façade damage on the eastern wall of Building A on Test Day 4. Fig. 6a shows a screenshot of the LiDAR point cloud of this damaged wall along with the detected damage marked by pink lines for cracks and yellow areas for the spalling, while Fig. 6b shows a photo of this wall taken using an ordinary camera during the visual inspection. The length of the cracks as well as the area of the spalled façade boards measured using the LiDAR point cloud are summarized in Table 2. As another advantage, LiDAR point clouds enable measurements on the buildings even after they are demolished.

Fig. 6: Façade damage on the east-side wall of Building A; (a) a screenshot of the LiDAR point cloud and the detected damage, and (b) a photo taken using an ordinary camera during the visual inspection.

<u>Cracks</u>		<u>Damaged areas</u>	
Label	Length (m)	Label	Area (m ²)
A-E-1	1.611	A-E-2	3.125
A-E-4	1.019	A-E-3	2.500
A-E-5	1.220	A-E-14	2.025
A-E-6	1.924		
A-E-7	1.945		
A-E-8	1.684		
A-E-9	0.968		
A-E-10	1.539		
A-E-11	0.594		
A-E-12	1.394		
A-E-13	0.904
