NONLINEAR DYNAMIC ANALYSIS OF AN INFILLED RC FRAME BUILDING DURING THE 2016, MUISNE, ECUADOR EARTHQUAKE

Abstract

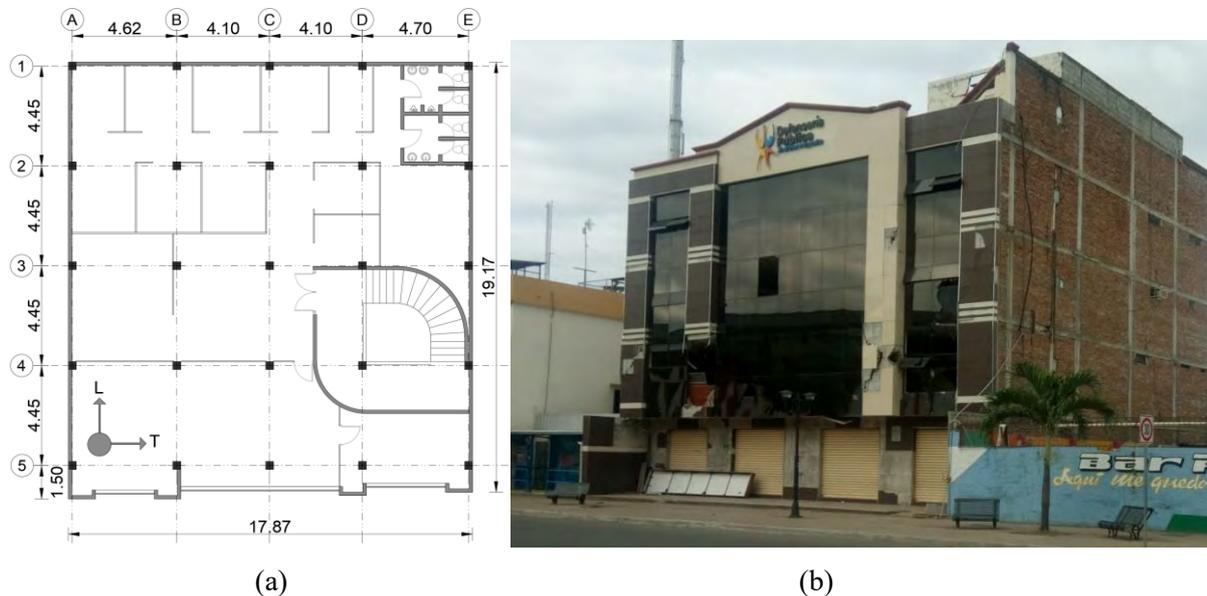
Fig. 1 – (a) Typical Plan View, dimensions in meters (b) Photo of the building after the 2016, Muisne earthquake

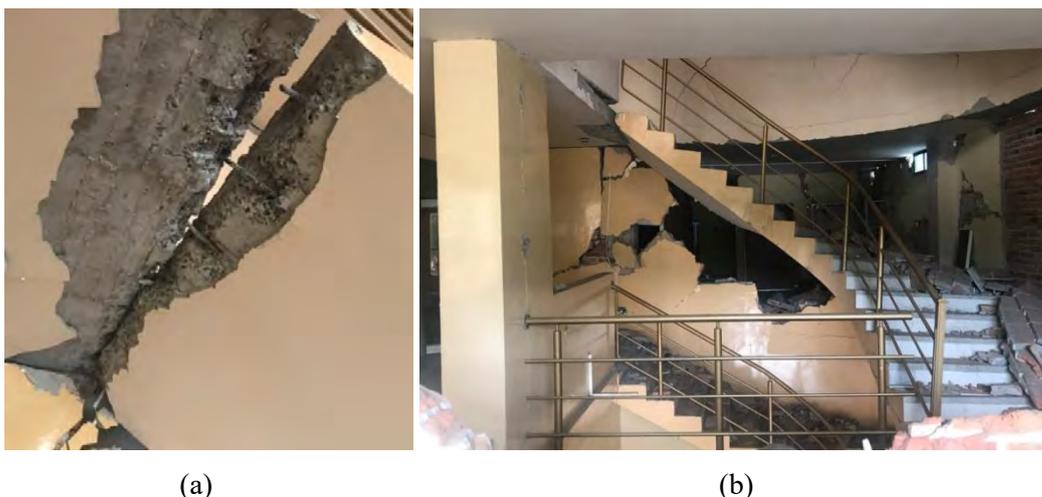
The stairs, specifically on the first story, were the most damaged element of the building. The stairs have an helicoidal shape and were built using a single layer of five-12mm rebars. This poor reinforcement, added to the eccentric location on the building plan and the inherent flexibility of the building structural system, almost caused the collapse of the first-to-second story section of the stairs. One of the 5 rebars connecting the stairs to the slab in the second story failed in tension. The stairs displaced three to five centimeters away from the slab. Considering the above, the connection between the stairs and the slabs is assumed as pinned and therefore, not considered in the analysis model.

The infill walls were constructed using clay bricks. Their dimensions were 300x140x60mm. Interestingly, the walls surrounding the stairs were built rotating the bricks a 90 degree angle, which results in 60mm as the base and not the height of each brick in the wall. All of these walls collapsed during the 2016, Muisne earthquake. Figure 2 shows the damage on the stair and the above-mentioned walls.

Fig. 2 – (a) View from below of the connection of the stair to the slab. Notice the first bar broken and the displacement of the slab (b) Collapse of clay brick walls surrounding the helicoidal stairs.

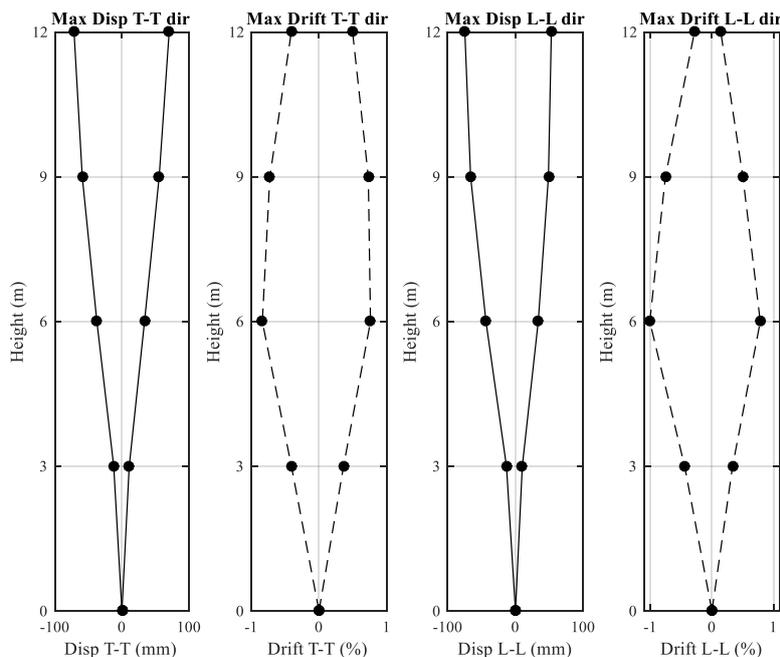
Based on the previous results, the model is considered to be valid. Next, peak story displacements and drifts are extracted from the results of the numerical model as shown in Figure 6. The maximum displacement is about 100 mm in the roof. The maximum story drift is approximately 1%, on the second story, which coincides with the concentration of damage that was evidenced in the post-earthquake recognition.

Fig. 6 – Peak story displacements and drifts

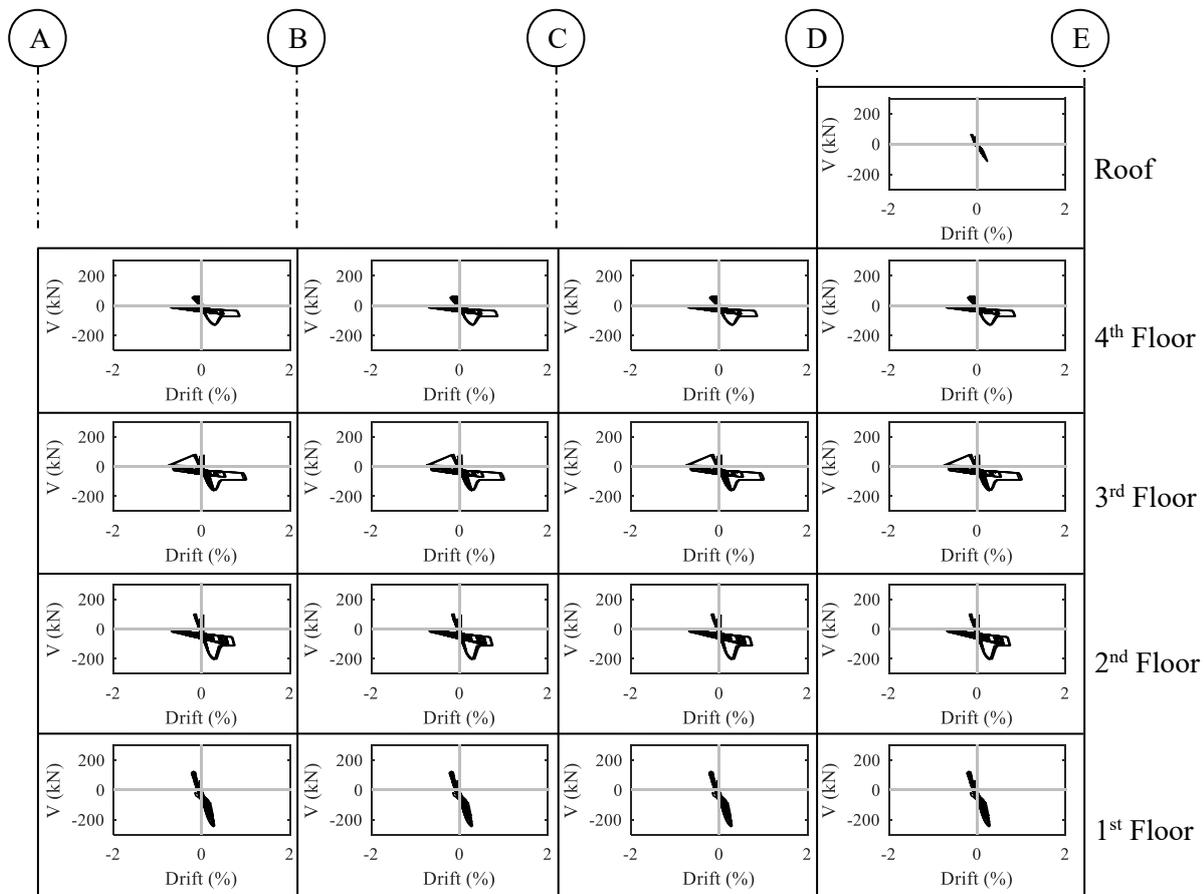
The damage state of the masonry infills is verified by contrasting the actual state of the infill walls in the post-earthquake recognition with the shear force-vs.-drift responses of each element representing the infills in the model. Figure 7 displays an elevation view of Frame 1 (back façade), following the axis notation shown in the plan view of Figure 1. Similarly, Figure 9 presents an elevation view of Frame A (side façade). Only one side façade is shown. Frame E response is similar to the one presented in Figure 9. Also, photos of the actual state of damage after the earthquake of a representative infill wall of each floor are exhibited in Figure 8. Furthermore, masonry walls in the first and fourth floor remained in good state. However, the damage concentrated in the second and third floor. Therefore, the elements that represent the infill walls in the model present a response that accurately describes the damage presented by the infills of the structure.

Fig. 7 – Shear force-vs.-drift plots in Frame 1 (back façade)

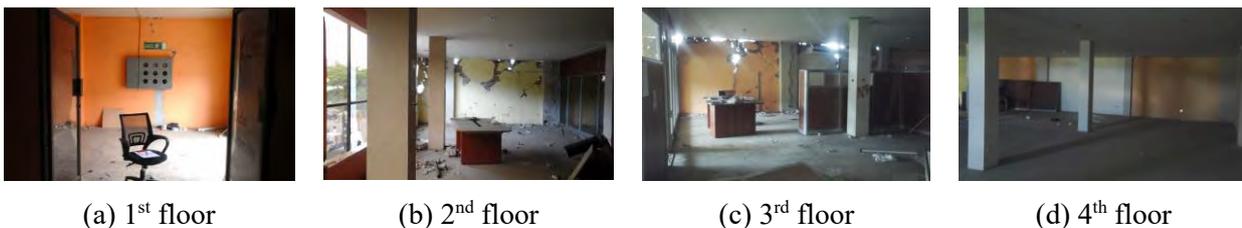
Fig. 8 – Actual state of damage of masonry walls in the post-earthquake recognition

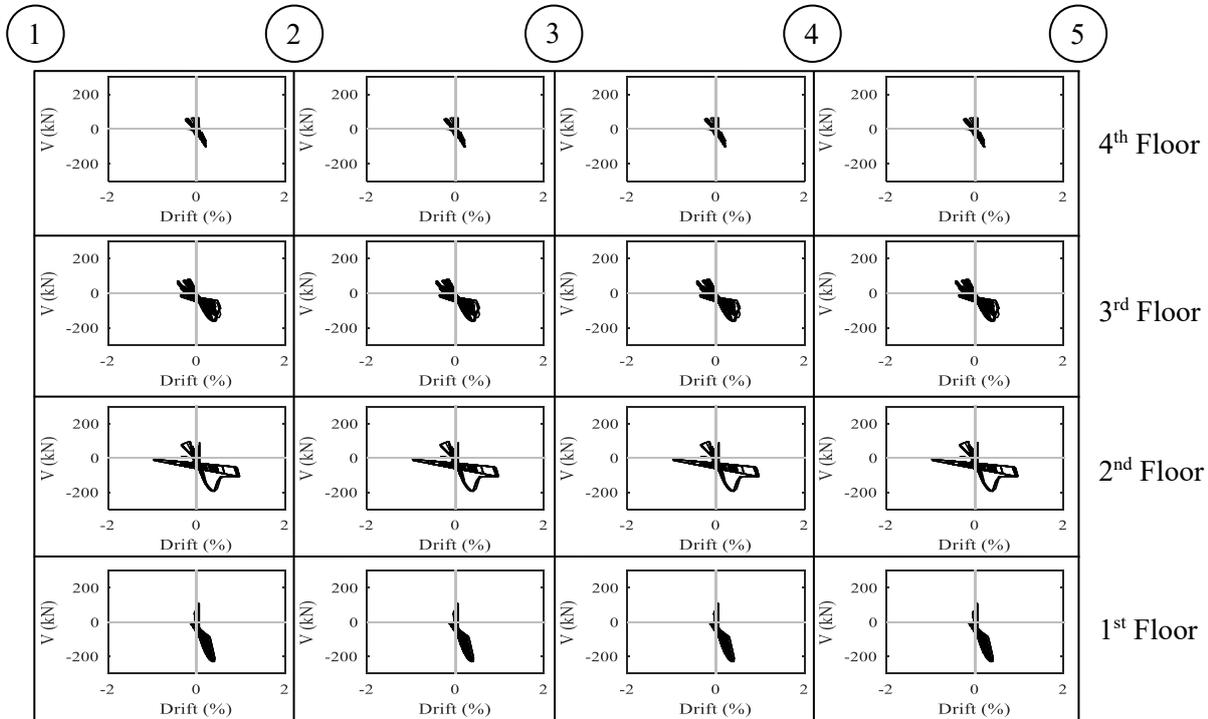
Fig. 9 – Shear force-vs.-drift plots in Frame A (side façade)
