Experimental Seismic Test of Drywall Partition Walls with Improved Detailing for Damage Reduction

R. Ryan⁽¹⁾, H. Hasani⁽²⁾

Abstract

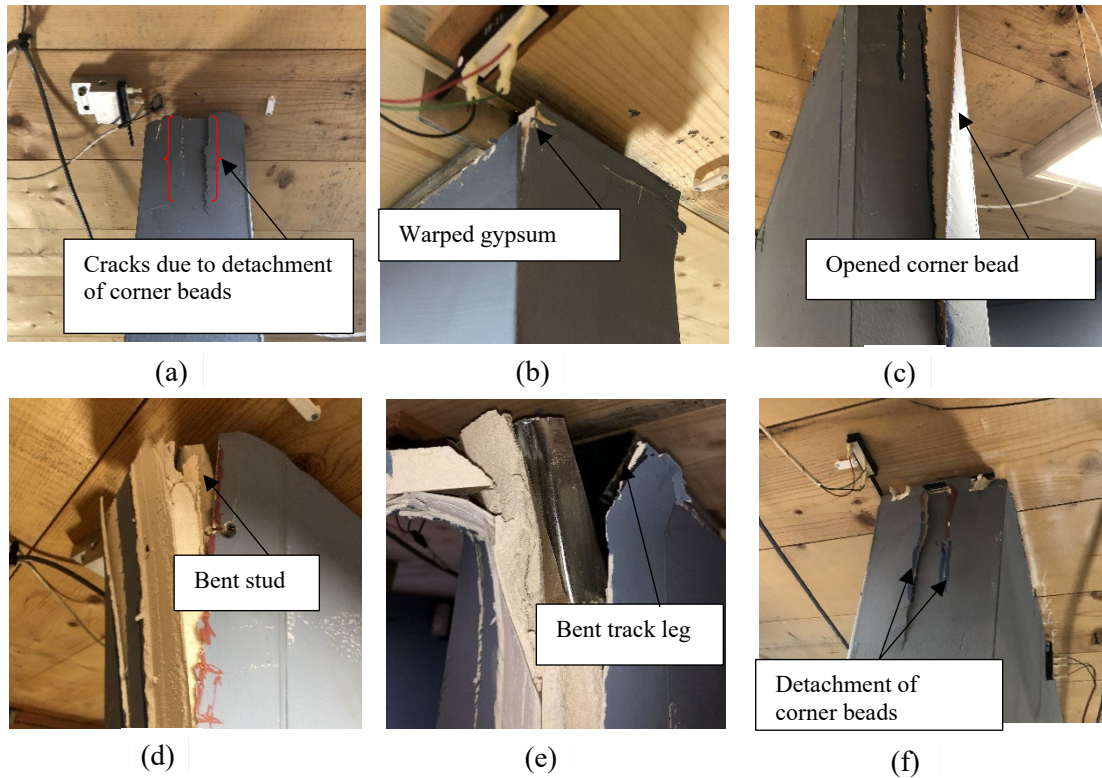
Damage observations for both walls are shown in Fig. 7. Corner beads at the end of both walls started to lightly detach at around 0.46% drift (shown for slip track detailing in Fig. 7(a)). This damage occurs because the entire wall below the top track tends to remain stationary, while the top track tends to move with the top diaphragm (natural behavior of slip-track). Since fire regulations permit only up to half-inch gap at the top of the gypsum [9], while the length of the top track leg is 2 in. for both types of detailing, the top track hits the gypsum at the top of the wall ends.

The detachment of corner beads increased with increasing drift. Light warping of the gypsum was observed at 0.67% drift (Fig. 7(b)), and the corner bead opened significantly at 0.84% in the slip-track connected wall (Fig. 7(c)). Coincident with this observation at 1.26 in. displacement, the resisting force increased significantly. Since the stud leg is 1.25 in., the authors believe that the considerable opening in the corner bead is due to the stud not returning to its nested track in the slip-track connected wall. Bending of the end stud was observed at 2.56% drift in the slip-track detailed wall (Fig. 7(d)). At 3.2% drift, the damaged end stud in the slip-track detailed wall bent the leg of the track (Fig. 7(e)), which was coincident with a considerable increase in the resisting force. While all of this damage progressed in the slip-track detailed wall, the telescoping detailed wall showed only minor damage at the top end of the wall (Fig. 7(f)).

Fig. 7: Phase 1 observations: (a) Light detachment of corner bead at wall ends (0.46% drift, slip track); (b) light warping of drywall (0.67% drift, slip track); (c) significant opening in the corner bead (0.84% drift, slip track); (d) end stud bending (2.56% drift, slip track); (e) track leg bent (3.2% drift, slip track); (f) light detachment of corner bead at wall ends (5% drift, telescoping)

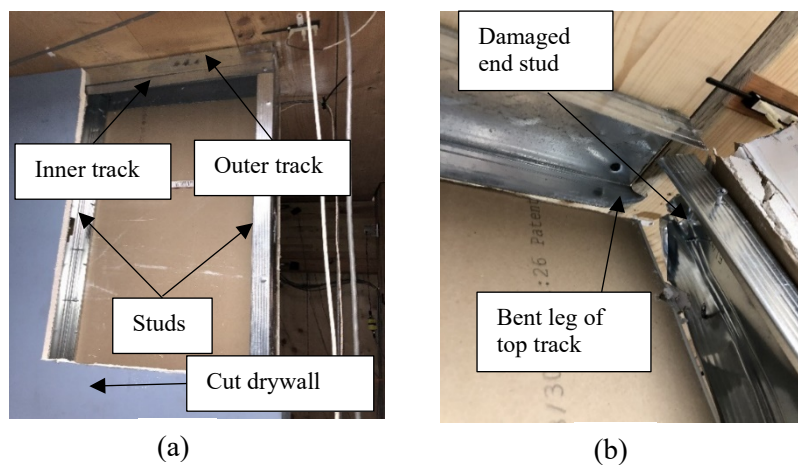
Photos from the post-test inspection of both walls are included in Fig. 8. These inspections suggest that the framing of the wall with telescoping detailing remained damage-free during the test (Fig. 8(a)). However, the stud and track of slip-track detailing suffered damage due to the detachment of end studs from the track (Fig. 8(b)).

Fig. 8: Phase 1 post-test inspection after removal of drywall: (a) damage in the wall with telescoping detailing; (b) damage in the wall with a slip track connection

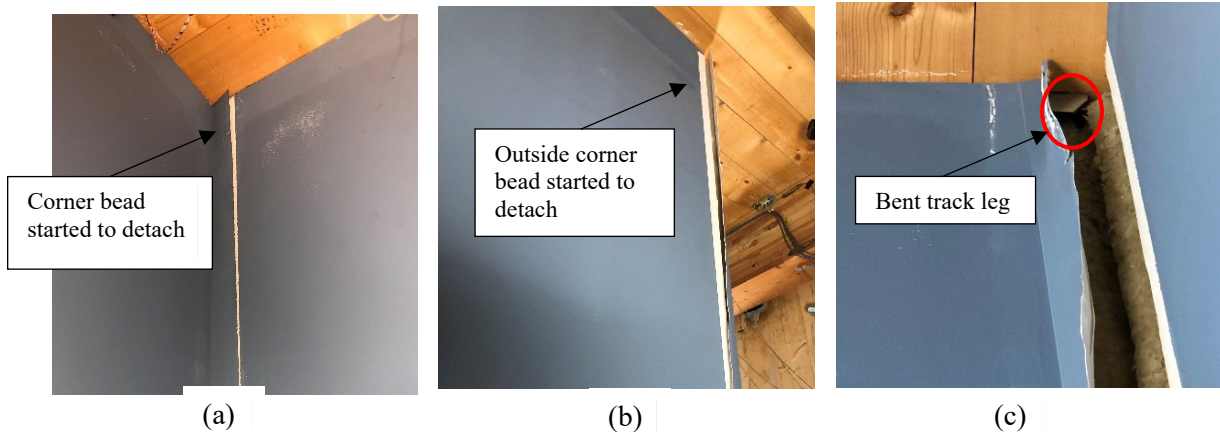
Representative damage is shown in Fig. 9 for the corner gap wall and Fig. 10 for the distributed gap wall. One of the corner beads started to detach at a 0.43% drift (Fig. 9a). At 0.84% drift, all of the corner beads started opening, and the width of the opening increased as the drift was increased (Fig. 9b). At 2.56% drift, the bending of the track leg within the corner gap region was apparent (Fig. 9c). For the distributed gap wall, at 0.84%

Fig. 9: Phase 2 observations in corner gap wall: (a) corner bead opening (0.43% drift), (b) opening of outer corner bead (1.05% drift), (c) bending of the track (2.56% drift)

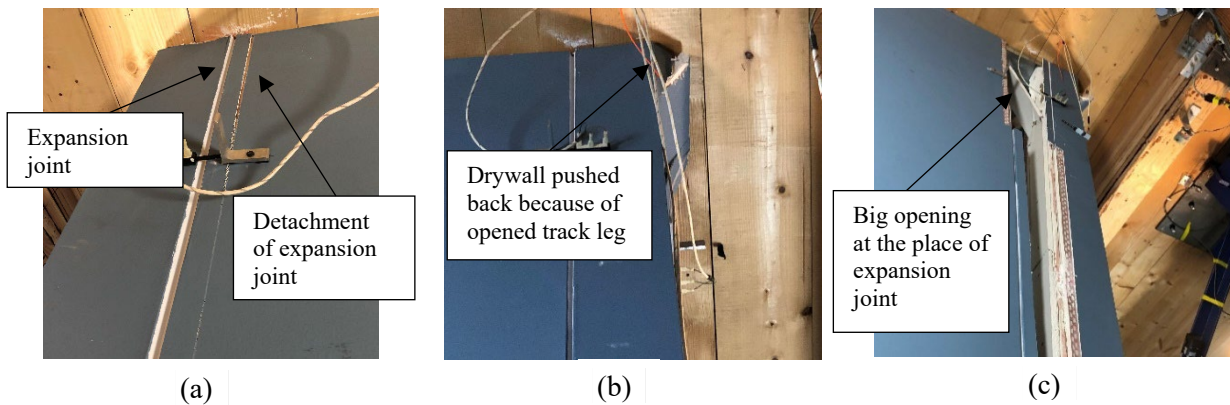
drift, the non-fire rated expansion joint adjacent to the return wall started to detach (Fig. 10a). At 1.05% drift, the leg of the track at the wall intersection began to open and pushed the drywall (Fig. 10b). At 2.56% drift, the distributed gap developed big openings adjacent to the return walls (Fig. 10c).

Fig. 10: Phase 2 observations in distributed gap wall: (a) detachment of expansion joint (0.84% drift), (b) opening of the track leg (1.05% drift), (c) opening in the fire-rated wall intersection (2.56%)

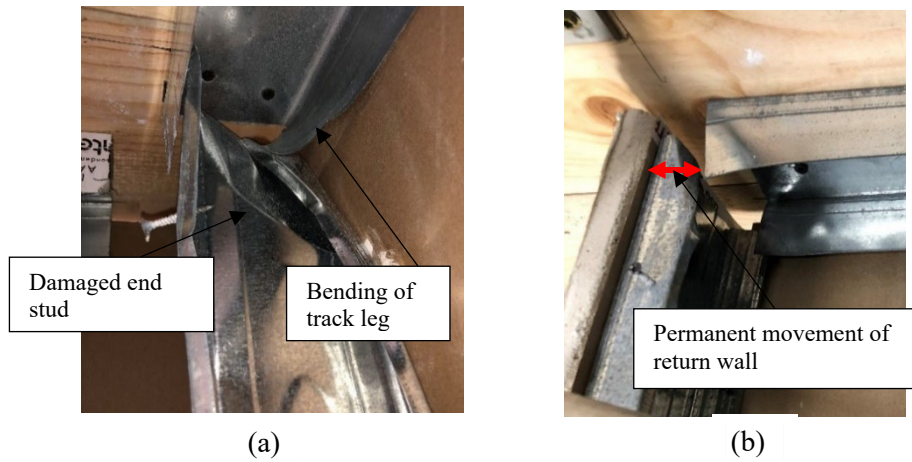
Photos from post-test inspections are shown in Fig. 11 for the corner gap wall and Fig. 12 for the distributed gap wall. In the corner gap wall, end studs were damaged, and the track legs were bent (Fig. 11a). Moreover, the return wall had permanently moved in its in-plane direction (Fig. 11b). In the distributed gap wall, the return wall moved permanently in its in-plane direction for both fire-rated (Fig. 12a) and non-fire rated (Fig. 12b) gap detailing. Besides, in the fire-rated wall intersection, the gap in the return wall also opened, and the studs pushed out through the track legs (Fig. 12c). Since the gaps on both sides adjacent to the wall intersection opened, the small corner section of the wall became unstable. Damage in the non-fire rated wall intersection for distributed gap detailing (Fig. 12d) included the opening of the track leg and studs being pushed out of the track.

Fig. 11: Phase 2 post-test inspections of the corner gap wall: (a) damage in the end stud and bending of the leg of track, (b) permanent movement of the out-of-plane wall in the in-plane direction

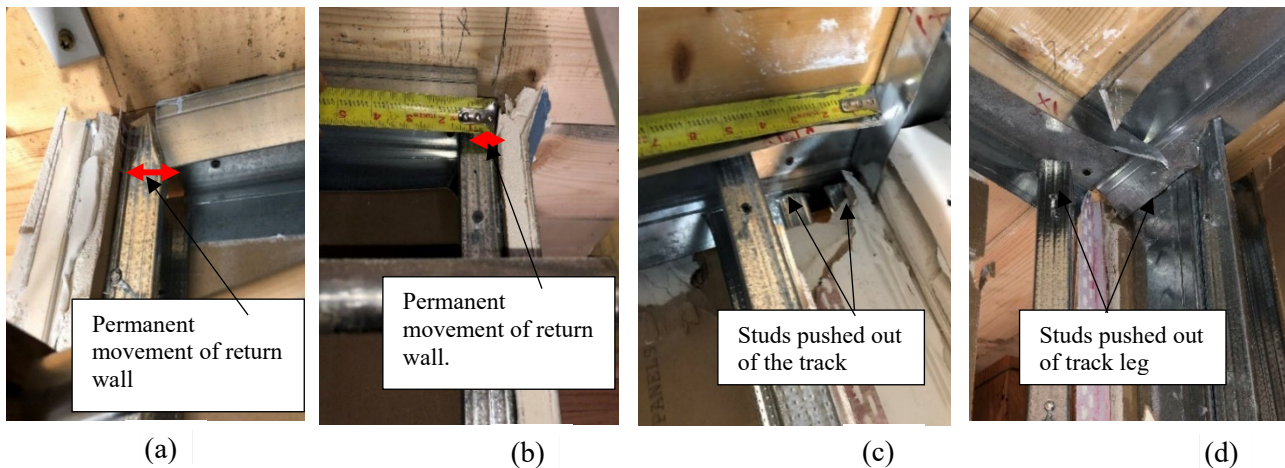
Fig. 12: Phase 2 post-test inspections of the distributed gap wall: (a) permanent movement of the return wall (fire-rated wall intersection); (b) permanent movement of return wall (non-fire rated wall intersection); (c) track opening in the return wall and pushing out of studs (fire-rated wall intersection) (d) track opening, and pushing out of studs (non-fire rated wall intersection)
