ASCE 41 Assessment of the Imperial County Services Building and Comparison with Recorded Response and Damage

D. Cook⁽¹⁾, A. B. Liel⁽²⁾

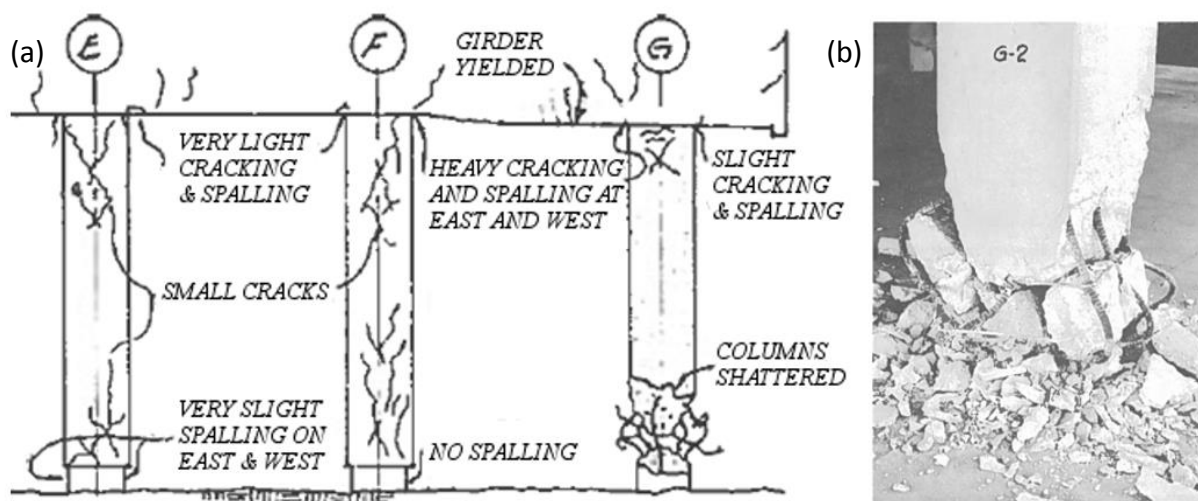
A number of reports documented damage to this building [15,16,17]. The building sustained significant damage to the first-story columns, especially on the eastern-most frame line (column line G), as shown in Figure 3. This eastern column line exhibited axial column failure above the ground slab where spacing transverse reinforcement was wider, likely following shear failure. Interior columns' damage in the first story consisted of shear cracks primarily associated with response in the E-W direction. First-story walls

showed some cracking. After the earthquake, the building was demolished due to the failure of the east-side columns.

Figure 3 – Illustrations of damage showing: (a) detailed damage description of frame line 1 at the first story; heavy shear cracking and minor spalling is apparent at the base of the first-story columns; (b) damage to columns on grid line G resulting in 9 in. of shortening of eastern-most bay (diagram and picture from [16]).

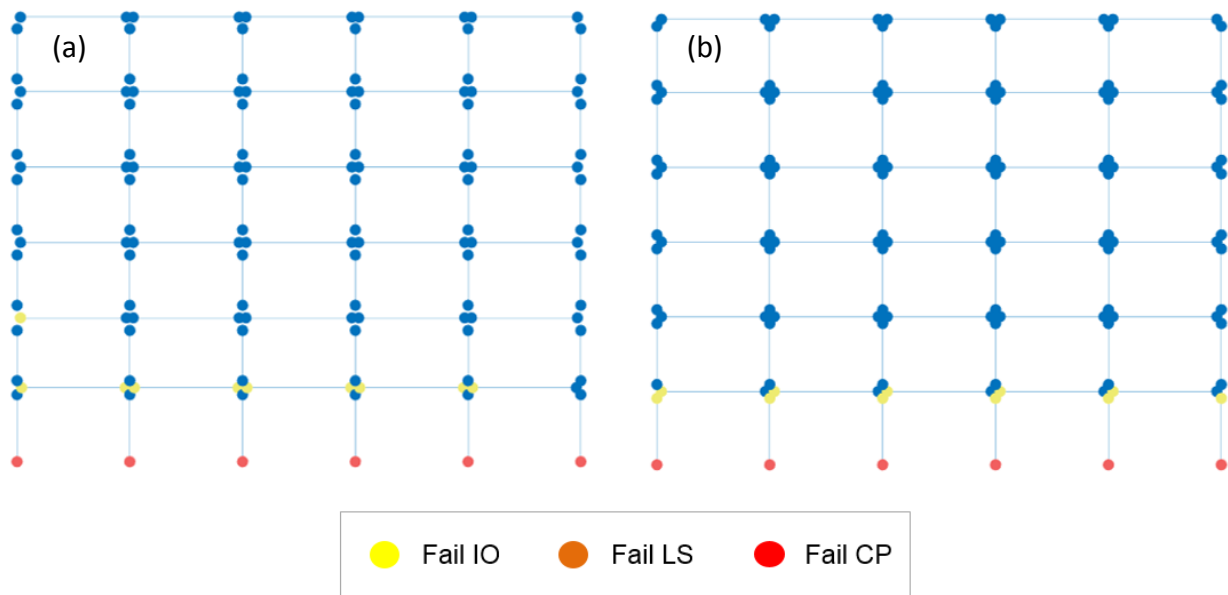
The distribution of damage over the height of the building is illustrated by comparison to ASCE 41-17 acceptance criteria in Figure 7. The model predicts that the columns fail CP at the base of the first-story columns, and IO at the top of some of the first-story columns, effectively creating a pinned-base response. Post-earthquake reconnaissance reported little to no damage in the upper stories, and the model response is consistent with these reports. The model predicts that most of the beams did not yield, although the second-floor beams failed the IO acceptance criteria. Damage surveys found only minor cracking in beams throughout the building. No damage was reported to joints in any of the available damage surveys, and no damage to joints was indicated by the analysis.

Figure 7 - Assessment of column and beam response relative to ASCE 41-17 nonlinear acceptance criteria for (a) exterior frame line 1 and (b) interior frame line 2.

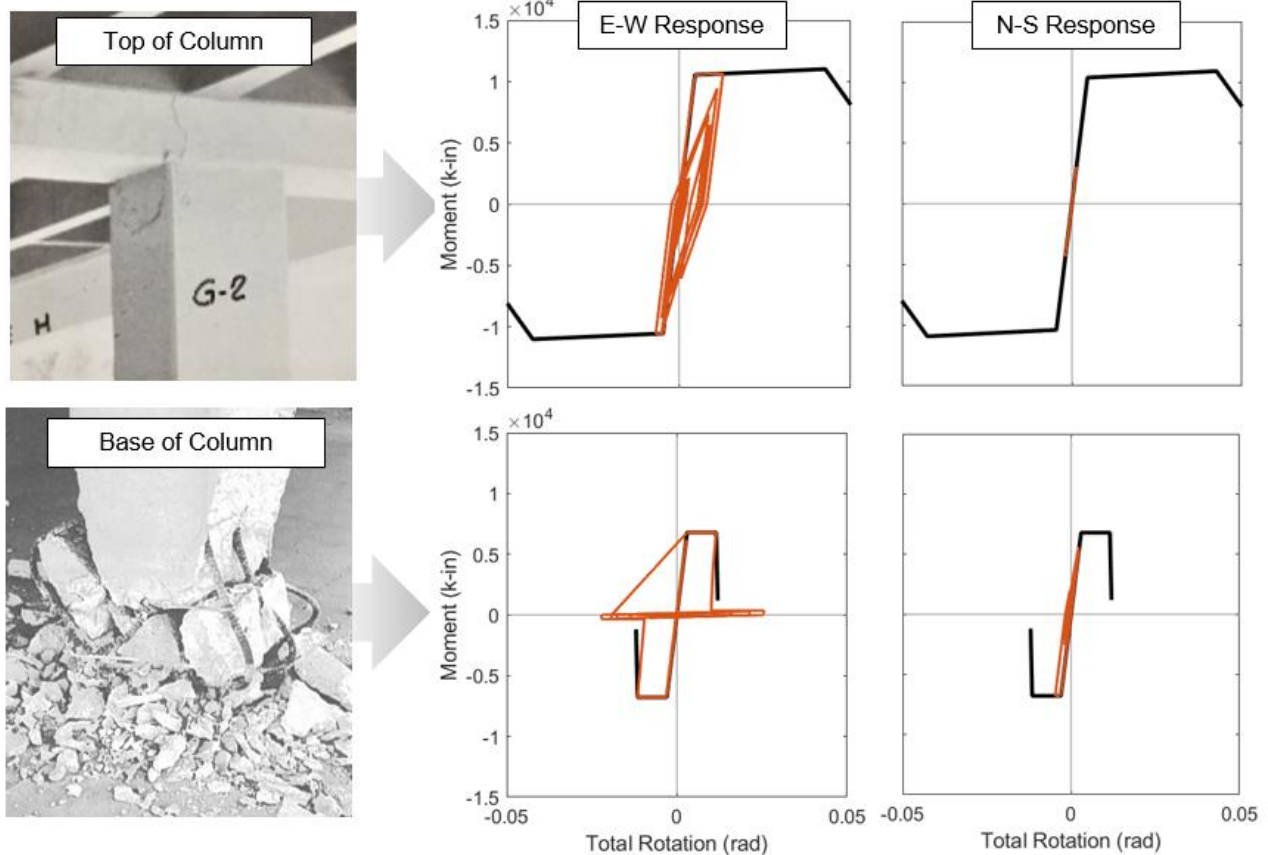
The response of the exterior first-story column G-2 is examined in more detail in Figure 8. These results show that, at the column base, the modeled column has lost practically all of its strength and stiffness, especially in the E-W direction. At the top of the column, however, where transverse reinforcement spacing is much narrower (2 – 3 in.), the columns have just reached their flexural capacity in the model in the E-W direction. These results seem qualitatively consistent with the damage photos, which showed limited flexural cracking at the tops of the columns. The model predicts the least ductile behavior and response most beyond the total rotation capacity (point E on Figure 4a) at the base of the columns on the eastern-most column line, due to the higher axial loads and consistent with observations of damage. The model response also indicates that all columns have exceeded their total rotation capacity and lost gravity-load bearing capacity, according to the definition of the ASCE 41 backbones. However, the observed damage would indicate that only the eastern most columns have lost gravity-load bearing. This would imply that the ASCE 41 damage assessment of the first story columns is conservative for most columns other than the eastern-most columns.

Figure 8 - Damage photos from [16] of column G-2, with model backbones and hysteretic response in the recorded ground motion. Total rotation of each hinge is defined as the sum of the elastic rotation of half of the column and the plastic rotation of the hinge.
