## A POTENTIAL VULNERABILITY IN HIGH-STRENGTH REINFORCED CONCRETE SHEAR WALL RETROFITS

*Keywords: reinforced concrete; retrofit; high-strength concrete; infill*

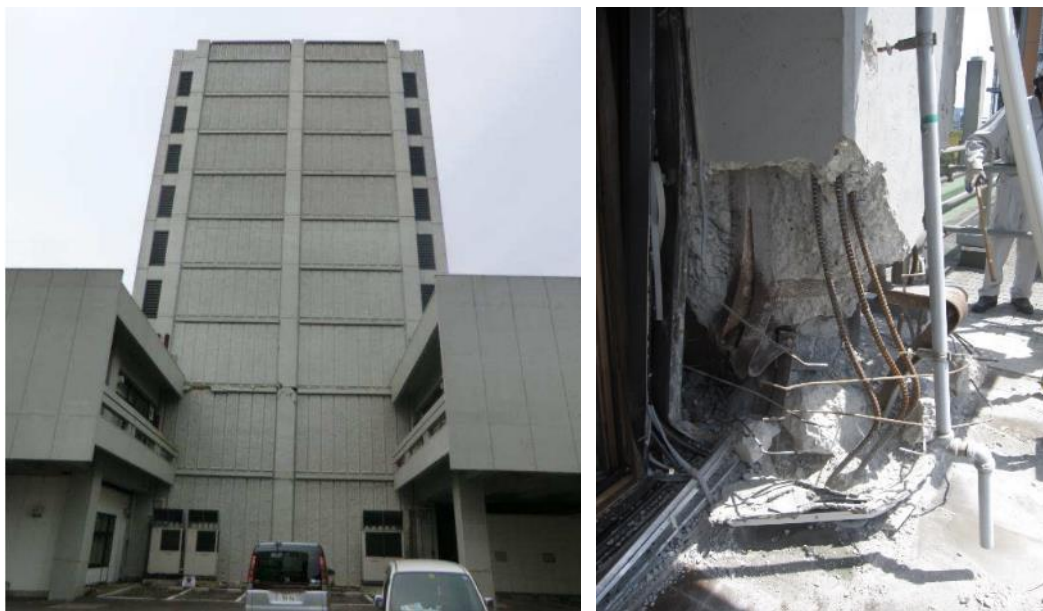
Built circa 1969, the Building of Faculty of Architecture and Engineering at Tohoku University is a nine-story steel-reinforced concrete building with a two-story podium. Columns in this building are reinforced with a combination of reinforcing steel bars as well as structural steel sections connected to each other by rivets. An overview photo of one of the two north-south structural walls from after the 2011 Tohoku Earthquake is shown in Fig. 1 (left). The building survived the 1978 Miyagi-Ken-Oki earthquake, and was subsequently retrofitted in 2001. During this retrofit, the panels of the structural walls were removed and replaced. The new panels contained a larger amount of reinforcement and higher-strength concrete. Nevertheless, during the 2011 Tohoku Earthquake the building suffered severe damage to the structural wall boundary elements Fig. 1 (right). This damage consisted of buckling and fracture of vertical structural steel angles and reinforcement.

Fig. 1 – (Left) Overview of Building of Faculty of Architecture and Engineering at Tohoku University (from Wang, 2014), and (right) damage observed to a boundary column after the 2011 Tohoku Earthquake.

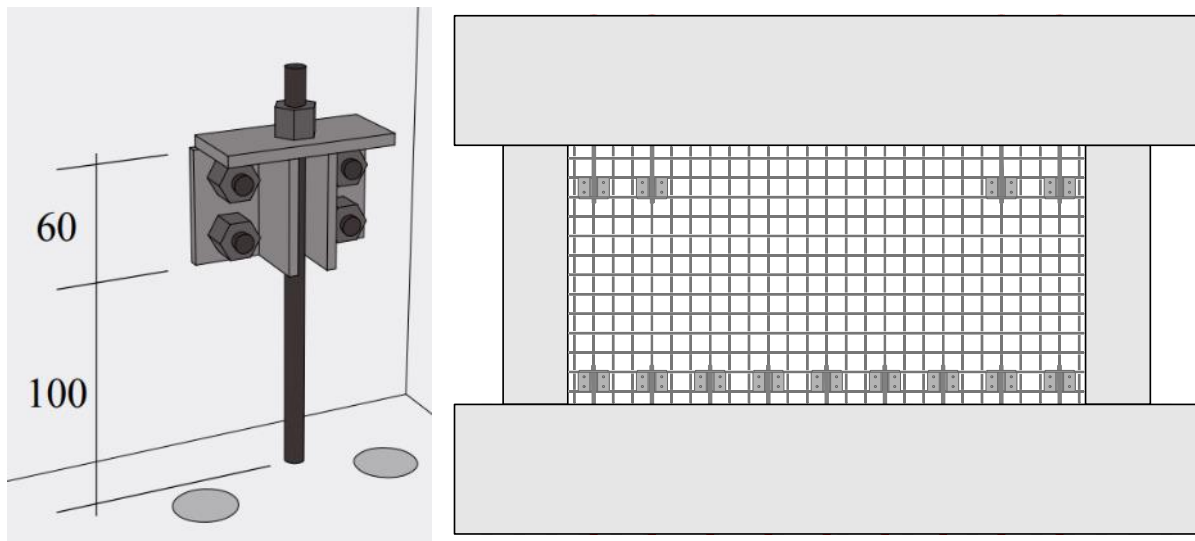
Fig. 4 – Retrofit used for Wall B: (left) photograph of retrofit, and (right) elevation view with panel concrete hidden.

Wall A was based on the details described above. Wall B was nominally identical to Wall A except for one aspect: Wall B contained external retrofits, dubbed here “bandages.” The purpose of these bandages was to shift the critical section and engage vertical bars in the panel, similar to the idea of hinge relocation proposed by Paulay and Priestley [5]. An isometric of a typical bandage is shown in Fig. 4 alongside a schematic. Each pair of bandages (referring to opposite sides of the panel) was sized to carry the vertical load from six internal D4 bars in the panel. Each bandage consisted of the following: pairs of L40x40x5 steel angles fastened to opposite faces of the wall panel with four horizontal through-panel 9.2-mm steel threaded rods. A thin layer of epoxy was applied to the surface between the panel and these angles before tightening them to a pre-calculated torque. Between these pairs of angles, there was a single 9.2-mm diameter, high-strength vertical threaded rod anchored into the bottom stub. This vertical threaded rod was clamped down against the angles using a 90x40x6-mm steel plate and high-strength nut. The vertical distance from the stub to this plate was 160 mm, corresponding to forty times the bar diameter of the D4 steel bars used as vertical reinforcement in the panel. A total of nine pairs of these “bandages” were used across the entire bottom of the wall. Because of the moment gradient, it was not necessary to use the same number of bandages across the top: instead, four pairs bandages were used (two pairs at each end).

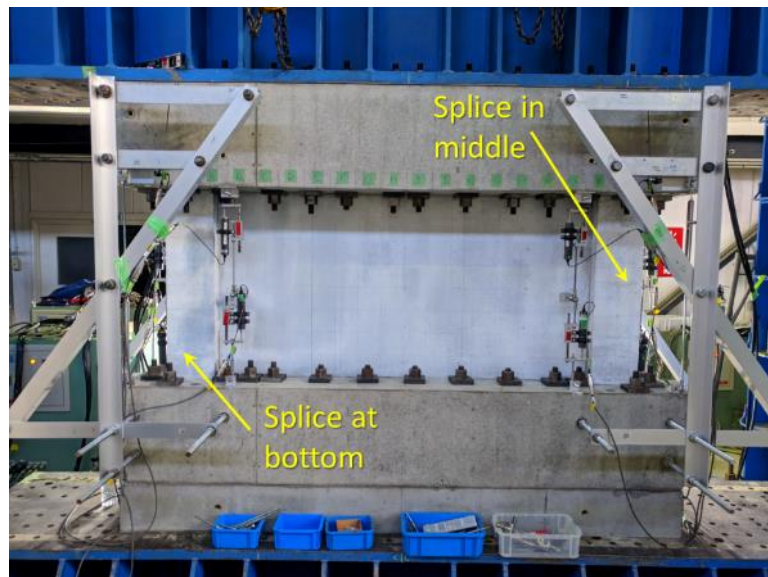
Fig. 6 shows a photograph of Wall A in the testing setup, with locations of the splices in the boundary columns indicated. Positive loading was defined such that the boundary column with the bottom splice was in tension. Negative loading put the middle splice in tension.

Fig. 6 – Wall A in testing rig, with locations of splices indicated.

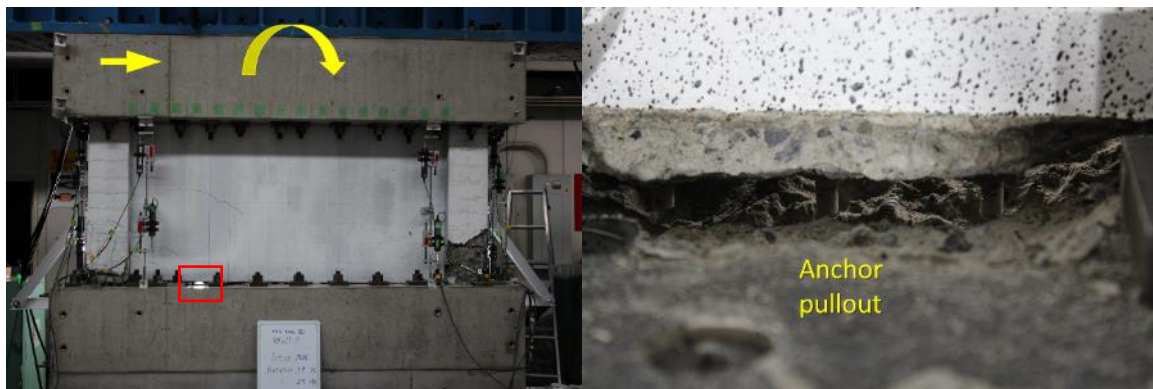
Wall A showed a concentration of damage at its base. Minimal cracking was observed along the height of the wall panel, with largest cracks observed at the base near the stub-wall interface. In boundary columns, there was cracking along the height but the largest cracks concentrated at the base. Fig. 7(a)(left) shows an overview of positive loading of Wall A, where light is visible beneath the left side of the wall panel as a result of concentration of damage at the base. This light was visible beneath

the panel at top rotations as little as 0.27%. Concentration of damage at the base of the wall panel and boundary element ultimately led to the anchor pullout as shown in Fig. 7(a)(right) in both directions of loading.

(a) (left) Overview of positive loading of Wall A, (right) showing pullout of anchors.

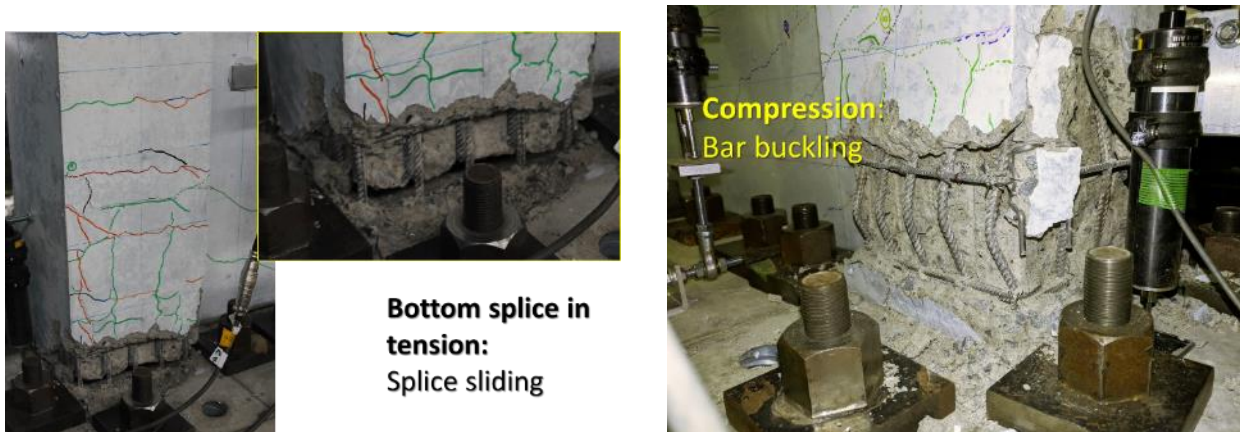
Photographs of the boundary elements of Wall A during the latter stages of positive loading are shown in Fig. 7(b) and Fig. 7(c). Fig. 7(b), where the bottom splice is in tension, shows a general sliding failure of the upper vertical bars past the lower vertical bars, which limited the strength of the wall. Fig. 7(c) shows the opposite side in compression, where bars were observed to have buckled as the specimen was loaded from +0.5% to +0.7%. This damage was like what had been observed of the Tohoku CE building following the 2011 Earthquake (Fig. 8). Under negative loading, Wall A continued to exhibit a concentration of damage at its base. For the column with the splice at mid-height, bars which previously buckled [Fig. 7(c)] elongated and eventually fractured (Fig. 9), again causing a decrease in the strength of the wall.

(b) Tensile side during positive loading.

(c) Compressive side during positive loading.

Fig. 7 – Positive loading of Wall A.

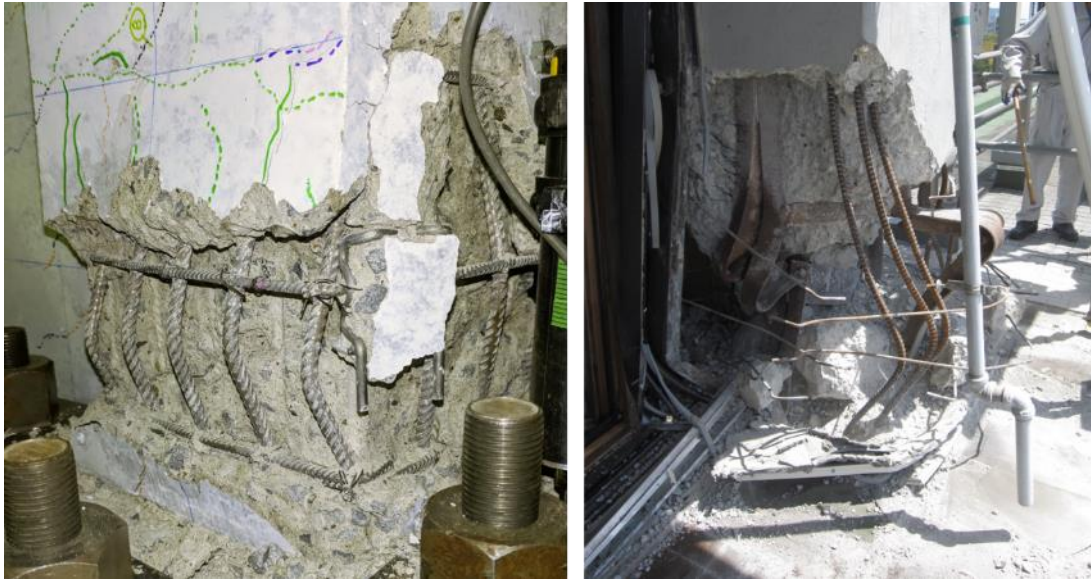
Fig. 8 – Comparison of Wall A and Tohoku CE Building.

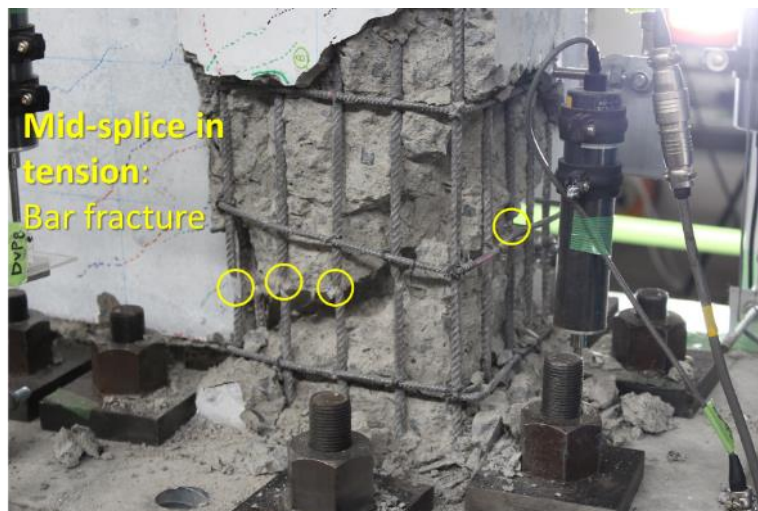
Fig. 9 – Negative loading of Wall A, which led to fracture of vertical bars.

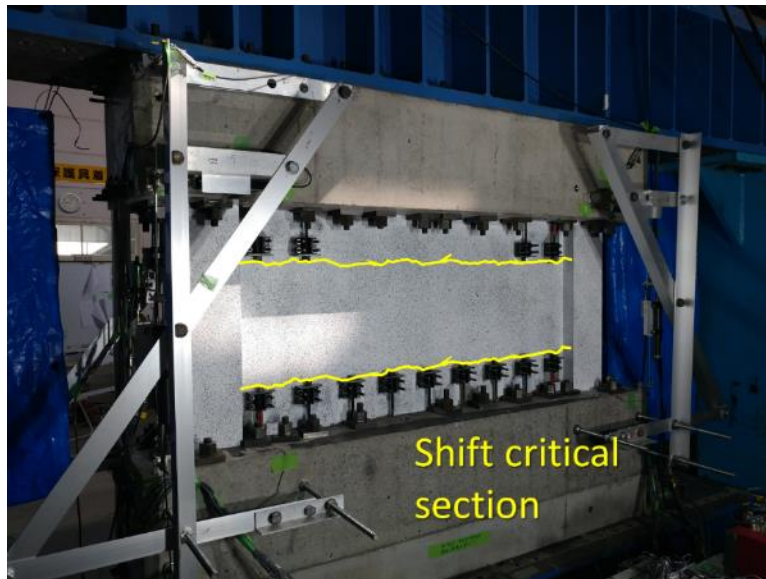
Fig. 10 – Concept of shifted critical section with Wall B.

Wall B was subjected to the same loading protocol as Wall A. The only difference between the two was the presence of “bandages” on Wall B. These bandages were intended to shift the critical section of Wall B from the stub to a height at which the vertical reinforcement in the panels would be engaged, as illustrated in Fig. 10. Wall B performed better than Wall A. Rather than concentrating solely at the base, cracking distributed over more of the boundary columns and infill panel. As a result, steel in the panel helped resist applied demands. A comparison of force versus top rotation curves is presented in Fig. 11. Wall A is shown in black and Wall B in red. This figure shows that not only did Wall B develop larger strengths, but it maintained its strength at larger top rotations than Wall A.
