## ASSESSMENT AND REPAIR OF DAMAGED ECCENTRICALLY BRACED FRAMED BUILDINGS FOLLOWING A SEVERE EARTHQUAKE

G.C. Clifton<sup>(1)</sup>, W.G. Ferguson<sup>(2)</sup> and M.A. Hodgson<sup>(3)</sup>, G.A MacRae<sup>(4)</sup>

The Christchurch earthquake series of 2010/2011 was the first event worldwide to cause Eccentrically Braced Frame (EBF) buildings to have fractures in their links. The response of these most systems was good, with a high damage threshold. However, the earthquakes were sufficiently strong to cause partial to full plastic mechanisms in EBF systems, with significant yielding of EBF active link webs over many to all levels in buildings from 3 to 22 storeys in height.

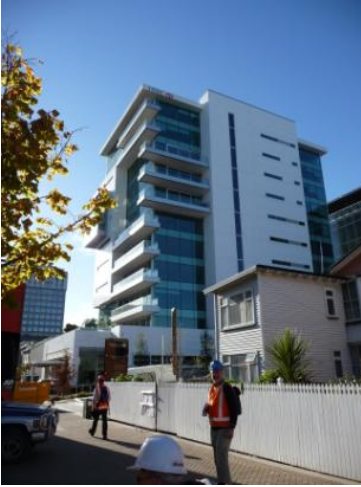
Figure 1 HSBC Building, Christchurch, March 2011 (from [1] )

The 2010/2011 Christchurch earthquake series were the first earthquakes worldwide to push EBFs so that some fractured. Many other links in a range of EBF buildings ranging from 2 to 22 storeys in height yielded [1]. One of these, HSBC Tower, is shown in Figure 1; this picture was taken in the week following the most intense earthquake of the series, the earthquake of 22 February 2011.

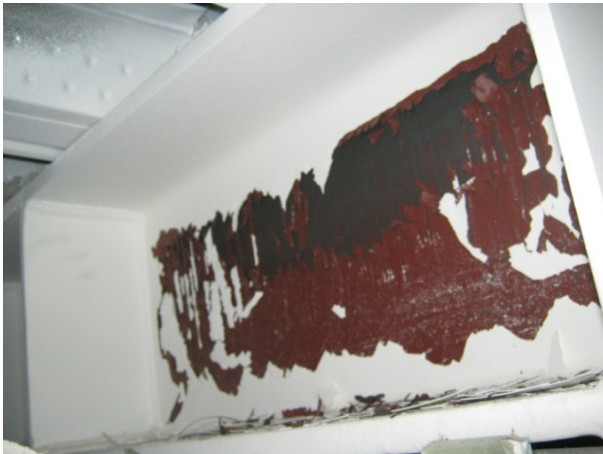
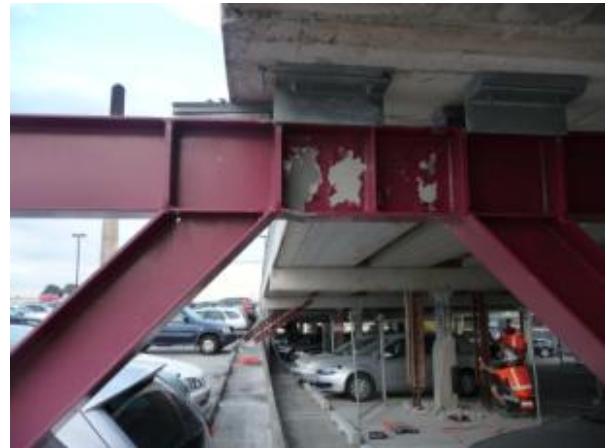
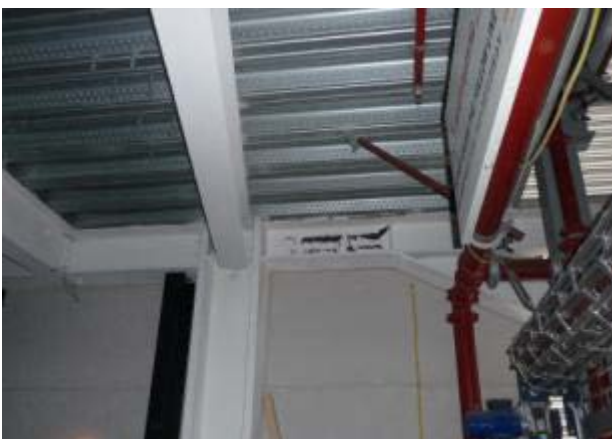
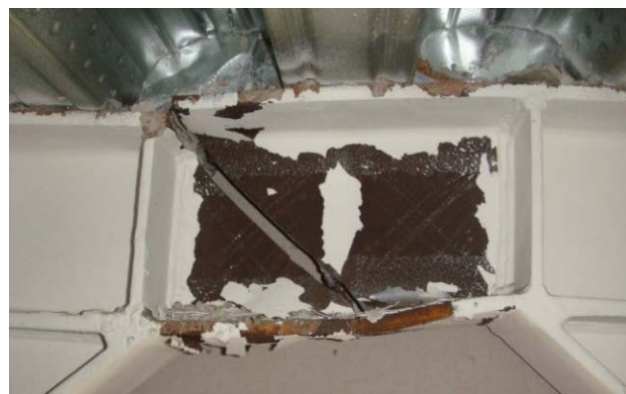
Figure 2 Yielded Active Links from Christchurch 22 Feb 2011 Earthquake (from [1])

That event caused yielding of most active links in every Christchurch central business district EBF building. Four examples are shown in Figure 2. These include two active links with yielding of the webs and no local buckling, cracking or fracture, Figure 2 (a) and (d); one with yielding of the webs and local buckling of the bottom flange at one end, Figure 2(b) and one which underwent web yielding and then fracture, Figure 2(c).

Clockwise from top left: (a) Yielded active link level 3, 12 storey HSBC Tower, (b) Active link at edge of building with slight flange local buckle, level 1, 3 storey car parking building; (c) Fractured and yielded active link, level 6, 22 storey Pacific Tower; (d) Yielded active link, level 4, 22 storey Pacific Tower
