A CASE STUDY ON RETROFITTING OF STONE MASONRY IN MUD BUILDINGS IN POST GORKHA EARTHQUAKE RECONSTRUCTION

Abstract

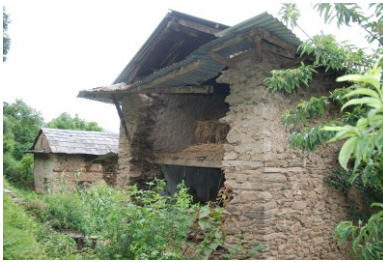
(a) Out of plane failure of orthogonal and gable walls.

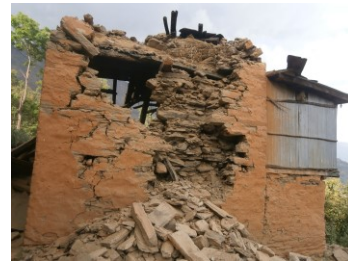
(b) Delamination caused due to separation of two layers of walls followed by out of plane failure.

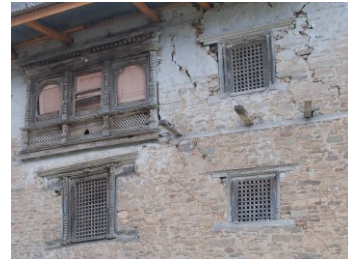
(d) Diagonal cracks propagating from the corners of openings

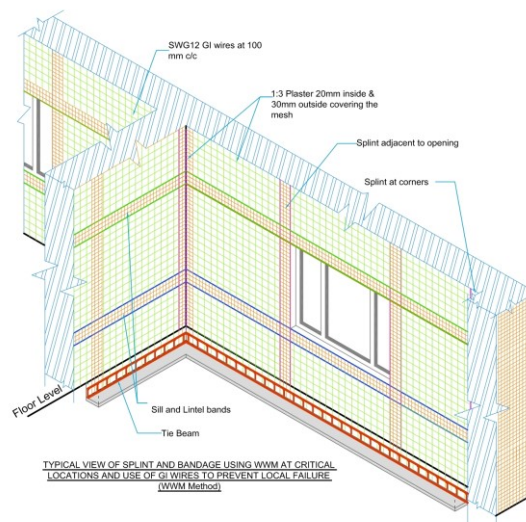
Fig. 3 – Typical design output of retrofitting for stone masonry wall using WWM Method (© NSET, 2015)

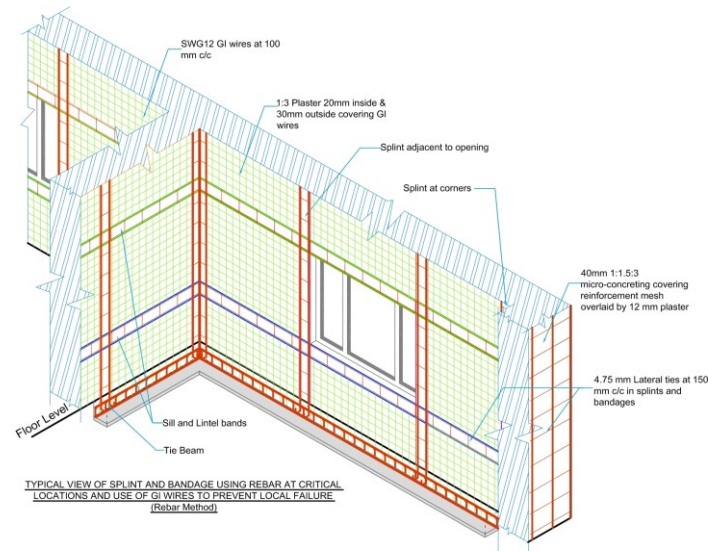
Fig. 4 – Typical design output of retrofitting for stone masonry wall using Rebar Method (© NSET, 2015)

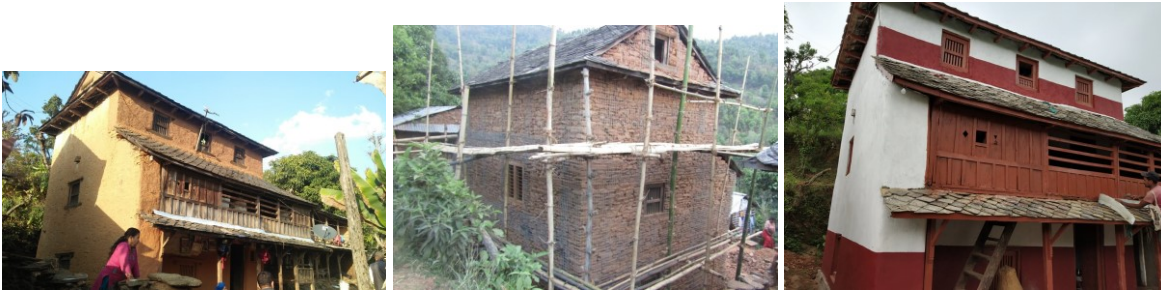
Fig. 5 – A building before (left), during (middle) and after (right) retrofitting (© NSET, 2015)

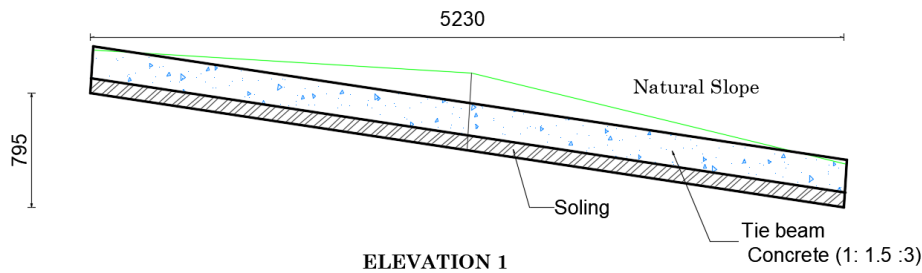
Fig. 8 – Placement of tie beams at slope

- a) Usually it is suggested to cast tie beams stretching horizontally over the ground at normal depth. However, due to presence of slope terrain at outer of either side elevations of some buildings, tie beams were placed at a slope of not exceeding 1:6, as shown in Fig. 8, which would meet horizontally running tie beams at front and back side of the building. Although it is possible to excavate and place horizontally at the recommended depth, it increases additional cost. The purpose of tie beams, simply, is to anchor splints and GI wires provided to prevent local failure of masonry units. Placing tie beams at a slope still fulfil the required purpose.

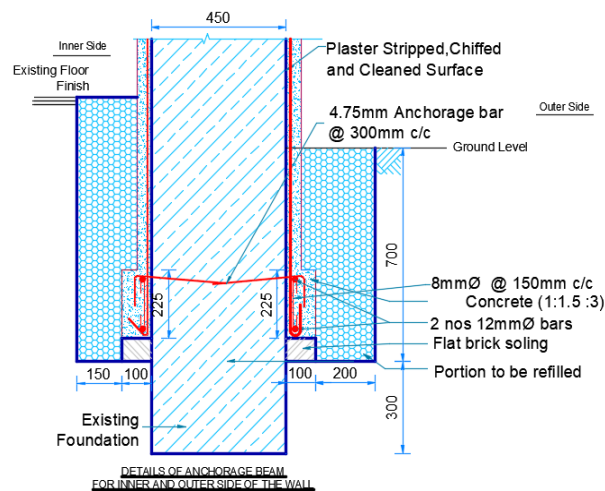
Fig. 9- Placement of inner and outer tie beams at same level to compensate required footing width

- b) Inner and outer tie beams were recommended to place with their top surface levelled with the existing floor level and ground level respectively. This typical provision was suggested to minimize the excavation works. However, theoretically, when footing width does not meet the required width, it is necessary to increase the bearing area below the existing footing for better distribution of gravity loads. Ironically, it is almost impossible to intervene at this level in rural region since it requires sophisticated equipment which will call out high cost. Due to this, it is suggested to place anchorage beam with its bottom at the same level with the bottom level of an existing footing. This solution is also not economically feasible as it involves huge excavation; hence, anchorage beams of required width were provided at a required depth below the ground level. Such case was encountered in one of the one and attic storied buildings and the solution as shown in Fig. 9 was implemented. This new assembly is similar to footing with shear key which prevents tilt, settlement and sliding [10].

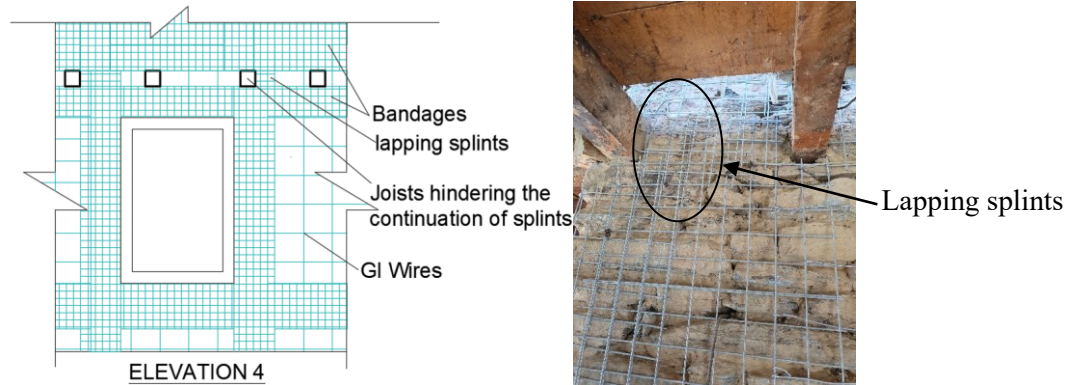
- c) In some buildings, the position of joists at the floor level hinders the continuation of full width of splints as shown in Fig. 10. When such problem encountered, the full width of splint was continued up to

Fig. 10 – Drawing showing joist hindering the continuation of splint (left) and similar picture taken while implementing (right) (©NSET)

possible top level. A lapping splint that could pass through the available gap was placed by overlapping with lower story splint and upper story splint. Furthermore, to compensate the width of splint, number of lapping splints were used such that the sum of width of lapping splints would not be less than the recommended width of splint. Moreover, bandages at the top level of lower story and at the bottom level of upper story tied these splints. Although throughout continuation of splints and bandages is of prime importance to achieve ductility which was targeted by a design, this was the most practical alternative that could be implemented. Likewise, a challenge with continuation of bandages was solved when encountered.

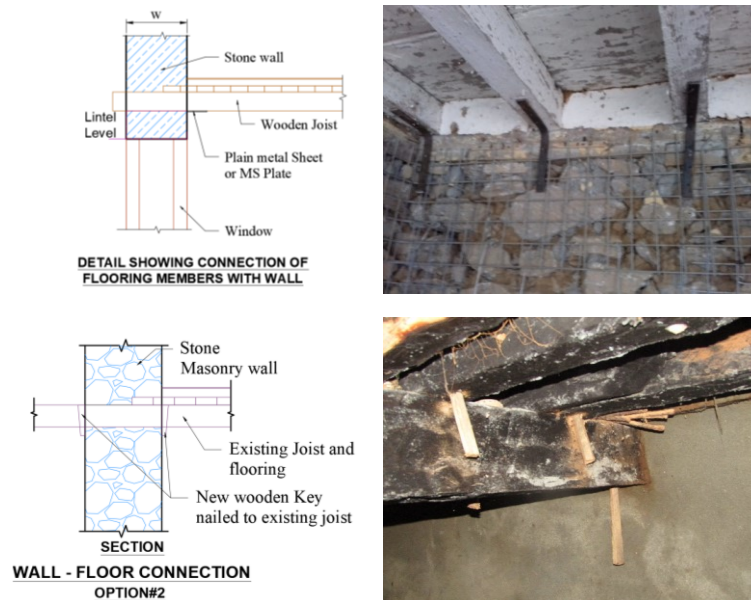
- d) In most of the buildings, wooden keys restraining lateral movement of timber members, such as joists, rafters, beams were not found. In such case, wooden keys were fixed with the timber members as shown in Fig. 11.

Fig. 11 – Drawings showing installation of Keys to connect floor and wall (left) and similar picture taken while implementing (right) (©NSET)

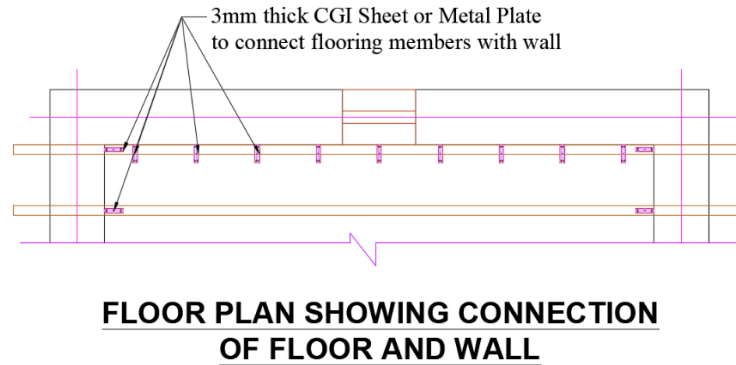
Out of plane failure of walls is prominent in the walls through which joists members do not pass. In other words, walls parallel to joists are more prone to out of plane failure. None the walls parallel to joists had any connections with the floor members. However, it was found that

Fig. 12 – Drawing showing installation of Keys to connect floor and wall which is parallel to joists

most of the buildings have joist members at an inch gap from these walls. Hence, MS plates were used to connect these walls with joists members as shown in Fig. 12.

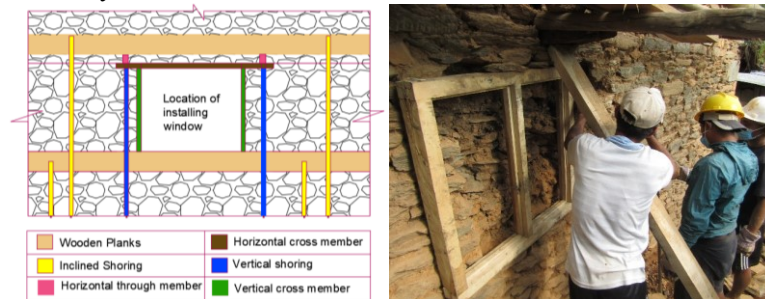
Fig. 13 – Drawing showing shoring provided while installing a window (left) and a picture of similar case while implementing (right) (©NSET)

- e) Sometime, it is necessary to install an opening for lighting and ventilation. Installation of an opening in existing SMM buildings involves high level risk causing even collapse of walls. However, it was accomplished working cautiously. First of all, horizontal wooden planks, which would be supported by inclined shoring, were provided from both inner and outer side as shown in the Fig. 13. Cautiously, stone units were withdrawn to insert horizontal through members which would be supported by vertical shoring from both sides of wall. Furthermore, stone units were withdrawn to insert vertical cross member followed by insertion of horizontal cross member. Thus, after ensuring sufficient props, units were withdrawn and simultaneously window frame was installed.
