REHABILITATION AND ADAPTIVE REUSE OF THE HISTORIC 1940s HOWARD HUGHES WOODEN AIRCRAFT HANGAR

P. Noll⁽¹⁾, S. Rees⁽²⁾, R. Pallmann⁽³⁾ and A. Jiras⁽⁴⁾

Keywords: Adaptive Reuse; Rehabilitation; Seismic Retrofit; Glulam; Historic Building;

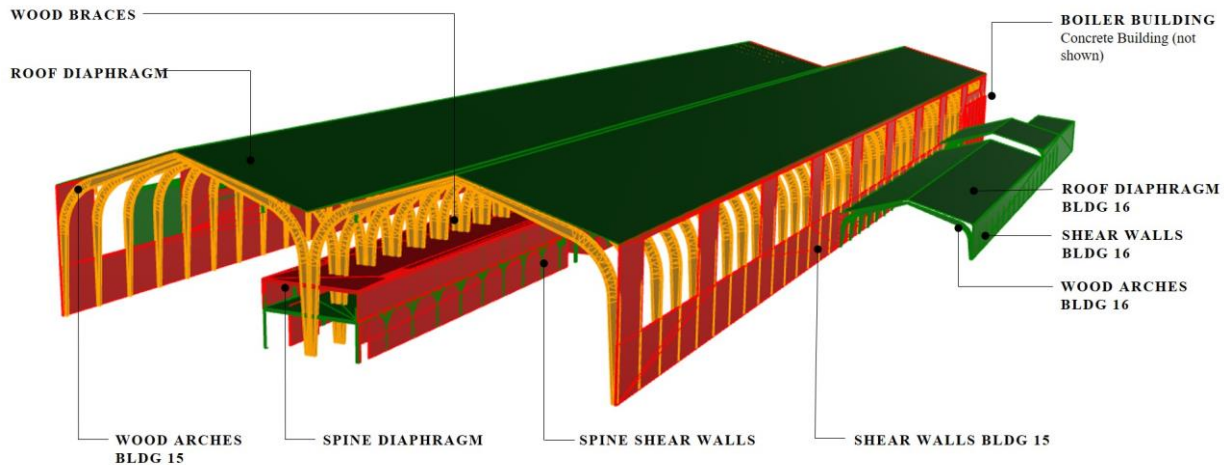
The analysis of the existing building under current seismic loads revealed several deficiencies in the seismic force resisting system, ranging from overstressed elements to components not meeting current code requirements (e.g. detailing requirements, minimum dimensions). The diagonal sheathed shear walls and transfer diaphragm in the center of the building were the main overstressed elements. Fig. 3 shows the

existing building elements and their performance, where elements in green are acceptable and elements in red were deficient.

Fig. 3 - Existing Building deficiencies

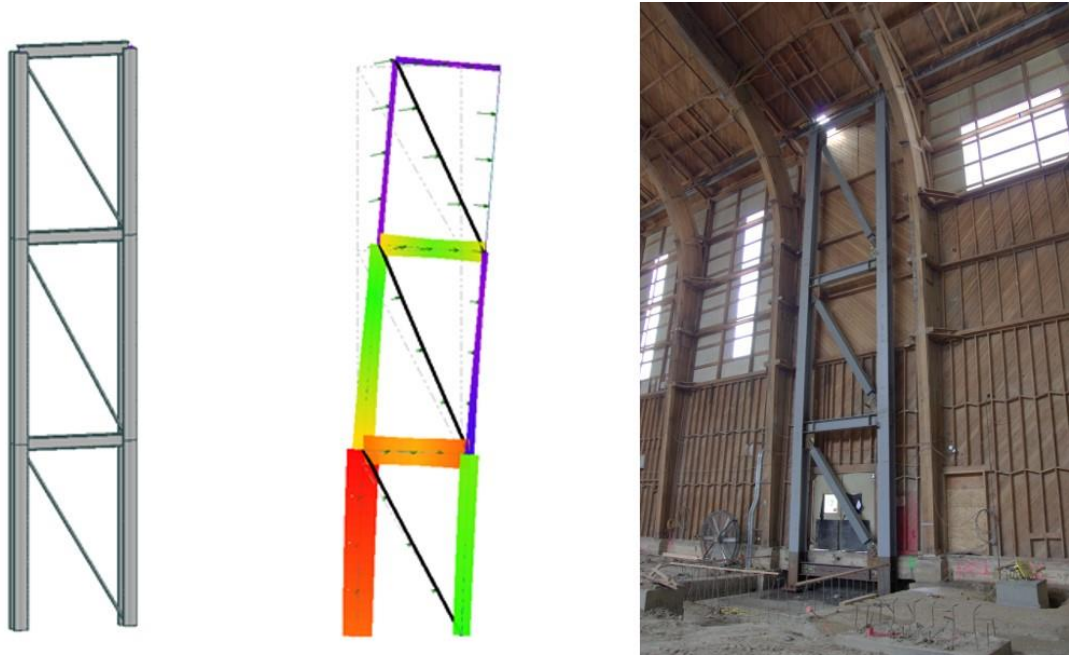
The existing lateral elements along the edge of Building 15 in the longitudinal direction consist of ten existing diagonal sheathed wood shear walls, 20 feet wide and 55 feet high (see Fig. 3). The historic conversation board requested that any seismic retrofit be limited to these bays to minimize visual impact to the building as seen from the outside. Considering the size of the existing frames and foundations, the maximum space available for new BRBFs led to a column center to center spacing of 11 feet, resulting in an undesirable aspect ratio requiring a design outside of the prescriptive code limits.

Fig. 7 - MTBF analysis model and installed on site

Fig. 7 shows the installed MTBF directly located in front of an existing shear wall, neatly fitting in front of the existing shear wall with minor visual impact to the building appearance. Additional construction challenges, e.g. anchor bolt spacing and design of foundations, were closely coordinated with the contractor and adjusted to allow for erection with limited space avoiding existing footings and structural elements.

General Structural Analysis Software by Oasys (GSA) was used to run the buckling calculations (see model in Fig. 7). The columns need to withstand the typical BRBF forces for capacity design as well as provide sufficient stiffness at the nodes themselves. Unlike typical BRBFs, the columns in MTBF are rotated by 90 degrees such that their strong axis is perpendicular to the brace direction to account for the different geometry and stiffness requirements.

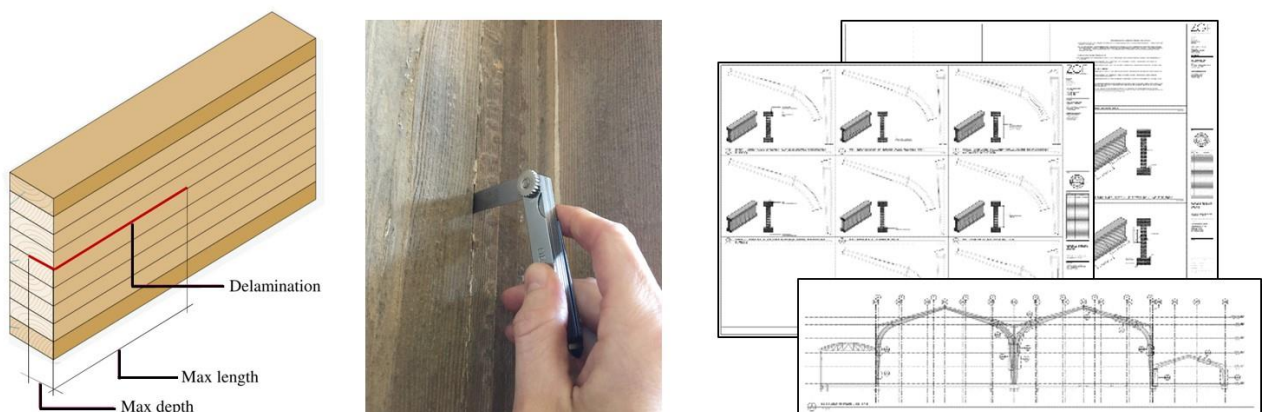
Fig. 9 – Extracts from the fully threaded screw installation guide

Without an additional and expensive field survey, the general contractor was concerned that it would be difficult to procure the correct screws (length and number of screws). To alleviate this concern, an installation guide (Fig. 9) was developed which defined the following steps for the field work: (1) Measure depth of delamination to determine if repair is required, (2) Measure location of delamination with regards to accessible edge of the beam.

These two steps together with the location of the delamination in the building enabled the contractor to choose the applicable repair detail and screw length from nine different repair details in field. Fig. 10 shows a screw during installation and two already installed screws below.

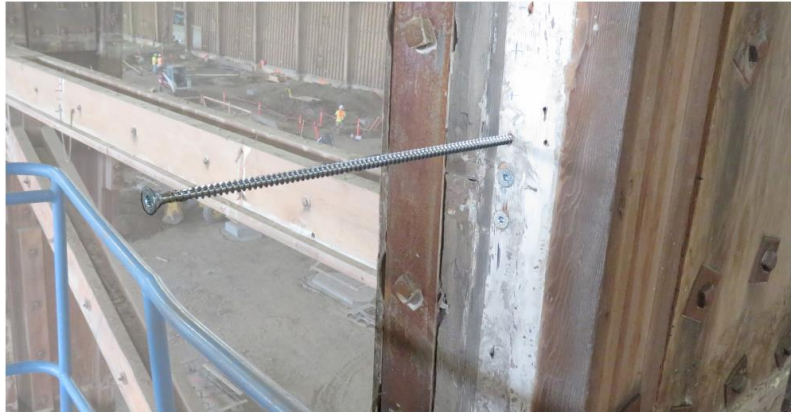
Fig. 10 - Fully threaded screw during installation

The ease of installation and detailed installation guide led to a very smooth and faster than expected installation. The work was completed ahead of schedule and the contractor ultimately preferred this method of strengthening.
