# INVESTIGATION AND ANALYSIS OF LIQUEFACTION-INDUCED DEBRIS FLOWS IN PALU, INDONESIA FOLLOWING THE 28<sup>TH</sup> SEPTEMBER 2018 CENTRAL SULAWESI EARTHQUAKE

R. Lagesse<sup>(1)</sup>, A. Brennan<sup>(2)</sup>, I. Rusydy<sup>(3)</sup>

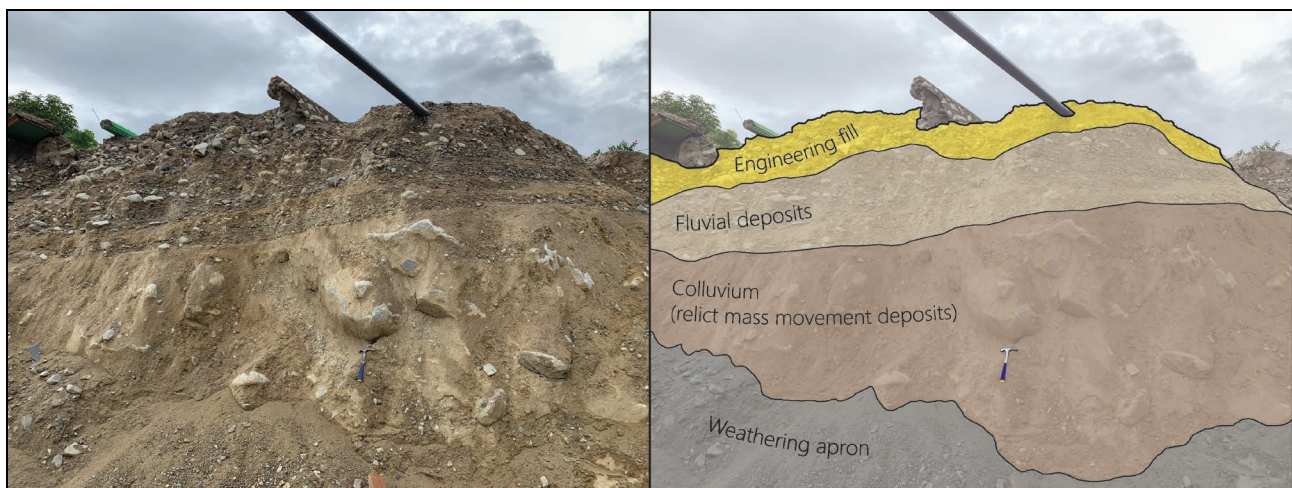
Subsurface materials were exposed in the head scarp (Fig. 2) demonstrating the following succession:

- <1 m granular engineering fill, predominantly sandy gravel and cobbles;
- 1-2 m of fluvial deposits comprising sandy gravel, gravelly sand, silty sand, sandy silt; and
- Underlying granitoid subangular to sub-rounded cobbles and boulders in a gravelly medium to coarse sand matrix – suspected colluvium / previous landslide deposit, base not proven.

Fig. 2 – Geological profile exposed in Balaroa Landslide head scarp.

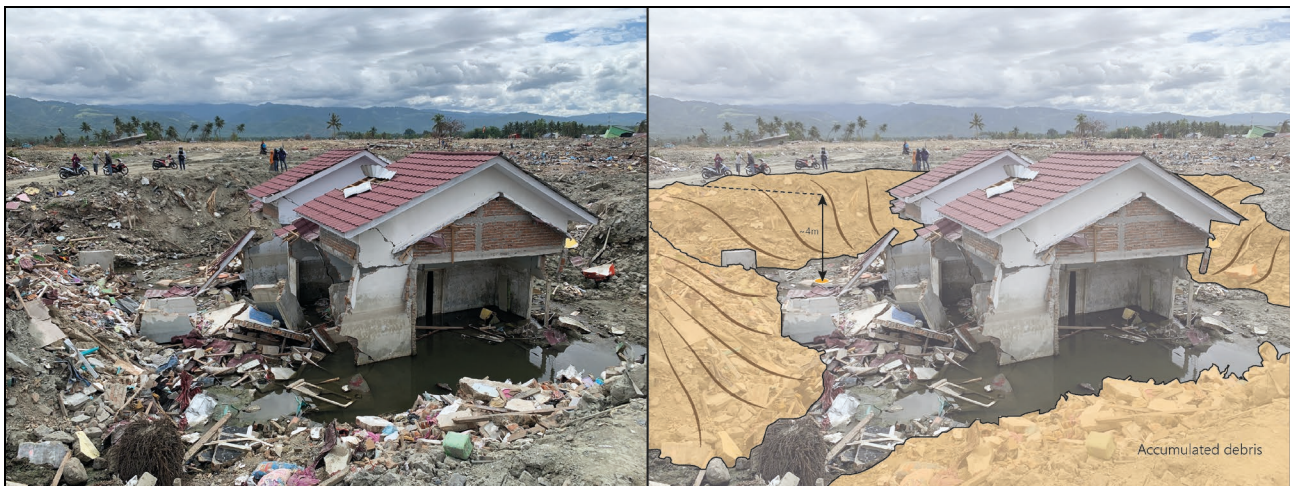
In the upper part of the landslide there is a stable area of ground that has been partially inundated with debris but has largely stayed in situ and as a result this has led to a secondary runout, approximately 1 km long, to the south of this area. Much of the lower depositional part of the landslide had been cleared, however, a damaged house situated in a gully formed in the debris with the base at original ground level suggested the deposited debris thickness was approximately 4 m (Fig. 3).

Fig. 3 – Deposited debris thickness in the accumulation zone of the Petobo Landslide.

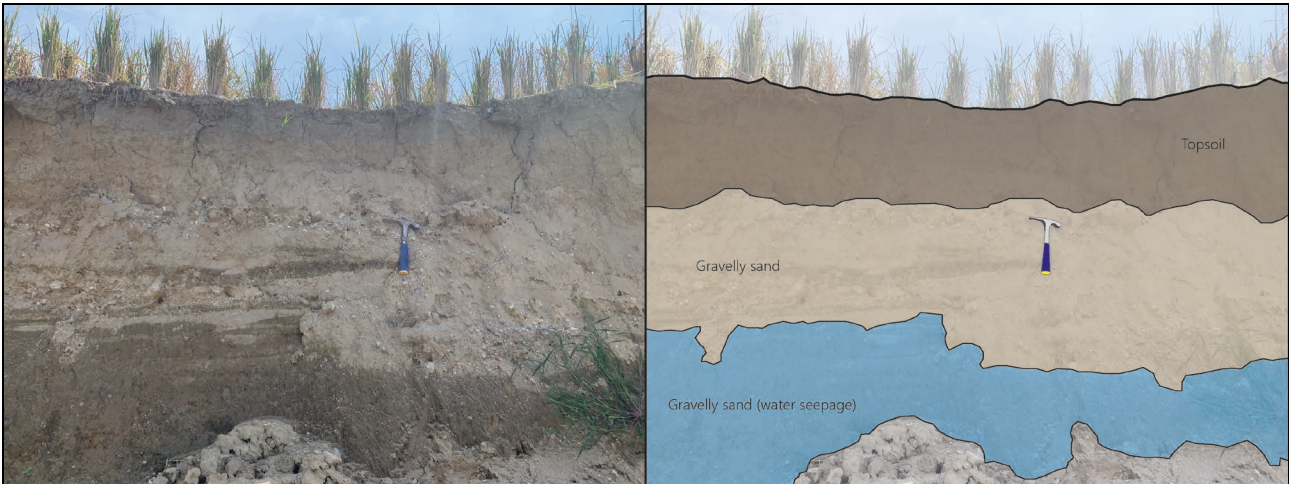
Subsurface materials were exposed in the head scarp (Fig. 4) demonstrating the following succession:

- <1 m of agriculturally reworked topsoil; and
- Underlying fluvial/alluvial deposits comprising occasionally gravelly fine to medium sand with occasional layers of increased fines content – base not proven.

Fig. 4 – Geological profile exposed in Petobo Landslide head scarp.

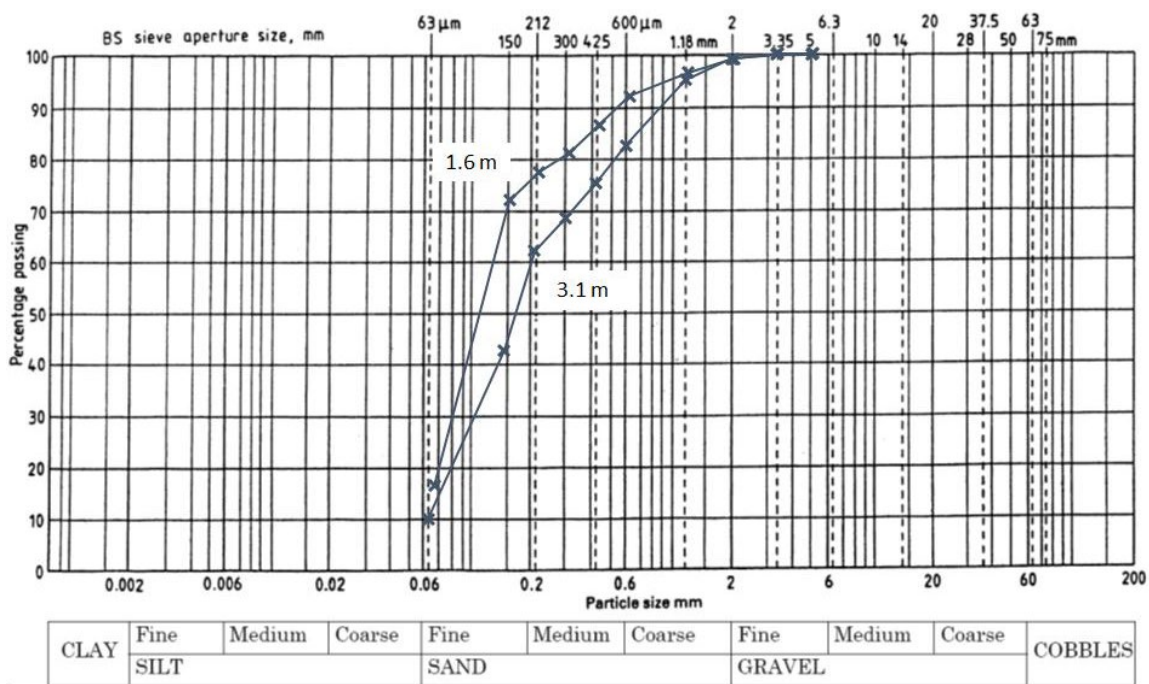
This succession was confirmed by a 3 m deep borehole hand-drilled prior to the earthquake in the area that is now the upper part of the landslide. Bulk samples of material were collected by EEFIT-TDMRC team from the northern end of the head scarp at depths of 1.6 m and 3.1 m. These were tested for particle size distribution at University of Dundee as shown in Fig. 5. The particle size distribution suggested a profile of silty fine sand. Darker patches of wet/damp material were observed in the exposed head scarp suggesting ongoing seepage of groundwater.

Fig. 5 – Particle size distribution of samples taken from Petobo head scarp

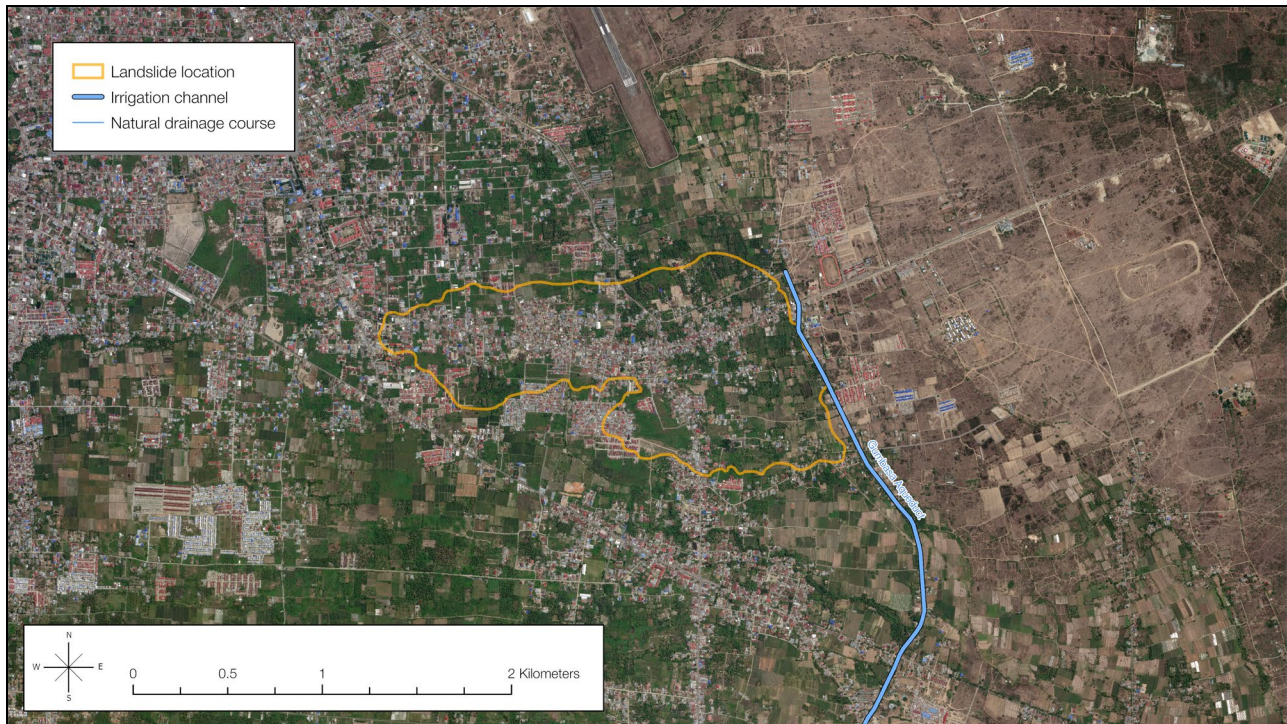
Anecdotal evidence suggests that groundwater in the area above the irrigation channel, as terrain steepens, is much deeper between 15 and 30 m below ground level. This is reflected in the aerial photography and satellite imagery of the area, with the land above the irrigation channel observed to be brown (no vegetation), whereas below the channel the ground is green in colour, indicating significant vegetation growth and agriculture (Fig. 6). There is also limited urban development upslope of the channel as groundwater extraction is likely more challenging.

Fig. 6 – Difference in vegetation growth due to groundwater conditions on either side of the Gumbasa Aqueduct in the Petobo area. Green vegetation growth (left) indicates wetter ground conditions as opposed to brown land with lack of vegetation growth (right) indicating mostly dry ground.

Representatives from the MoPWPH suggested that there were plans to restore the irrigation channel following the landslide, adding to it an impermeable geosynthetic clay liner (GCL) as well as upgrade the local drainage network. They also remarked that a new residential area was planned at the southern end of the airport, to the north of the Petobo Landslide. The airport was pre-existing to the development of the main irrigation channel and it is possible the continuation of the channel was restricted by planning restrictions related to the airport.

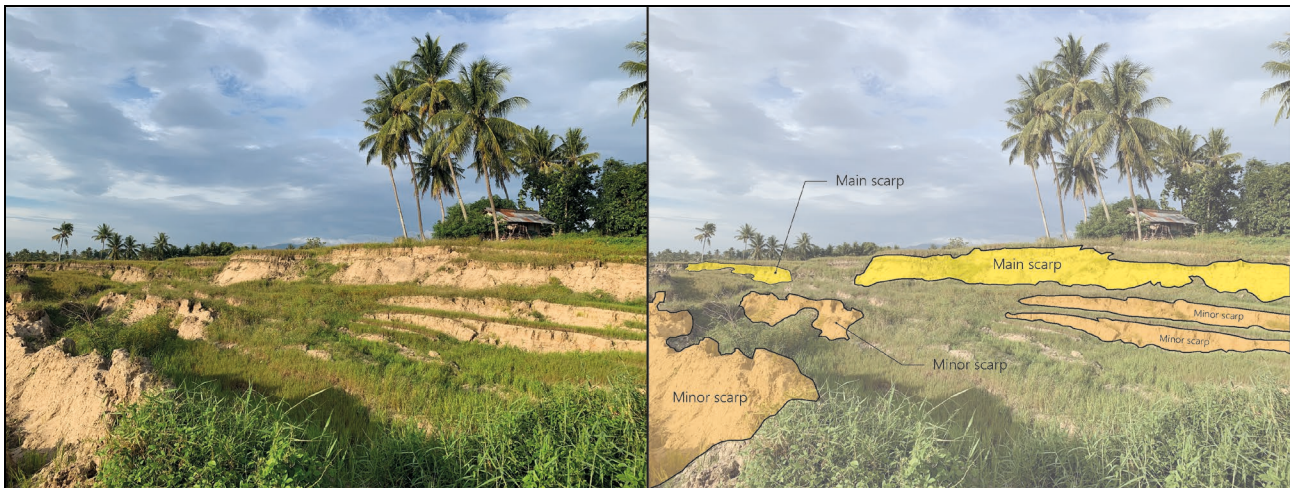
The exposed part of the head scarp was measured to be 3 to 4 m at its highest, although measurement was partially obstructed back-tilted blocks. Significant minor scarps were observed due to abundant back-tilted blocks remaining intact (Fig. 7). The overall slope angle from the top of the head scarp to the toe was less than 1°. The landslide is bounded to the north by a major drainage line – the same drainage line that it eventually becomes entrained in.

Fig. 7 – Upper part of the Sidera Landslide with the main scarp and minor scarps indicated.
