URBAN LIQUEFACTION COUNTERMEASURE PROJECT APPLIED TO CHIBA AND OTHER CITIES AFTER THE 2011 TOHOKU EARTHQUAKE

New measures have been taken to lower the groundwater level in six cities that were affected by liquefaction due to the 2011 Tohoku Earthquake (Great East Japan Earthquake). The authors have developed these measures and verified their effectiveness in several cities, and this paper reports the results. In particular, since a detailed study was conducted in Chiba City, this paper focuses on Chiba City.

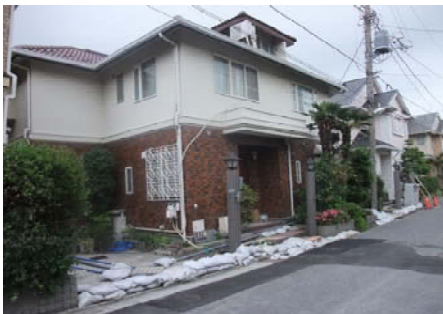
During the 2011 Tohoku (Great East Japan) Earthquake, liquefaction occurred in the Tohoku region of northeastern Japan and in the Kanto region surrounding Tokyo because the earthquake was huge. According to the Ministry of Land, Infrastructure, Transport and Tourism (MLIT), about 27,000 wooden houses were damaged due to liquefaction. The geomorphologic conditions of sites of liquefaction were as follows: i) artificially reclaimed lands along Tokyo Bay and the Pacific Ocean, ii) filled grounds on former ponds and marshes in lowlands, iii) sites excavated to get iron sand or gravel and then refilled, and iv) filled sloping grounds on hills or terraces. On flat land with a liquefied layer of uniform thickness, uniform subsidence occurred due to the change in volume of the liquefied layer and houses penetrated into the ground at some inclination due to the loss of bearing capacity or due to a decrease in the shear modulus of the liquefied layer, as shown in Figs. 1 and 2.

Fig. 1 - Settled and tilted houses in Urayasu City

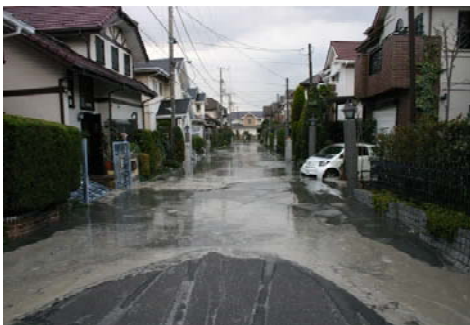
At many flat roads in residential areas, liquefaction caused several phenomena that interrupted traffic: i) much muddy water boiled onto roads (Fig. 3), ii) road asphalt heaved, was thrust or was deformed into waves at many sites, and iii) many small road cave-ins occurred several months after the earthquake. The duration of shaking during the 2011 Great East Japan Earthquake was extremely long, and the main shock was soon followed by big aftershocks because the earthquake was a “megathrust earthquake” with extremely large magnitude of $M_w=9.0$. Shaking continued for a long time after the occurrence of liquefaction. Due to the shaking of the liquefied ground, large horizontal displacement, which is a kind of sloshing of liquefied ground, was induced and caused roads to thrust (Yasuda and Ishikawa, 2014).

Fig. 3 - Muddy water boiled onto roads in Urayasu City (Photo by Mr. Ogawa)

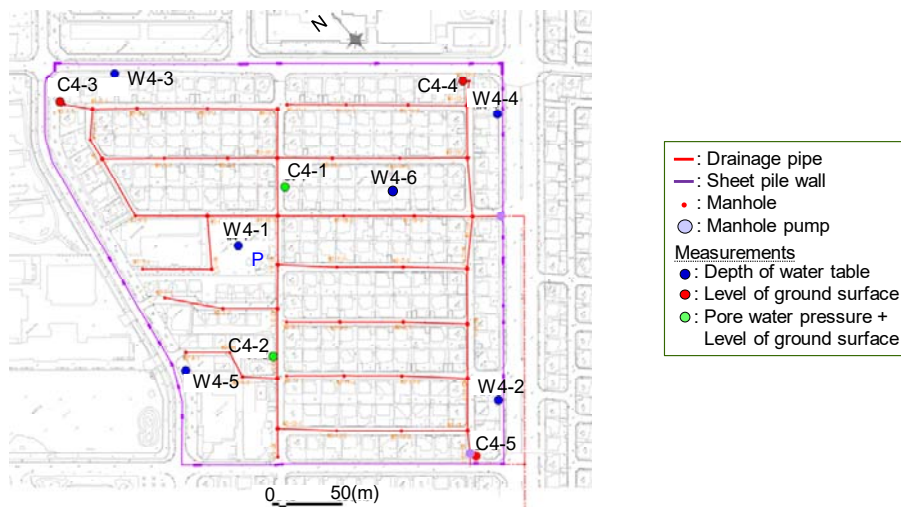
Figure 20 shows the layout of drainage pipes in Isobe 4-chome. 260 wooden houses exist in an area of about 7.1 ha. Site “P” is the in-situ test site mentioned before. As shown in Fig. 17, loose, reclaimed, sandy soil is deposited from the ground surface to the depth of 4 m to 6 m. Reclaimed clayey soil is underlaid. The level of the ground surface is about T.P. (Tokyo Peil) + 3m. The depth of the drainage pipes was designed with a slope of 2 mm/1000 mm from northwest to southeast because there is a small river in the southeast

Fig. 20 – Layout of drainage pipes in Isobe 4-chome in Chiba City (Chiba City, 2019)

direction. Drain water flows through the drainage pipes into two manholes located at the southeast boundary of the area, then the water is pumped up and into a pipe connecting to the river. The standard method to construct a drainage pipe at a shallow depth is to excavate a trench, place a drainage pipe and backfill the trench with sand. However, noise, vibration and traffic obstruction generated by construction were concerns because houses are clustered close together in this area, as shown in Fig. 21. Thus, the drainage pipes were placed by a special shield method. Vertical shafts of about 2.5 m in diameter were constructed at intervals of about 50 m, and then specially made drainage pipes of 30 cm in diameter were installed from the shafts, as shown in Fig. 22. Later, manholes were constructed in vertical shafts. The distance between drainage pipes was planned as 40 m, and the planned depth of the pipes was GL-3 m, as in the in-situ tests. Sheet pile walls were installed to a depth of about 6 m around the district to prevent water flow from outside the area. Many sensors were installed to measure the depth of the water table, the settlement of the ground surface, the pore water pressure during and after the construction of drainage pipes.

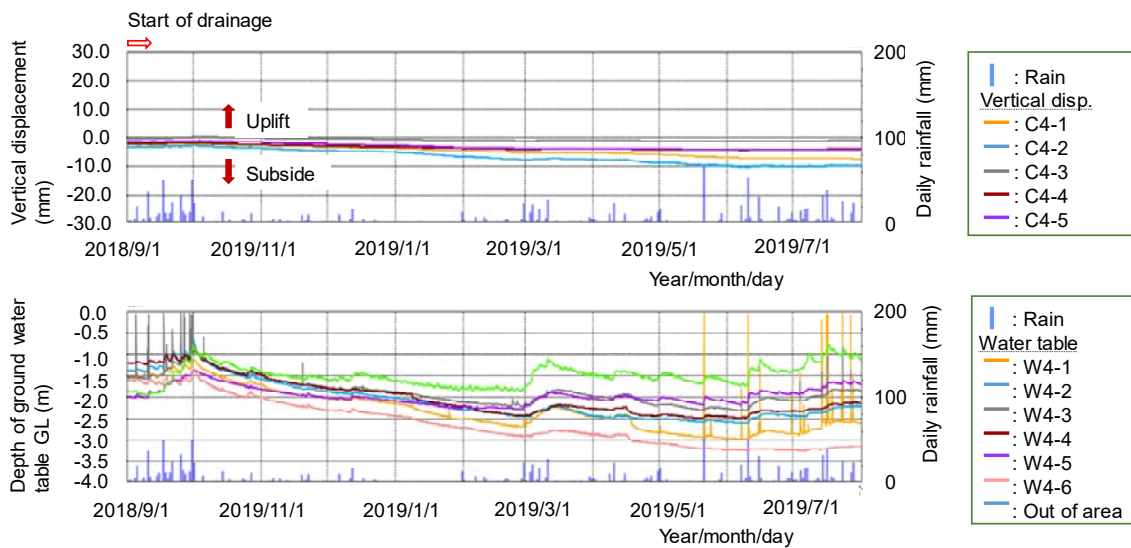
After the construction of drainage pipes and sheet piles, water drainage started from September 3, 2018. To prevent local subsidence induced by a rapid decrease in the ground water level, plugs were installed in the drainage pipes to control the decrease. Figure 23 shows time histories of the ground water level and the settlement of the ground surface for one year from the start of drainage. Daily rainfall is also plotted in the figure. The ground water table decreased to about GL-2.2 m to -2.9 m in one year due to the drainage from an original ground water level of about GL-1.2 m to -1.6 m. As shown in this figure, short increases in

Fig. 23 – Time histories of the ground water level and the settlement of the ground surface in Isobe 4-chome (Chiba City, 2019)

the ground water table occurred just after rains. The settlement of the ground surface due to lowering the ground water level was very small, from 3 mm to 6 mm, less than the settlement during the in-situ test. Figures 24 (a) and 24 (b) show the distribution of the level of the ground water table in the area before drainage and 10 months after drainage had started, respectively. As shown in these figures, the ground water level decreased uniformly in the whole area to T.P. 0 m to +1 m from an original level of T.P. +1.5 m to +2.1 m. Measurements of the ground water level and the settlement of the ground surface continued one more year. However, the level of water table did not change, and the settlement increased only slightly. Finally, the effect of lowering the water level was judged based on Fig. 15. All sites where the ground water level was measured were classified as A, B1, B2 or B3 not C. The total cost of lowering the ground water level in this area was about US \$15 million.

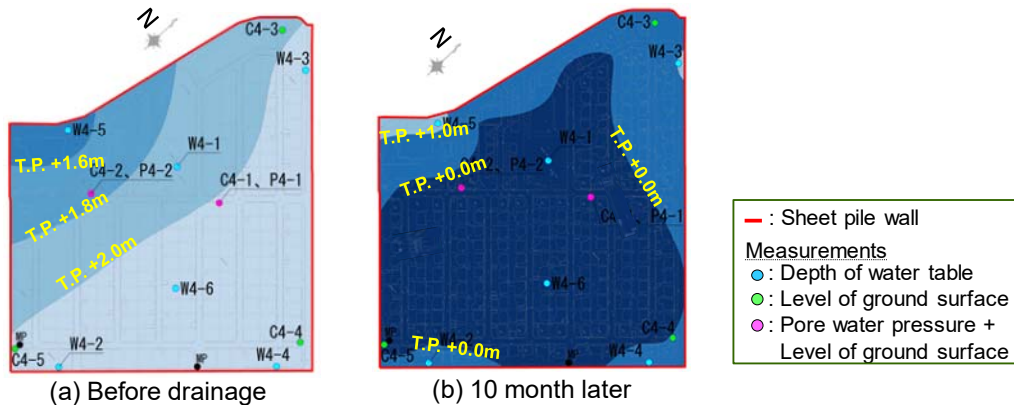
Fig. 24 – Distribution of the ground water level in Isobe 4-chome (Chiba City, 2019)

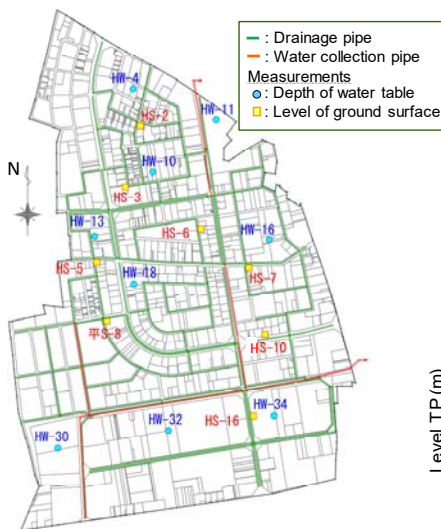
Figure 25 shows the layout of drainage pipes in the Hirai-tobu district. 245 wooden houses existed in

Fig. 25 - Layout of drainage pipes in Hirai-tobu in Kashima City

an area of about 68.5 ha. This area is located on sand dunes, and the ground surface slopes gently toward the coast from west to east. As the dune sand is suitable for construction material, it has been extracted and backfilled with other sandy soils at many spots historically. So, as shown in Fig. 26, loose, filled sandy soil is deposited from the ground surface to the depth of 5 m to 15 m, irregularly. A layer of dense, diluvial, gravelly sand lies beneath the sandy soil deposit. The depth of the drainage pipes was designed at a slope of 1 to 48 mm/1000 mm from west to east and with the depth of about 3 m below the ground surface. Drained water flows into water collection pipes, then flowed to ocean naturally. Drainage pipes were constructed by a standard method because wooden houses were being constructed in the area and existing houses were scattered, as shown in Fig.27. First, groundwater level was lowered by well-point method, trenches were excavated, as shown in Fig. 28, then drainage pipes of 200 mm to 300 mm in diameter were placed inside the trenches using permeable sheets and the trenches were backfilled with gravelly sand.

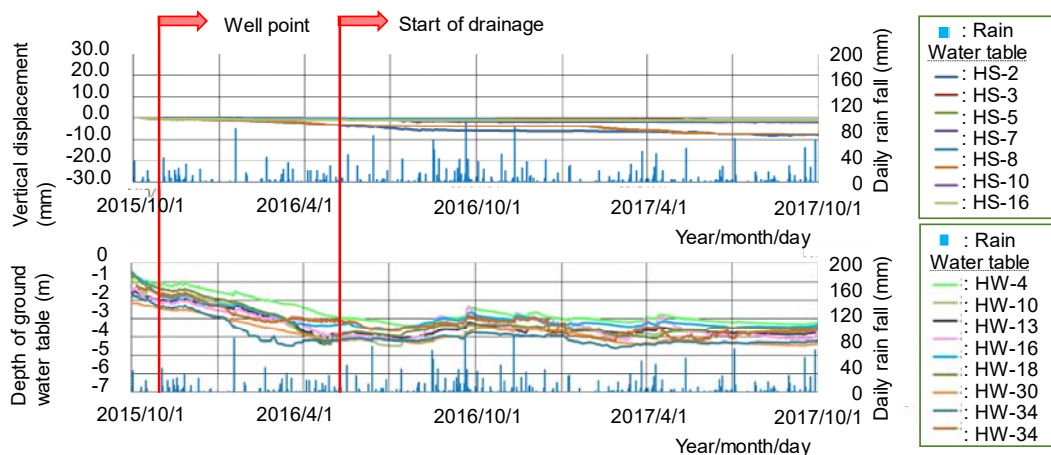
After the construction of the drainage pipes, water drainage started on April 20, 2016. Figure 29 shows the time histories of the ground water level and the settlement of the ground surface, together with the daily rainfall for two years from the start of drainage. The ground water table decreased to about GL-3.0 m to -4.0 m in two years from an original ground water level of GL-0.5 m to -2.0 m. There were few short-time increases in the ground water table due to rainfall. Figures 30 (a) and 30 (b) show the distribution of the level of the ground water table in the area before drainage and two years after drainage, respectively. As shown in these figures, the ground water level decreased to T.P. +4 m to +7 m from an original level of T.P. +6 m to

Fig. 29 - Time histories of the ground water level and the settlement of the ground surface in Hirai-tobu

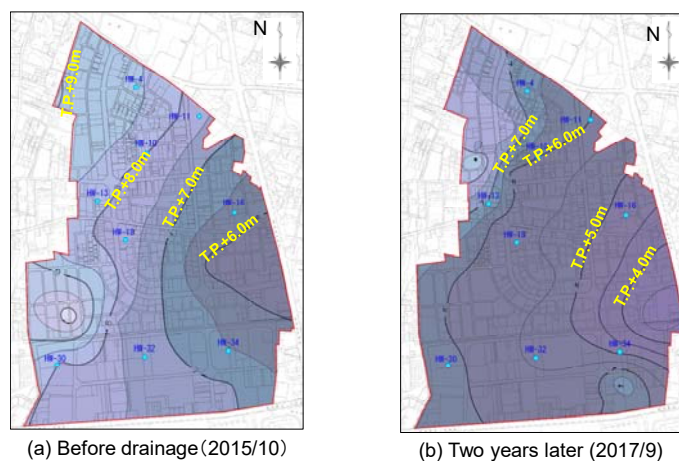
Fig. 30 – Distribution of the ground water level in Hirai-tobu

+9 m, in the whole area. Measurements of the ground water level and the settlement of the ground surface continued for two more years. However, the water table level remained about constant, and settlement increased by only 1 mm. Finally, the effect of lowering of the water level was judged based on Fig. 15. All sites where the ground water level was measured were classified as class A, B1, B2 or B3 not C. The total cost of lowering the ground water level in this area through this method was about US \$32 million.
