STUDY OF THE SOIL FAILURE MECHANISM AT PALU, INDONESIA DURING THE 2018 SULAWESI EARTHQUAKE

Abstract

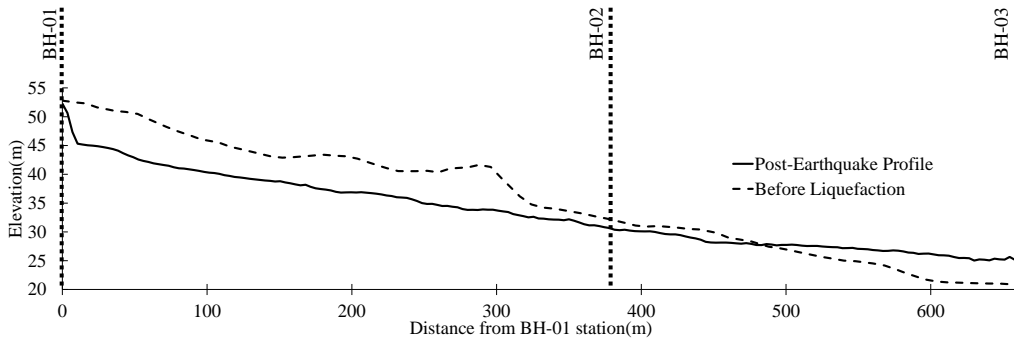
Fig. 6 shows the change in soil profile at Balaroa due to soil failure. The ground elevation profile before the earthquake was obtained from digital elevation model data [11]. As for the post-earthquake ground elevation profile, it was obtained through LIDAR data of the region. Due to the soil failure, the whole sandy topsoil layer between BH-01 and BH-02 slid and mounted at the lower elevation ground, as expressed in the figure in elevation at BH-03. Since the soil failure is predominant between BH-01 and BH-02, the current study focuses on the soil profile between BH-01 and BH-02.

Fig. 6 Change in soil profile at Balaroa due to liquefaction

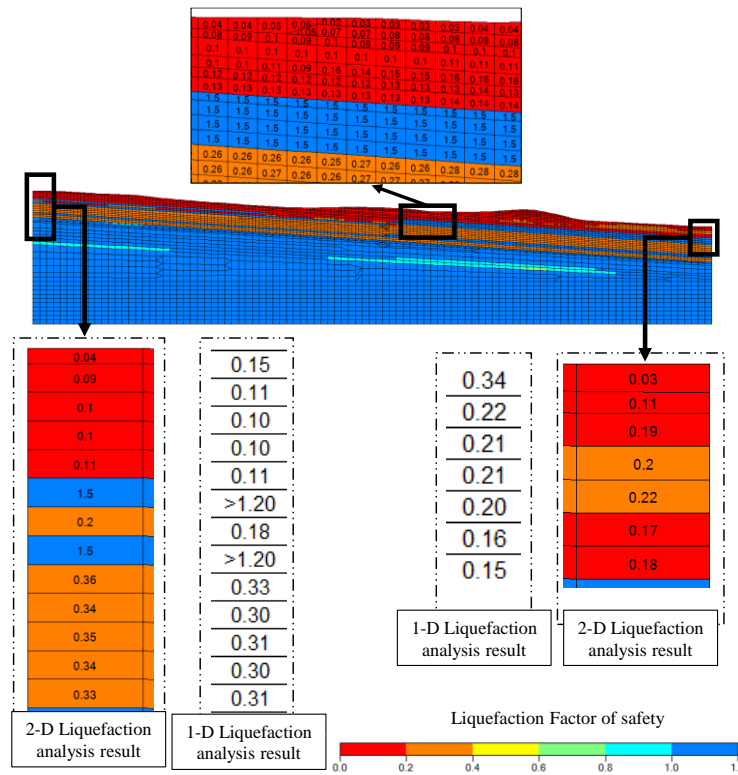
Fig. 13 Comparison of analysis results obtained from 1-D and 2-D soil response analysis

The liquefaction results obtained from 1-D and 2-D analysis are compared in Fig. 13. The top layer of soil which comprises of very loose sand resulted in low factor of safety values. At a depth of around 6m from the top surface there is boulder and gravel at BH-01 and BH-02 respectively. This leads a clear demarcation at both BH-01 and BH-02, that up to a particular depth the soil was highly susceptible to liquefaction failure. Similar results were obtained both from 1-D analysis and 2-D analysis, however the 2-D analysis leads to slightly more critical factor of safety values. This can be attributed to the consideration of the vertical wave motion which, in the case of the Sulawesi earthquake had a larger PGA compared to the horizontal wave motion.

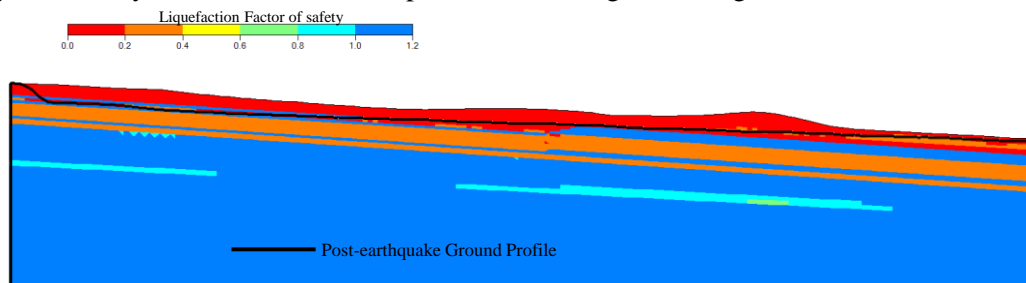
In order to verify the analysis results, Fig. 14 shows the overlay of the liquefaction contour and the post-earthquake ground profile. The region in the model where the factor of safety is <0.2 correlates well with the soil failure profile. The failure of the soil surface can be mainly attributed due to liquefaction. The results also justify the soil layer stratification assumption made during modelling.

Fig. 14 Comparison of analysis result and the observed post-earthquake soil profile

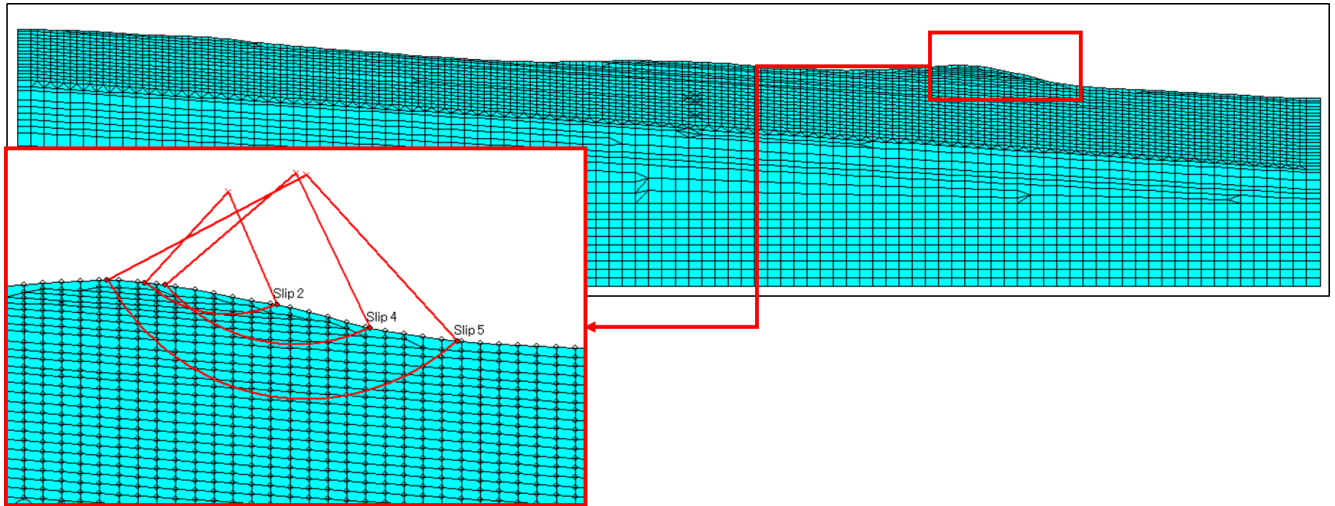
Several slip lines are defined considering the soil type and failure locations as described in Fig. 15. Finally, 3 slip lines with lowest safety factor are selected. The lowest safety factor occurred on Slip 2 which consist of sandy soil and located at the top of the slope as described in Table 5. The elements observed on Slip 2 consist of very loose sand with low shear strength and located on the top of the slope, resulting to lowest shear resistance. Nevertheless, the lowest safety factor does not go below 1.00.

Fig. 15 Selected Slip Surface for Slope Stability Analysis

Slip no.	Safety Factor
Slip 2	1.04
Slip 4	1.26
Slip 5	1.41
