THE SURA POST-EARTHQUAKE ASSESSMENT METHODOLOGY. CASE STUDY: M7.1 MEXICO EARTHQUAKE, 2017

M.J. Barrera⁽¹⁾, V. Gonzalez⁽²⁾, E. Cardona⁽³⁾, G.M. Estrada⁽⁴⁾, J.D. Rendon⁽⁵⁾

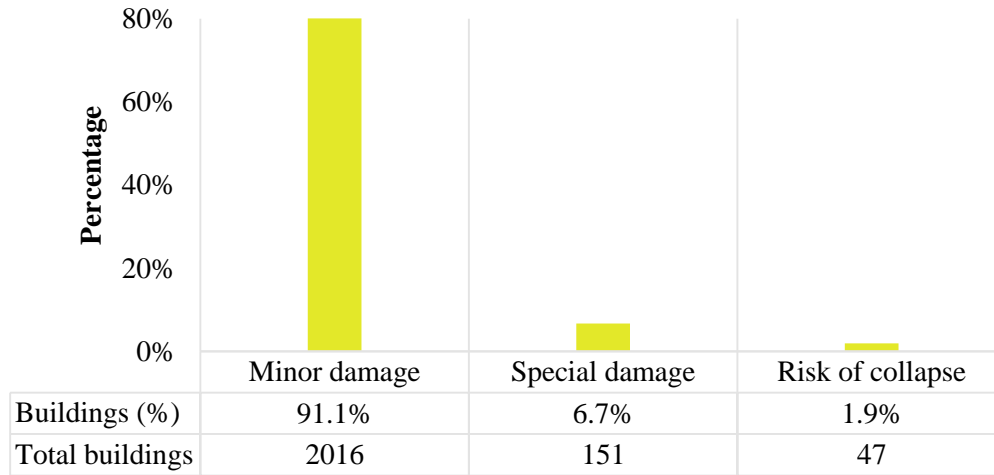
The results from the application of the SURA Post-Event Structural Assessment Methodology on 2214 structures show that 91% of the structures were categorized as having minor damage, 6.7% as special treatment

structures, and 1.9% were classified as presenting risk of collapse. Fig. 2 shows the percentage of structures classified under each category.

Fig. 2 – Percentage of inspected buildings classified under each damage category

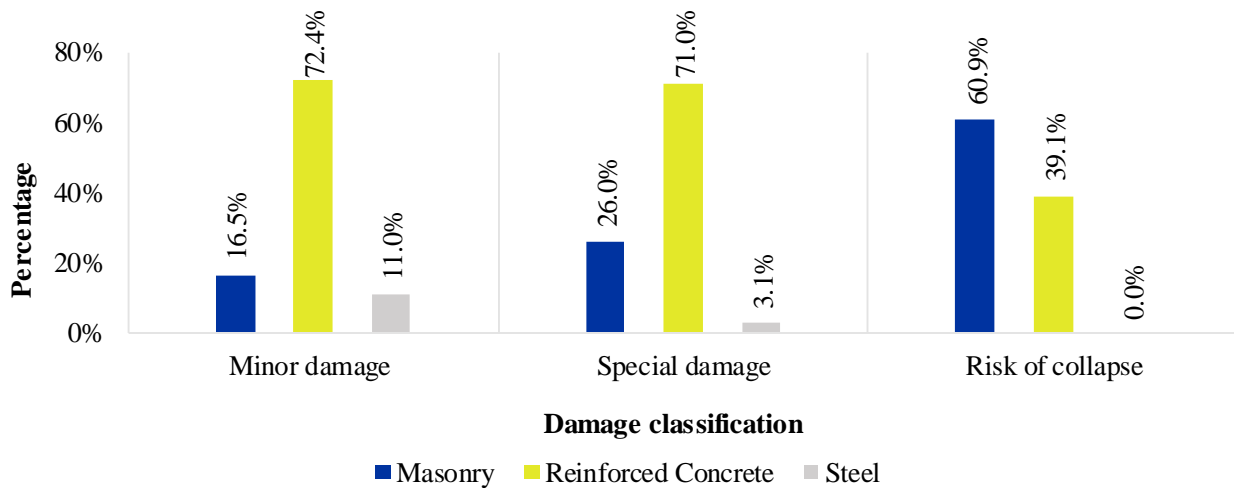
Fig. 3 shows the percentage of buildings classified in each damage category for three different structural materials. Of the assessed structures classified as having risk of collapse, 61% were masonry structures, while of those classified as having special damage 71% were reinforced concrete structures. Fig. 3 highlights the superior performance of steel structures, which presented no risk of collapse, and represented only 11% of those classified as having minor damage.

Fig. 3 – Damage classification of inspected building stock by structural material

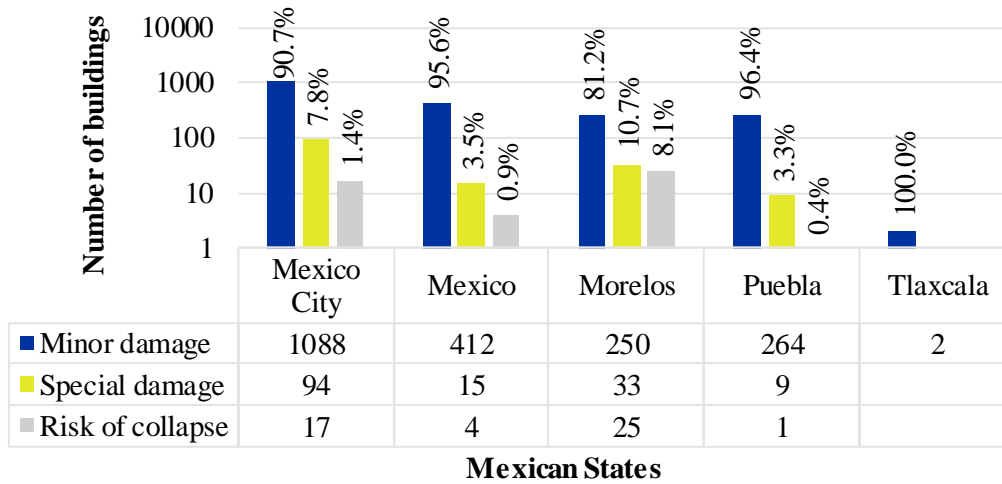
Although most of the claims received were filed in Mexico City, Morelos was the state with the most structures that presented a high risk of collapse (see Fig. 4). An important part of these structures were constructed in adobe.

Fig. 4 – Damage classification of inspected building stock by state

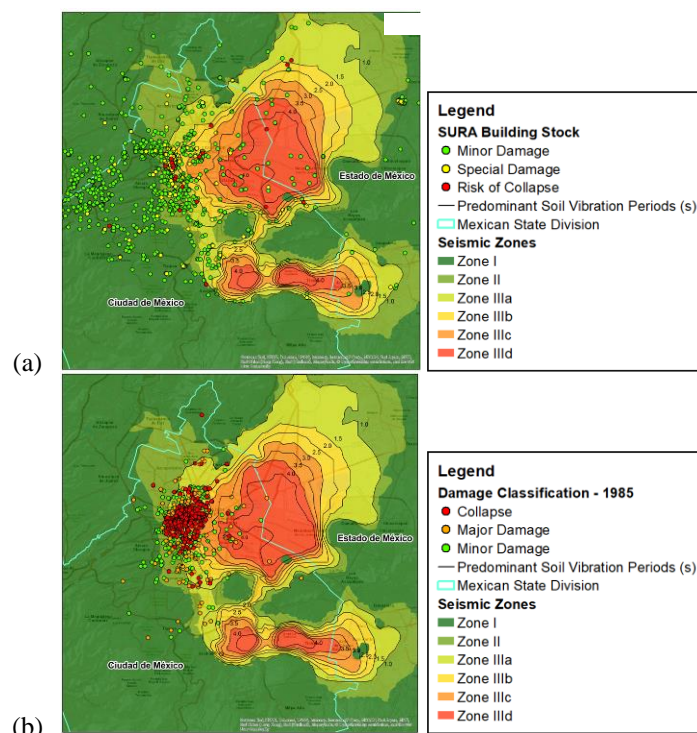
Fig. 5 – Damage distribution over Mexico City's seismic zones for (a) the 19 September 2017 event and (b) the 19 September 1985 event [4]

Fig. 5 shows that most of the structures assessed by SURA that were damaged by the 19 September 2017 earthquake in Mexico City were concentrated in zones I, II and IIIa, with 40% of collapses occurring in zone IIIa. For the 19 September 1985 earthquake, Zone IIIb presented the most structures classified in all damage levels.

When comparing the two events, most of the damage resulting from the 2017 event was primarily located in soils with a vibration period lower than 2.0 seconds, while in the 1985 event, damage was concentrated on soils with vibration periods between 1.0 and 3.0 seconds.

Of all the structures assessed by SURA in the six seismic zones shown above after the 2017 event, 92% were located in soils having periods of 2.0 seconds or less. Of these structures, 85% presented minor damage, 6% were classified as having special damage, and 1% were classified as having risk of collapse.

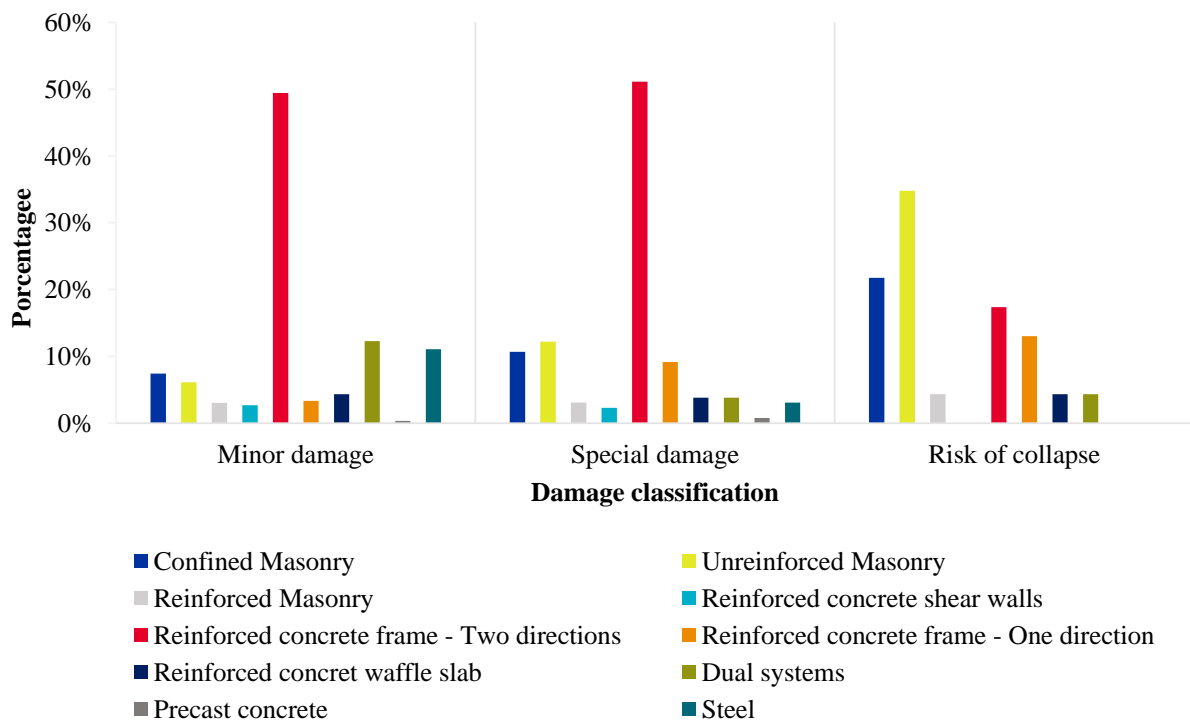
Fig. 6 shows the percentage of buildings pertaining to each identified structural typology that were classified in each of the three damage categories. 35% of the structures classified as having risk of collapse were unreinforced masonry structures, while 22% were confined masonry structures. For the structures classified as having special damage, 51% were found to be reinforced concrete frames in two directions. Among the structures that presented good seismic performance, steel structures and shear wall reinforced concrete structures were in no case classified as having risk of collapse, and only 3% and 2.3%, respectively, were classified under the special damage category.

Fig. 6 – Damage classification of inspected building stock by structural typology.

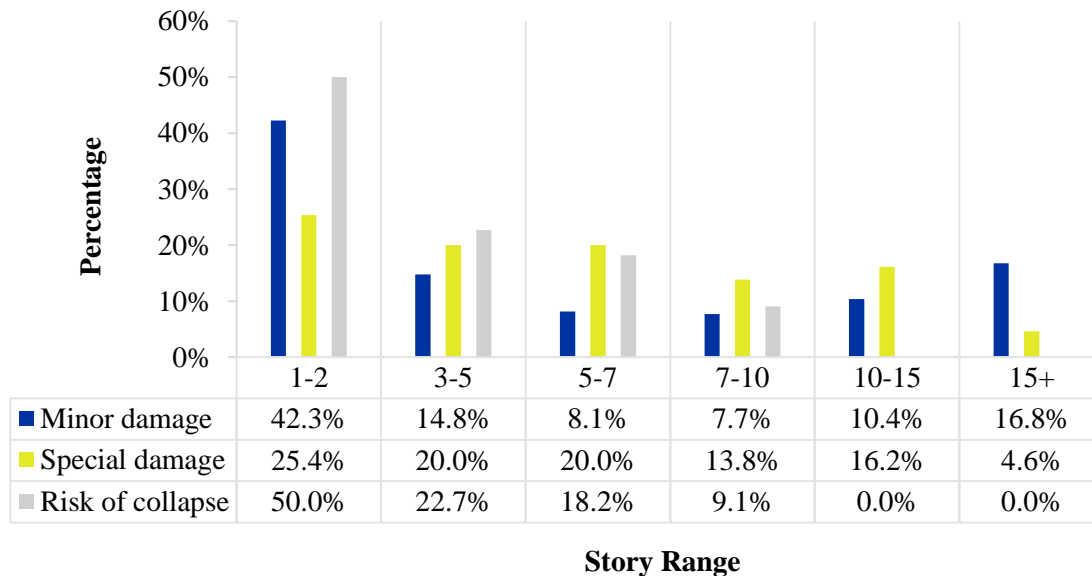
Of the inspected building stock, 57% had 5 stories or less, 17% had between 5 and 10 stories, and 26% had over 10 stories. Fig. 7 presents the percentage of buildings pertaining to each story range that were classified in each of the three damage categories. This shows that most of the damage was found in low-rise buildings (1-2 stories), which correspond to 42.3% of the buildings classified in minor damage, 25.4% of those classified in special damage, and 50% of those classified as collapse or having risk of collapse. None of the high-rise structures (10 or more stories) were classified as having risk of collapse.

Fig. 7 – Damage classification of inspected building stock by story range

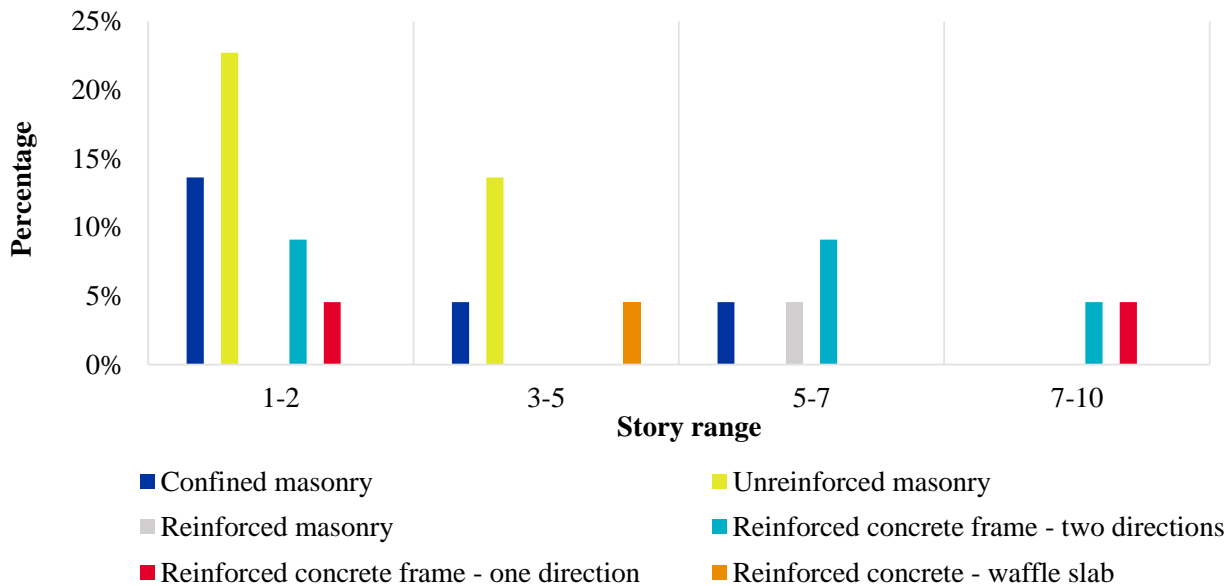
Of the structures classified as having risk of collapse (see Fig. 8), 36% were unreinforced masonry structures, of which 23% were low-rise and 13% were mid-rise (3 to 5 stories). This same analysis was done for reinforced concrete frames, which represent 23% of the structures classified as having risk of collapse. Of these, 9% were low-rise structures, another 9% had 5 to 7 stories, and 5% had 7 to 10 stories.

Fig. 8 – Inspected buildings classified with risk of collapse by structural typology and number of stories

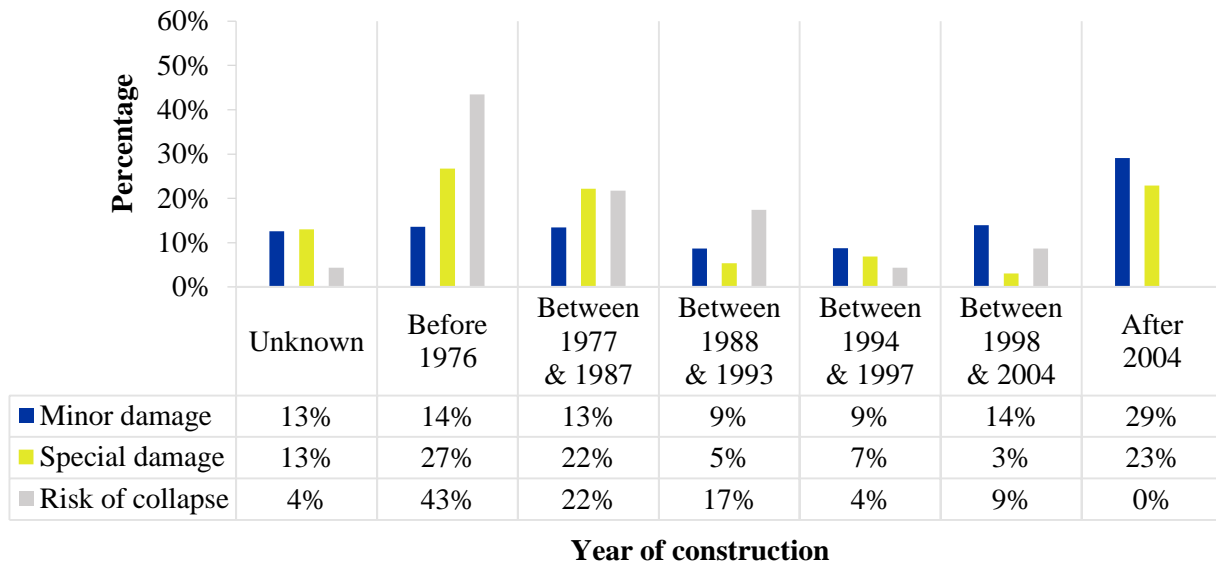
When crossing damage classification with year of construction, of all the structures classified as having risk of collapse, 43% corresponds to structures built before 1976. For buildings classified under special damage, 27% were built before 1976. 29% of buildings classified under minor damage were built after 2004 and this damage could be explained by an unfavorable interaction between structural and non-structural components (see Fig. 9).

Fig. 9 – Damage classification of inspected building by year of construction

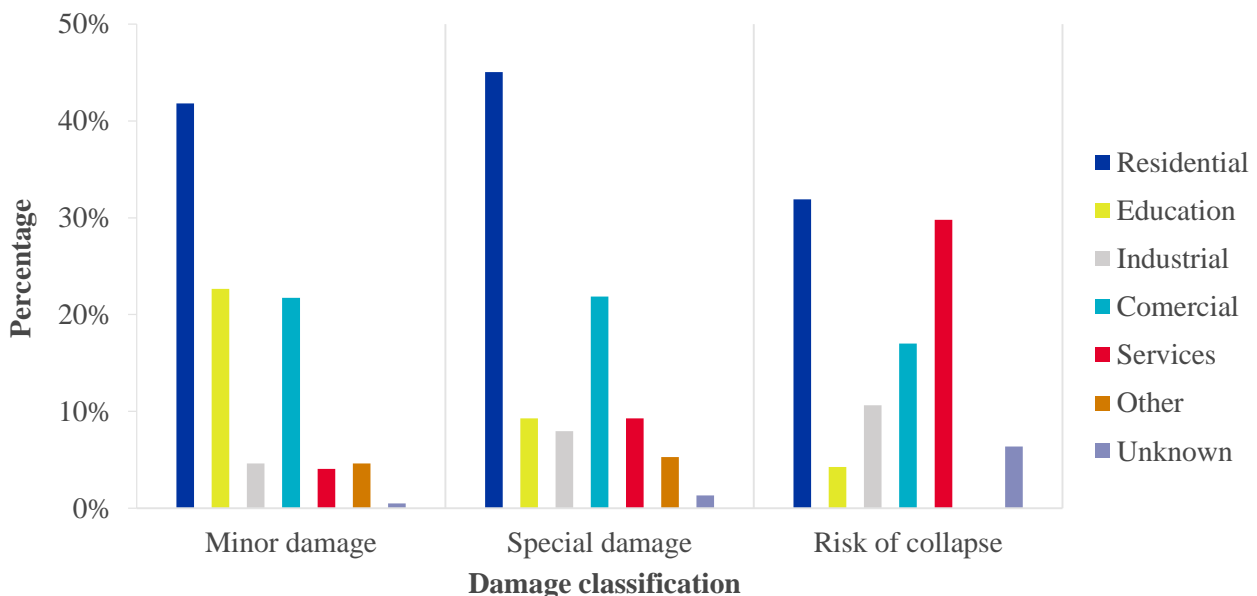
Fig. 10 shows the percentage of buildings pertaining to each use that were classified in each of the three damage categories. The building use defined as “services”, which include hotels, healthcare facilities, prisons, religious centers, restaurants and sports facilities, represent only 5% of the assessed building stock. However, it also corresponds to 30% of the structures classified under risk of collapse and 9% of the structures classified as having special damage. The commercial buildings, which make up 21% of the assessed building stock, represent 22% of the structures with special damage and 17% of those with risk of collapse.

Fig. 10 – Damage classification of inspected buildings by use

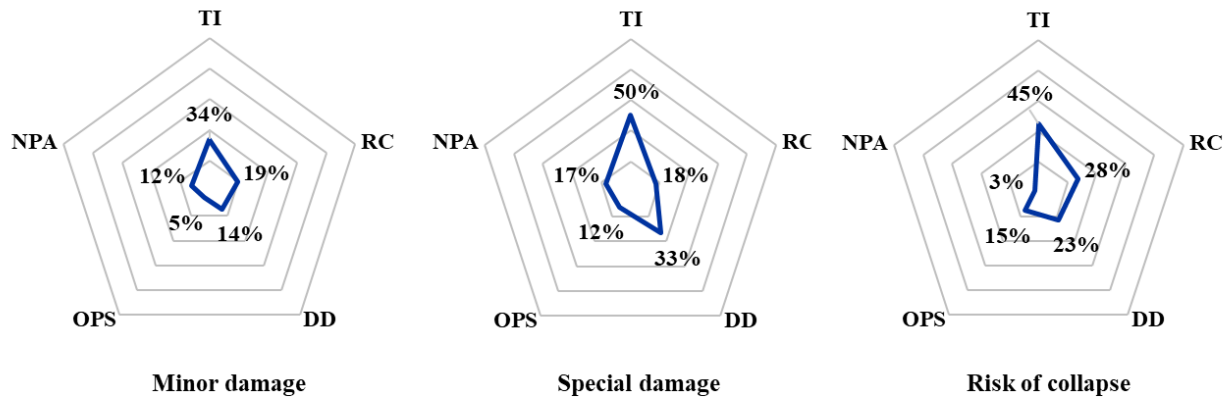
Structural irregularities in plan and height have been proven to have considerable effects on the seismic performance of a structure. Fig. 11 presents the distribution of irregularities in plan for each of the three damage classifications. Torsional irregularity is the most commonly observed in all three damage states, but its

influence is predominant in structures presenting special damage and risk of collapse. Reentrant corners also influence seismic performance, with 28% of structures with risk of collapse presenting this irregularity, and a lower percentage seen in buildings with minor or special damage.

Fig. 11 – Damage classification by plan irregularities

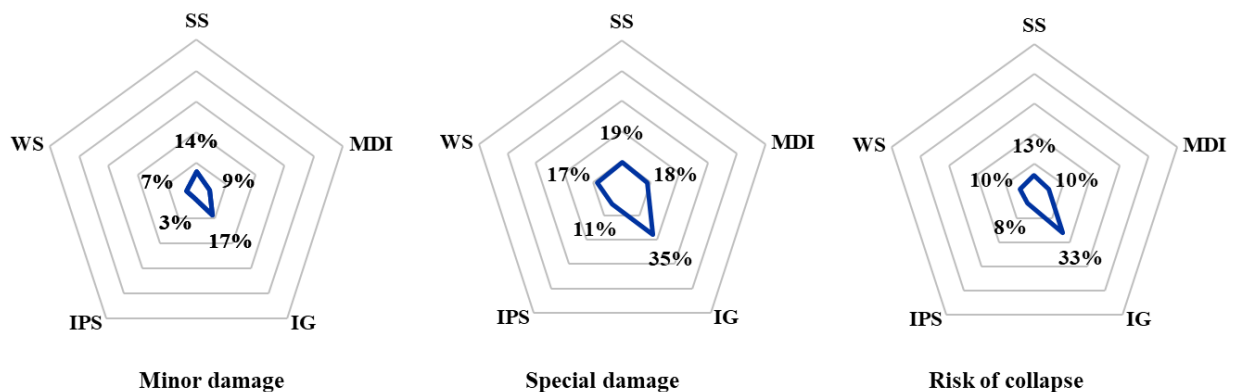
Fig. 12 presents the distribution of irregularities in height for each of the three damage classifications. 35% of buildings having special damage and 33% of buildings having risk of collapse present geometric irregularities, which was the most observed. Soft story and weak story irregularities represent 23% of the structures having risk of collapse and 36% of structures classified as having special damage.

Fig. 12 – Damage classification by height irregularities
