## Damage Investigation of Non-structural Components in Buildings with SHM System in the 2018 Osaka Earthquake

S. Ogasawara<sup>(1)</sup>, K. Kanda<sup>(2)</sup>, Y. Suzuki<sup>(3)</sup>

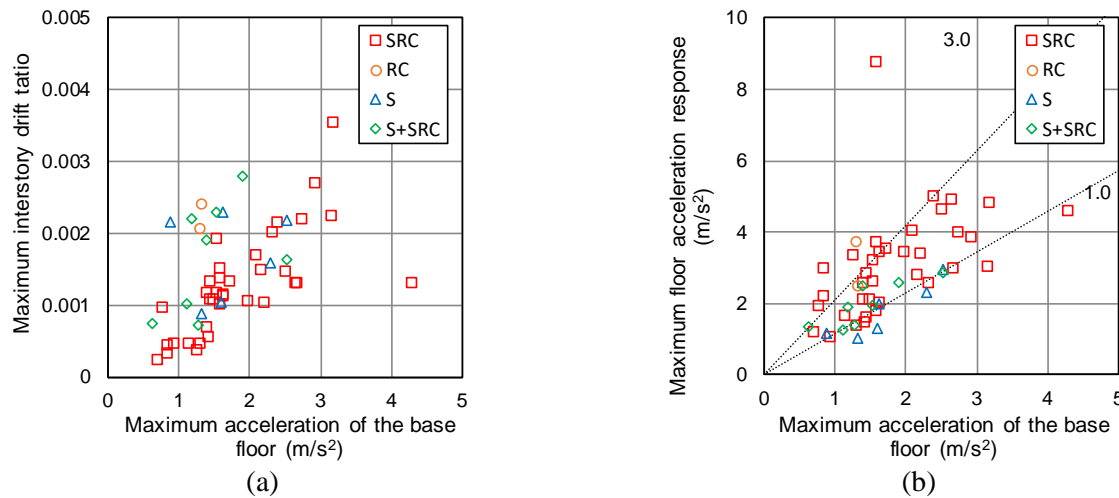
Fig. 4 – Relationship of response between base floor and floor sustaining maximum response: (a) Maximum interstory drift ratio; (b) Maximum floor acceleration

The maximum interstory drift ratio shown in Figure 4 (a) is at most 0.33% (1/300) and tends to increase as the base acceleration increases. For concrete-based buildings, the difference between the RC and SRC buildings occurred primarily because most SRC buildings have shear walls, while the RC building is made of moment frames that have fewer shear walls. The steel buildings and the combined steel and SRC buildings tend to be larger variation in the maximum interstory drift ratio because some buildings consist of only moment frames, while the rest are made of moment frames with braces.

The largest acceleration measured among all floors was 8.8 m/s<sup>2</sup> (0.90g), one significantly larger than the rest in Figure 4 (b). This particular record, was observed by a sensor near the damaged expansion joint, and most likely was obtained as a result of pulse-like vibration during its serious failure. Excluding this record, the maximum floor acceleration is in a range of 5.0 m/s<sup>2</sup> (0.50g). Figures 4 (b) also indicates that the floor acceleration is amplified by a factor of one to three from the base to the top. The maximum accelerations of most buildings exceeded 1.0 m/s<sup>2</sup> (0.10g), which has been confirmed as the approximate magnitude at which damage to non-structural components began to occur, particularly in ceilings, from the experience of the 2011 Tohoku earthquake [2].

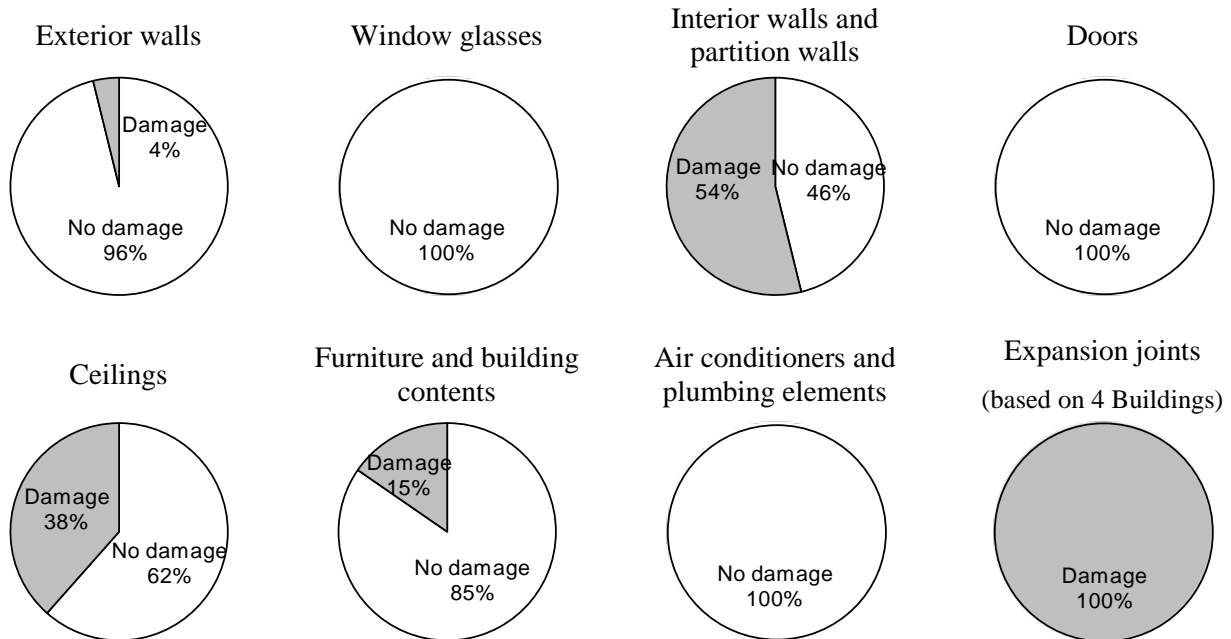
Fig. 5 – Damage ratio of non-structural components (based on 26 buildings)

We investigated damage of non-structural components of the buildings. Figure 5 shows the damage ratio with respect to the number of buildings that sustained relevant damage. Here, the building is classified as damaged unless it did not exhibit any damage to the relevant non-structural components. Major characteristics observed from the survey are summarized as: 1) Most non-structural components around the expansion joints were damaged; 2) Many buildings suffered damage to interior walls, partition walls, and ceilings; 3) There was no damage to window glasses, doors, and furniture and building contents; and 4) Four buildings out of 26 (i.e., 15%) suffered no damage to non-structural components.

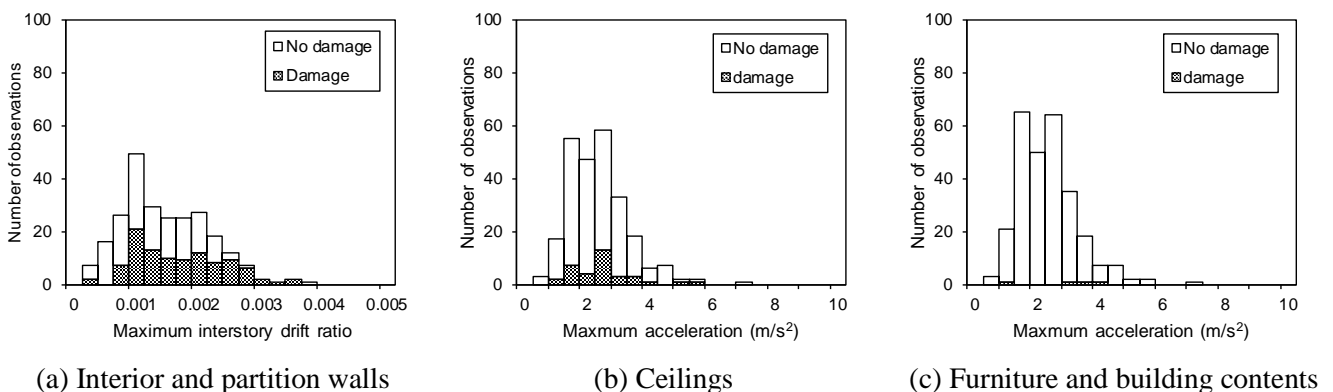
Fig. 6 – Distributions of damage: (a) With respect to maximum interstory drift ratio; (b)(c) With respect to maximum floor acceleration

Figure 6 shows the maximum response (interstory drift ratio and floor acceleration) and the number of damage cases. Here the number of observations was classified as damaged when damage was observed in at least one non-structural component in the floor. The number was counted with respect to the floor of the section installed the sensor. The interstory drift ratio on each floor was the same in the section installed the sensor, and the acceleration on each floor was linearly interpolated in the section. Detailed investigation result of damaged components is presented below.

Many small cracks occurred in interior and partition walls. Cracks were detected most extensively around core spaces running vertically, such as staircases and elevator shafts, and also around openings, such as doors and windows. Most of them were slight damage, characterized by fine cracks in the walls. Interior and partition walls were composed of many types of materials and installation methods, hence detailed classification of the walls was difficult. Therefore, the relationship between the maximum interstory drift ratio (of the two horizontal directions) and the damage severity of walls was analyzed without detailed classification into respective types of wall. Figure 6 (a) shows the maximum interstory drift ratio and the number of damage cases. In one case, cracks were observed at 0.05% (1/2000) in a concrete non-structural wall at the stair room, but most likely this occurred as a result of the concentration of local deformations in the wall. If this case is excluded, notable damage, i.e., cracks, was found to occur from a maximum interstory drift ratio of about 0.1% (1/1000).

As for the damage to ceilings, misalignment of ceiling panels and damage to lights and other equipment attached to the ceiling were observed most frequently. A few ceiling panels fell, where the maximum acceleration at the corresponding floor was  $3.8 \text{ m/s}^2$  (0.39g). This was caused by collisions between the wall and ceiling. Figure 6 (b) shows the maximum acceleration at the corresponding floor and the number of damage cases that match the definition adopted for ceilings. Minor damage such as misalignment was found to occur beyond a maximum acceleration of about  $1.5 \text{ m/s}^2$  (0.15g).

Furniture and building contents were damaged at five cases. The main damage was the shift and fall of the shelves that were not fixed. These were damages reported to the facility manager. We could not investigate the damage to tenants, so other damage may have occurred. Figure 6 (c) shows the maximum acceleration at the corresponding floor and the number of damage cases. The monitor installed at a high place fell at  $1.0 \text{ m/s}^2$  (0.10g), but it is probable that larger acceleration occurred at the base of the monitor than on the floor. Excluding this case, damage such as fall was found to occur beyond a maximum acceleration of about  $3.5 \text{ m/s}^2$  (0.35g). However, it depends on whether measures are taken to prevent falls.

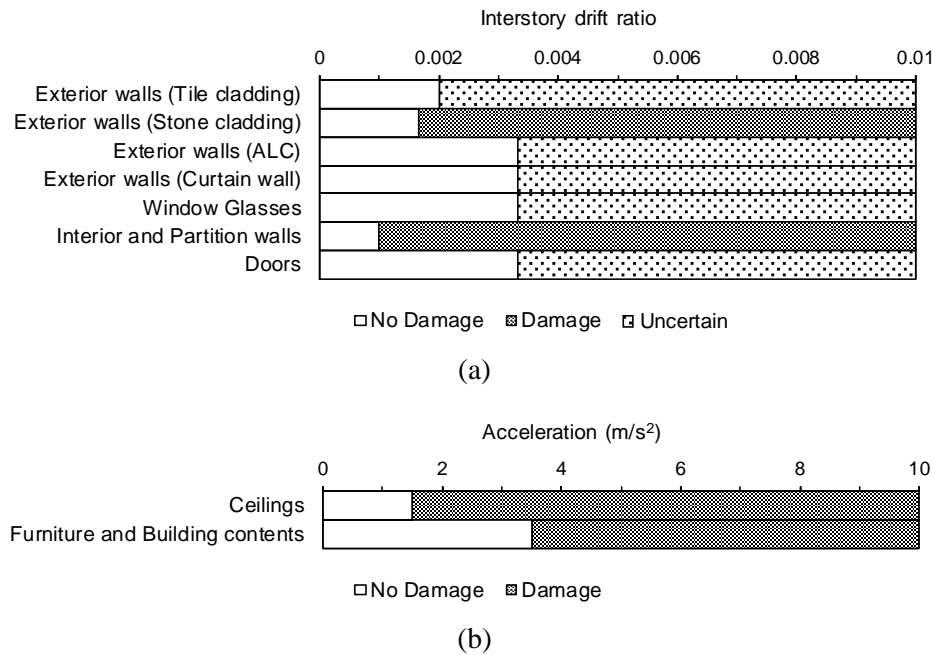
Fig. 7 – Damage distribution of non-structural components; (a) displacement-sensitive non-structural components with respect to interstory drift ratio; (b) acceleration-sensitive non-structural components with respect to maximum floor acceleration

We examined the building response that caused damage to non-structural components. Figure 7 shows damage levels of displacement-sensitive or acceleration-sensitive non-structural components. Here, “no damage” means that non-structural components sustained no damage until the specified displacement or acceleration; “damage” means that at least one non-structural component of the 26 buildings experienced damage in the concerned range; and “uncertain” means that the damage level could not be evaluated because none of the components reached the relevant level of displacement or acceleration. Based on the damage data, a general sequence in which non-structural components are damaged can be estimated such that damage occurred first at expansion joints, followed by interior and partition walls, further followed by ceilings, furniture and building contents, and exterior walls. Doors and window glasses are likely not damaged earlier than other types of non-structural components.

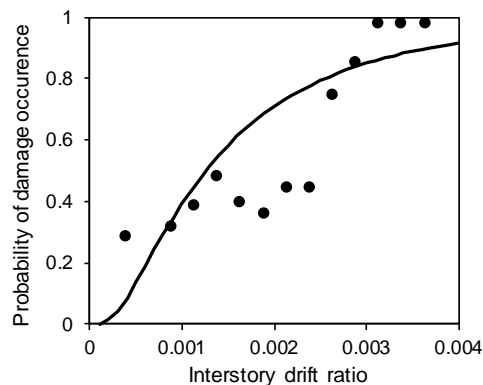
Fig. 8 – Example fragility curve of interior and partition walls obtained from actual damage

Since we had much damage data for interior partition walls which tended to be damaged even in small interstory drift ratio, we tried to evaluate their fragility curve. Figure 8 illustrates an example fragility curve estimated for interior and partition walls using the data shown in Figure 6 (a). The interstory drift ratio at damage initiation was taken to follow the log-normal distribution. According to this figure, the damage

probability exceeds 50% at an interstory drift ratio of 0.13% (1/800). Caution is needed when referring to this curve, because the damage was counted with respect to each floor (i.e., judged damaged if at least one non-structural component was damaged in the floor), and the data was limited for the interstory drift ratio of at most 0.40% (1/250).
