POST-EARTHQUAKE BUILDING SAFETY EVALUATION WITHIN THE PERFORMANCE-BASED DESIGN FRAMEWORK

F. Sánchez-Flores⁽¹⁾, A. Terán-Gilmore⁽²⁾

Abstract

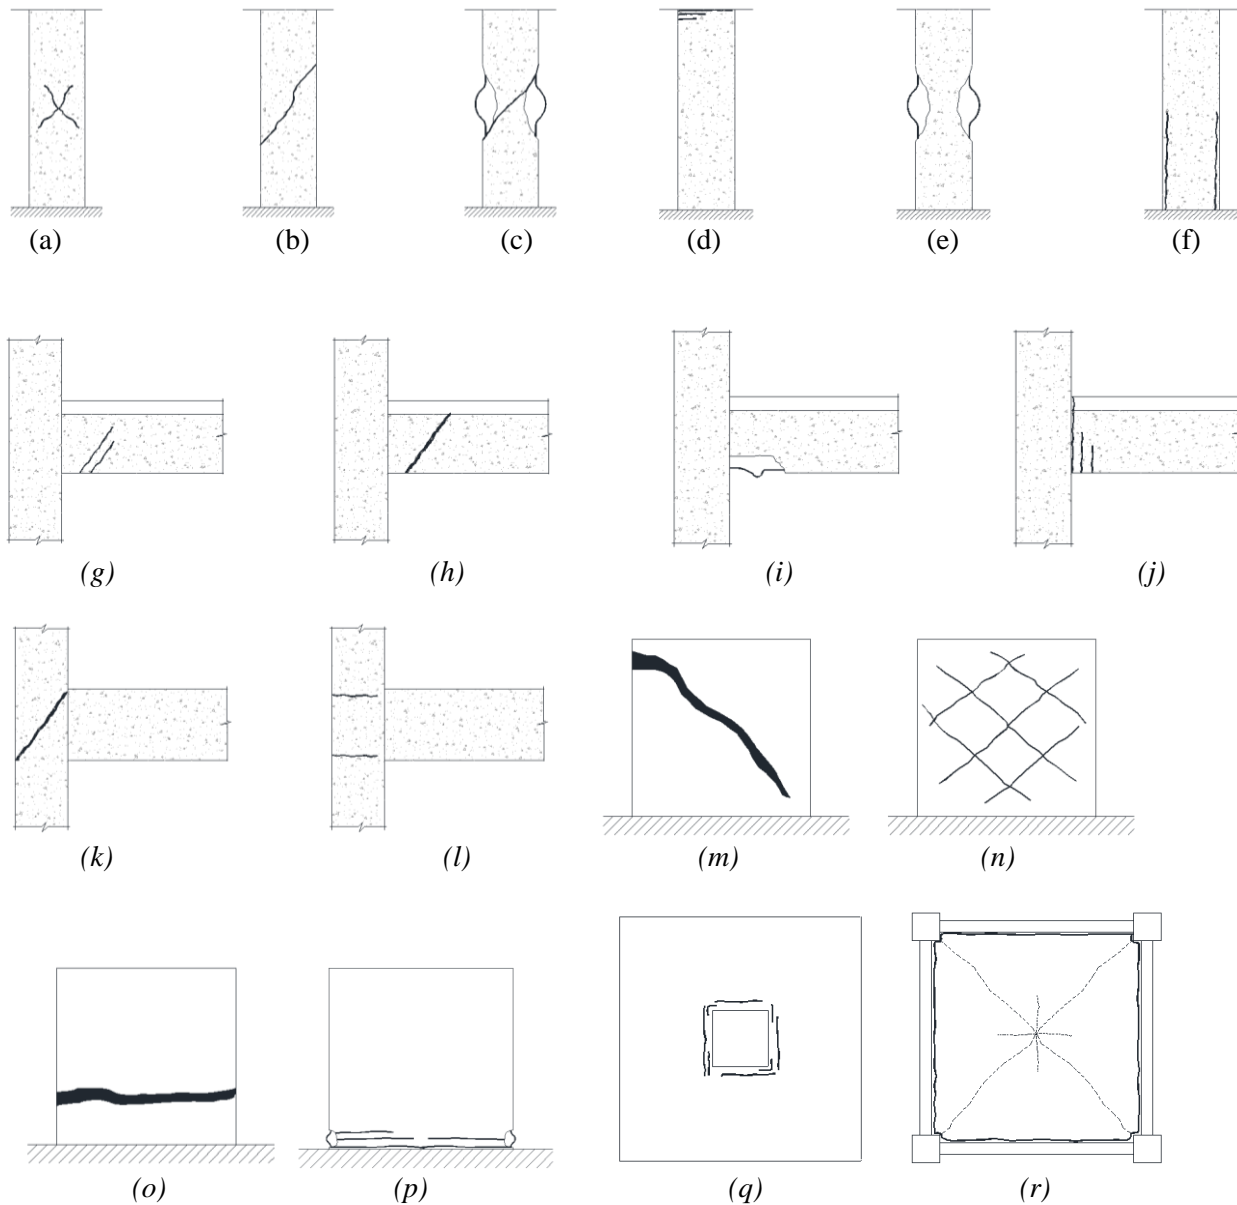
Fig. 3 – Common damage on typical structural elements

(a), (b), and (c) shear damage on columns; (d) flexure damage, (e) flexocompression damage, (f) anchorage damage on columns; (g) and (h) shear damage on beams; (i) and (j) flexure damage on beams, (k) and (l) shear and anchorage damage on connections, respectively; (m) and (n) shear damage on walls; (o) and (p) flexure damage on walls; (q) and (r) shear and flexure damage on slabs, respectively.

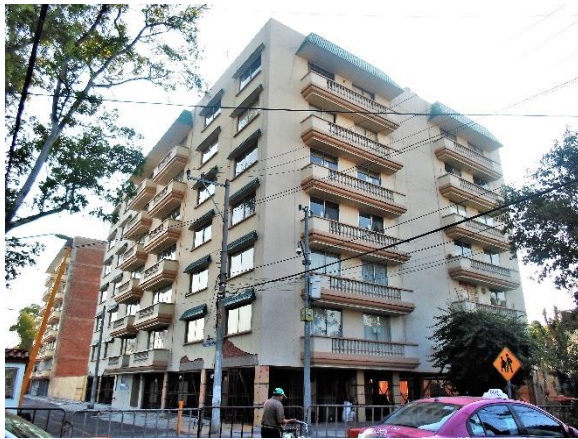
(a) Condition during the inspection

The building under study is located in a northern neighborhood in Mexico City named *Lindavista*. It was impacted by the partially collapsed adjacent building and classified as a high-risk building. After the demolition of what remained of the neighboring collapsed structure, a rapid inspection was required to assess the structural safety of the building.

The seven-storey building has habitational use. The actual condition during inspection and a typical floor plan are shown in Fig. 5. The primary structural system is formed by forty-eight RC columns located in the

intersection of longitudinal and transverse lines. There are RC shear walls in the transverse line *E* between lines 3-4, and in the elevator shaft. However, RC walls are not a complete secondary system because they not fully resist the seismic forces. Non-structural masonry walls provide supplemental stiffness to the building. Due to the openings in its first floor, the building can be classified as a soft-story building. The floor system consists of flat grid slabs directly supported in the columns.

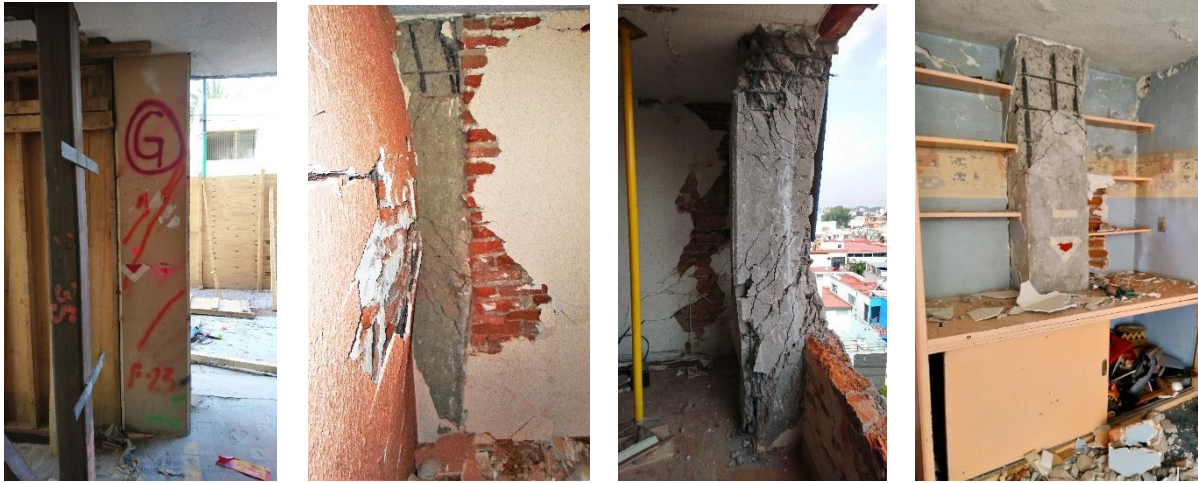
Fig. 6 – Damaged columns

Post-Earthquake Damage index, D_i . The critical damage was found in the 6th story due to the impact of the adjacent building. Columns in the transverse line *A*, namely, 2*A*, 3*A* and 5*A* were severely deformed in such a way that they reached, as shown in Fig. 6, the C_P level. In the 1st story, crack widths of columns located in longitudinal lines 1 and 6 was, as shown in Fig. 6, between 1 and 3 mm. These columns reached the L_S level. Other structural elements such as columns, floor slabs and RC walls remained in O_P level. A damage survey of non-structural masonry walls was carried out. Most walls in C_P level were in the 6th floor near the impact area. Masonry walls in L_S level were observed throughout the building. After a holistic study of the damage underwent by the building under performance-based design concepts such as SCWB, a red flag is assigned to the *Post-Earthquake Damage index, D_i .*

(a) Column 1G

(b) Column 2A

(c) Column 3A

(d) Column 5A

Building assessment. There are two red flags and one green flag. According to Table 5 a red placard should be placed in the building and the protocol for high risk structure must be implemented.

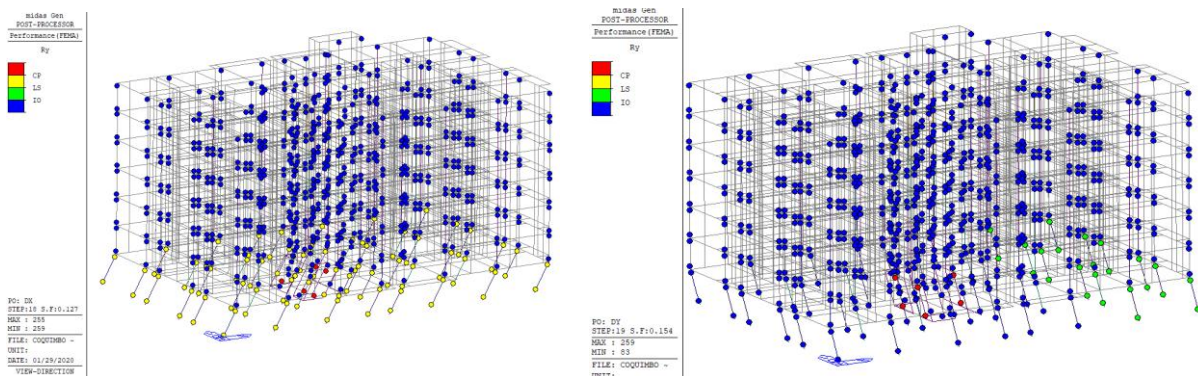
Fig. 7 – Performance level of the building (pushover analysis results)

To verify the global performance of the building, a static nonlinear analysis was performed with Midas Gen®. The results in the two analysis directions are shown in Fig. 7. It may be observed that in both directions the building reaches the collapse prevention level, and thus, a red placard should be assigned to it. This result coincides with the placard assigned to the building in the previous Section.
