SEISMIC EVALUATION OF NON-DUCTILE REINFORCED CONCRETE SMALL HOUSES

P. Rojas⁽¹⁾, F. Grau⁽¹⁾, J. Taylor⁽²⁾, E. Reuter⁽³⁾, J. Gonzalez⁽¹⁾, W. Loja⁽¹⁾

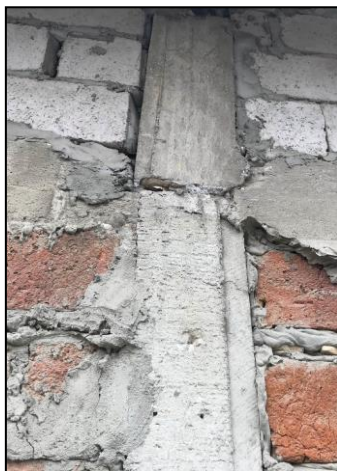
The beam-column connections were typically poor as seen in Fig. 5(a). It was often obvious that a beam was not poured continuously, which can produce a weak point in the connection. Fig. 5(b) shows an example where a steel purlin is connected inadequately to a reinforced concrete column by a steel shape welded to the reinforcing steel bars of the column. Frequently, the first story column and second story column did not line up.

(a) Inadequate connection column - beam

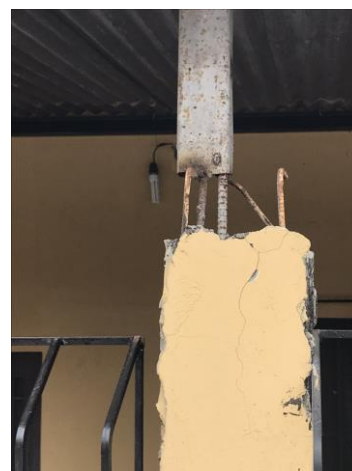
(b) Inadequate connection column - roof

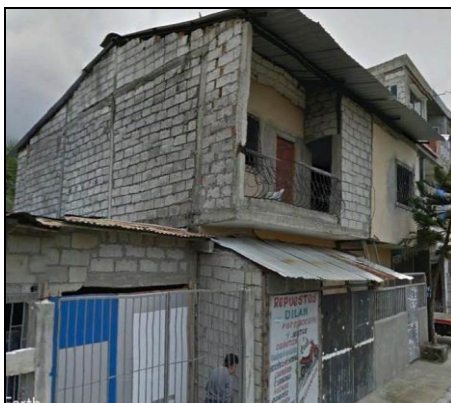
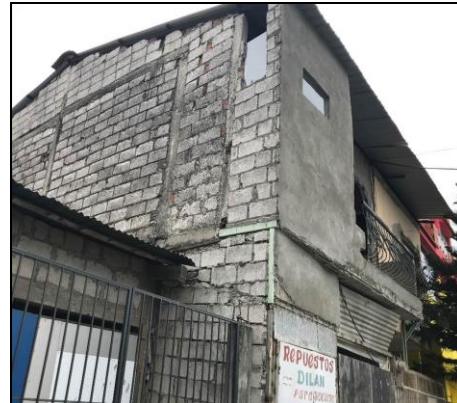
It was common to see buildings constructed progressively over time. Expansions included the addition of a second story above the first, the expansion of a second story into a cantilever, and outward expansion. In Bastion, the addition of basements built into the hillside was also common. All expansion types exhibited similar issues, including mixed material elements, missing structural elements, and poor connections. The buildings shown in Fig. 6 are examples of expansions with mixed materials and poor connections.

(a) Google Earth, March 2015

(b) Survey Photo, June 2019

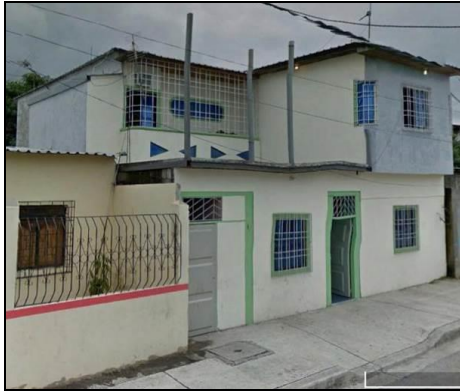
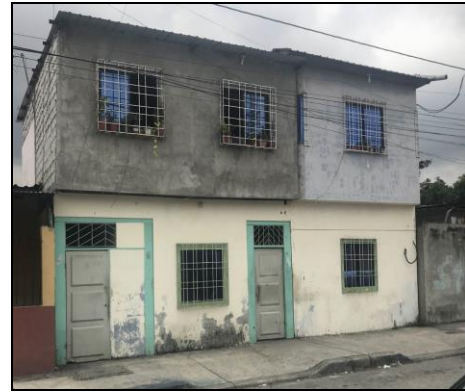
(c) Google Earth, March 2015

(d) Survey Photo, June 2019

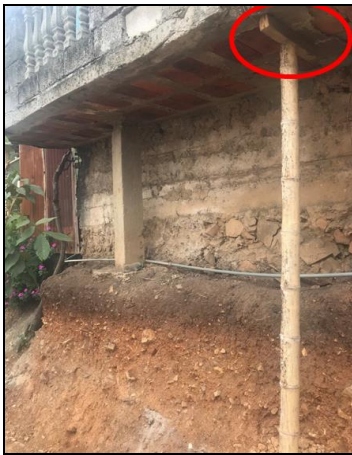
In many houses, especially those built progressively over time, structural elements were missing. The buildings shown in Fig. 7 are examples of these observations. These missing elements were sometimes only visible from the side of the structure. The front of the house was often covered in a thin layer of cement, plaster, paint or tile for aesthetic purposes concealing the presence or absence of structural elements from view. Fig. 7(a) shows an example where a cantilever slab is deflecting excessively and the owner decided to support it using a provisional bamboo strut. Fig. 7(b) and 7(c) show examples where a column and a beam confinement elements are missing.

(a) Missing structural element

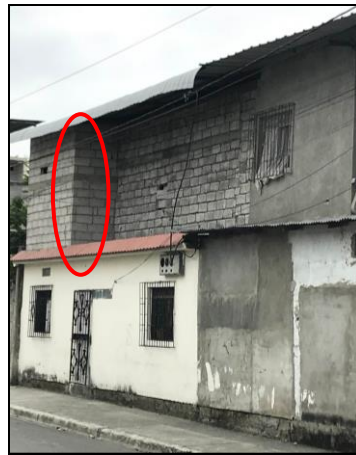
(b) Column absence

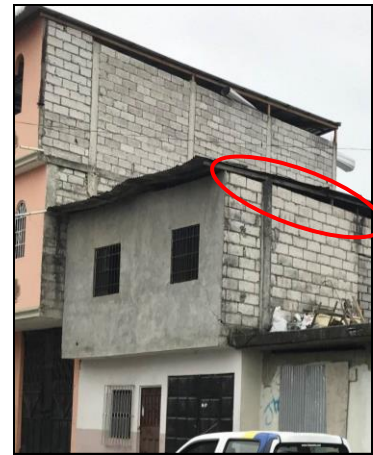
(c) Ring beam absence

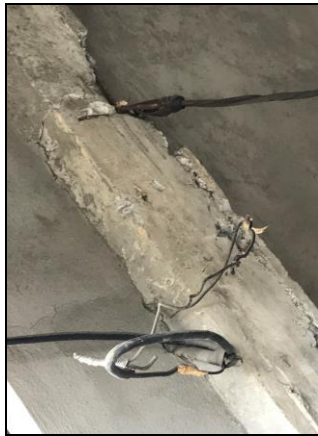
It was very common to see concrete elements which had been intentionally removed by homeowners (see Fig. 8) for different reasons. It was especially common to see columns adjacent to door openings demolished locally to provide a connection point for door frame welding. In one house, the opening and closing of a door frequently caused pieces of the adjacent column to crumble and fall. The owner realized the concrete was poor quality, so he demolished the column without a plan to replace it (Fig. 8b). Columns and beams were

(a) Portion of column removed

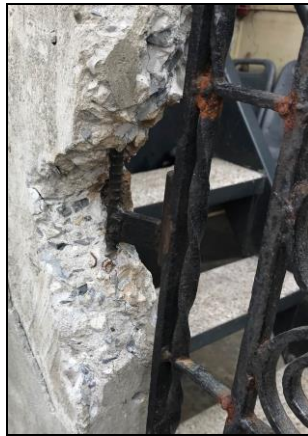
(b) Structural element demolished to welding a door frame

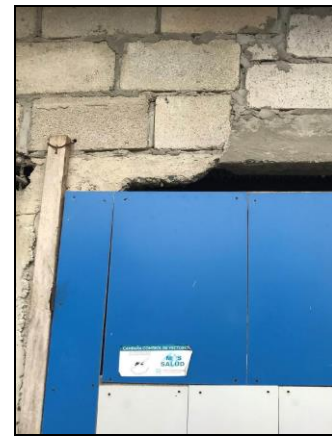
also demolished partially in several houses to accommodate changing door and window openings (Figure 8c), destroying their structural integrity.

(c) Portion of beam removed

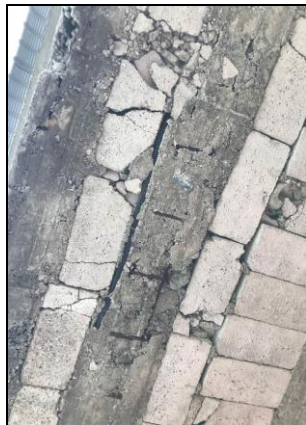
Adequate cover is important to fully integrate the reinforcing steel into a beam or column and to protect it from potential corrosion. In a large number of houses, cover was so thin that the concrete is crumbling, exposing the rebar, leaving it susceptible to corrosion as seen in Fig. 9.

(a) Inadequate beam cover and exposed rebar

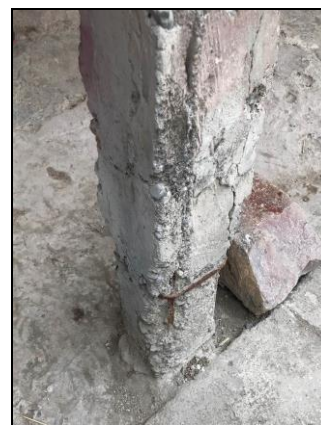
(b) Inadequate cover of a column and exposed rebar

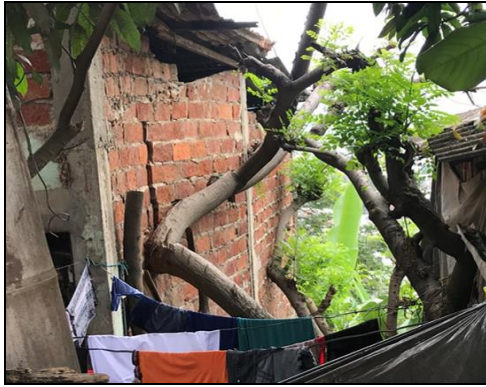
damage. The house shown in Fig. 10(a) has a failed masonry wall due to tree growth, which was exacerbated by the 2016 earthquake while Fig. 10(b) shows some masonry wall cracking between openings. These damages put the structures at additional risk in a future earthquake event.

(a) Non Structural damage caused by a tree

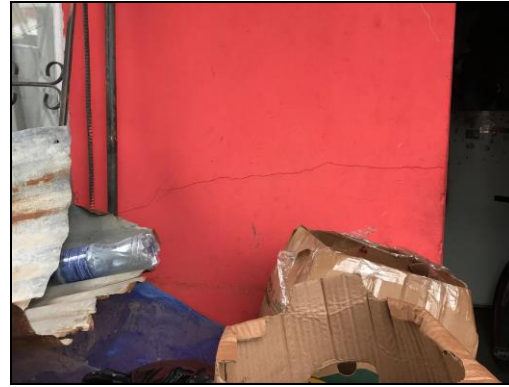
(b) Non Structural damage between openings
