STUDY ON THE DISASTER INVESTIGATION OF RC BUILDING UTILIZING UAV

The investigated building is the RC government office building that was damaged by the 2016 Kumamoto earthquake. It is a three-story RC structure built in 1974. The longitudinal direction is a moment resisting frame structure, and the short direction is a frame with shear walls. In 2010, seismic reinforcement was performed by installing a steel braces with frames. Due to the 2016 Kumamoto earthquake, in the longitudinal direction, it was confirmed that the column was slightly cracked, and the painting of steel braces with frames were partly peeled off. In the short direction, shear failure of the shear wall and shear failure of the short beams were confirmed.

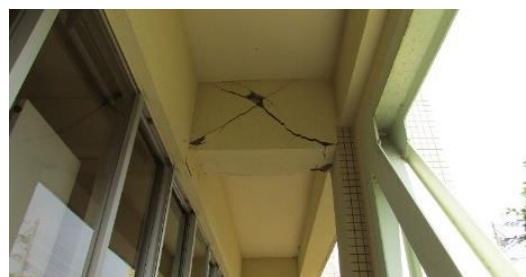
Fig. 2 – Failure situation of the beam in the short direction

Due to the 2016 Kumamoto earthquake, in the longitudinal direction, it was confirmed that the column was slightly cracked, and the painting of steel braces with frames were partly peeled off. In the short direction, shear failure of the shear wall and shear failure of the short beams were confirmed. Fig. 2 shows the failure situation of the beam in the short direction.

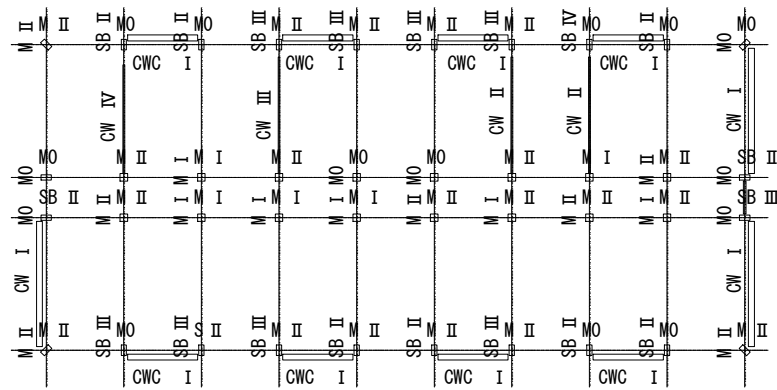
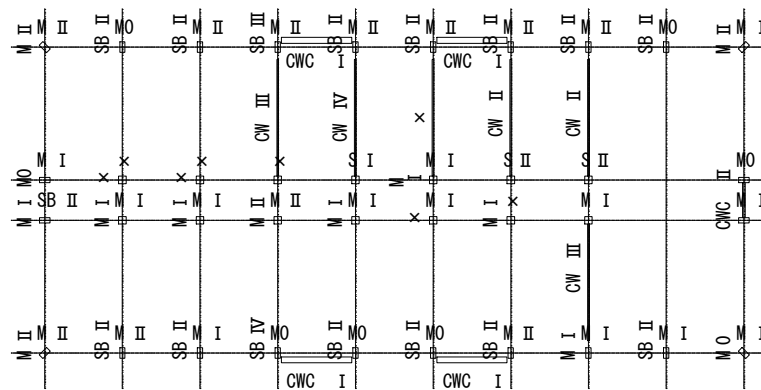
Fig. 4 – List of damage levels on the first and third floors

First, the whole building was inspected by humans. As a result, the first and third floors were judged to be severely damaged, and the post-earthquake damage evaluation was performed on the first and third floors. Fig. 4 shows a list of damage levels on the first and third floors. Table 3 shows a list of the residual seismic capacity R and the results of the post-earthquake damage evaluation. Both the first and third floors were judged to be "Moderate" based on the determination of the short direction.

Next, the post-earthquake damage evaluation by drone is performed. The post-earthquake damage evaluation is determined only by the damage level of the outer members. Table 3 shows the results. In this building, the results of the post-earthquake damage evaluation in all floors and directions were the same for humans and drones. For the residual seismic capacity R , the difference between human and drone was up to 1.25 in the longitudinal direction and up to 4.45 in the short direction. In the short direction of this building, several shear walls inside the building were severely damaged, and the members were not included in the calculation in the post-earthquake damage evaluation using a drone, so a large difference occurred in R . From the above, it is necessary to consider the structural type of the building when determining the post-earthquake damage evaluation using a drone.

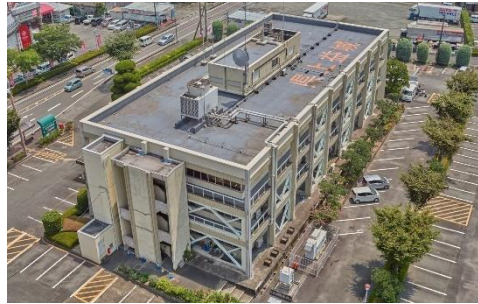
Fig. 5 – Whole building

The whole building was photographed from a long distance using a 100 million pixel camera. Fig. 5 shows the whole building taken from the west sky. It is possible to grasp the whole building, and it is considered that if major damage such as collapse or severe damage to the outer peripheral members has occurred after the earthquake, they can be confirmed.

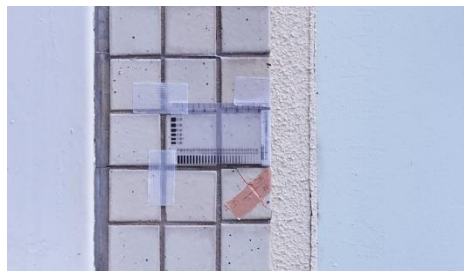
Fig. 6 – Evaluation of the crack width

Fig. 6 shows a photograph taken with a drone and the evaluation of the crack width. Table 4 shows a comparison between the measured crack width by humans and the evaluated crack width by drone investigation. The results for 2-2x are also shown. General-purpose software was used to evaluate the crack width from the photographed image. In the image shot with a 100 million pixel camera, the crack width was successfully evaluated at a shooting distance of 5 m. In the case of the shooting distance was larger than 10m, the evaluation accuracy was low.

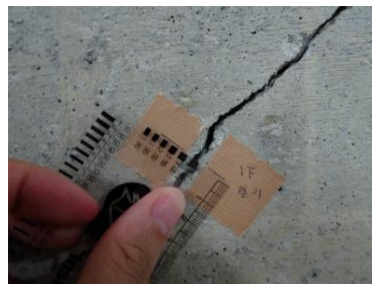
Fig. 7 – Measurement of crack width by humans

Four cracks on the shear wall inside the building were measured. Fig. 7 shows the measurement of crack width by humans. Next, the shear wall was photographed with a 20-megapixel camera in the case of turning on and off. Table 5 shows a comparison between the measured values by humans and the evaluation values of the crack width by drone investigation.

In the case of large cracks, it cannot be evaluated accurately. In the case of small cracks, automatic detection by general-purpose software was not possible. From the above, it is considered difficult to evaluate the crack width of members inside the building using a drone.

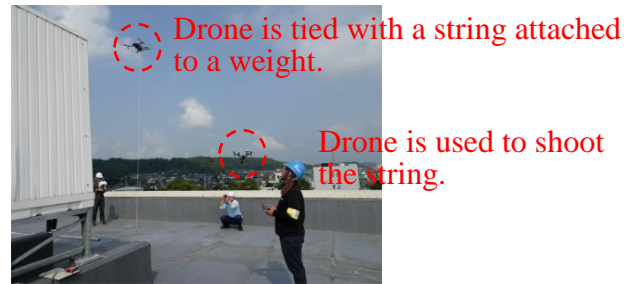
Fig. 8 – Incline angle measurement using a drone

The water tank installed on the roof and inclined by the earthquake was targeted for the investigation. First, the incline angle was measured by a human using a plumb-bob. As a result, it was approximately 3 °.

Fig. 8 shows the incline angle measurement using a drone. Fig. 9 shows the photographed image. In the measurement of the inclination angle by drone investigation, it is approximately 4 °. The accuracy of the incline angle is somewhat effective. However, in the case of using the above method, two pilots are required. In addition, due to the adjustment of the position where the string appears and the influence of the wind, the required time is longer than that of a human investigation.

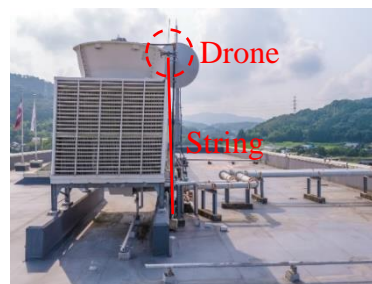
Fig. 9 – Photographed image

On the other hand, as a result of direct measurement of the incline angle from a still picture of the water tank, the value was the same as that of a human measurement of the incline angle (approximately 3 °). By using the gimbal function mounted on the drone, it is thought that the incline angle of the building can be easily measured.

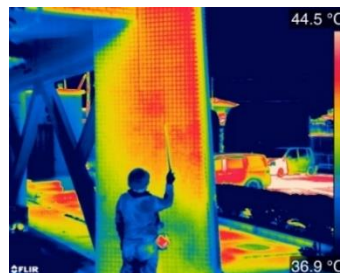
Fig. 10 – Column shot by the infrared thermography camera

Fig. 10 shows the column shot by the infrared thermography camera. A percussion examination by a human was also performed at the same time. The temperature where the tile peeling was high. In the event of a disaster by earthquake, it is dangerous to approach the tiles for percussion examination. Therefore, using a drone can ensure the safety of the investigator and conduct an investigation.

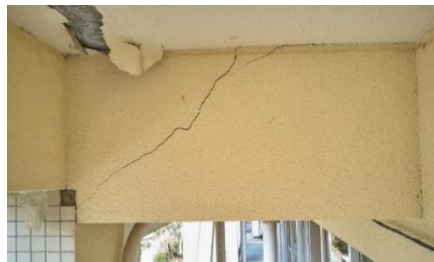
Fig. 12 – Beam damage

Next, the beam on the first floor was shot by FPV. Fig. 12 shows the beam damage. If a technician looks at the image, it is possible to estimate the damage level of the structural member.
