PHOTO-INTERPRETATION OF BUILDING DAMAGE DUE TO EARTHQUAKES USING AERIAL PHOTOGRAPHS

Naoki OGAWA¹ and Fumio YAMAZAKI²

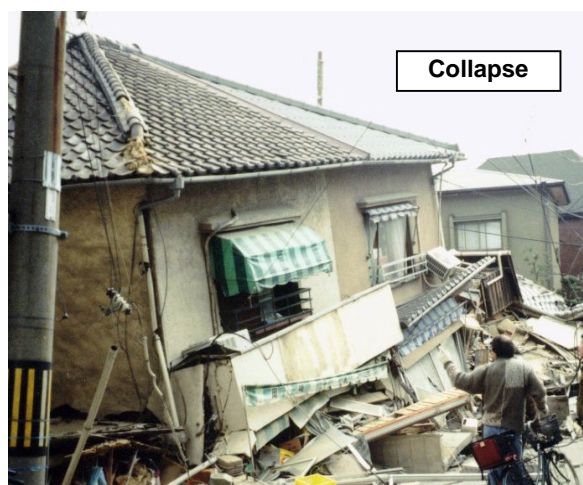
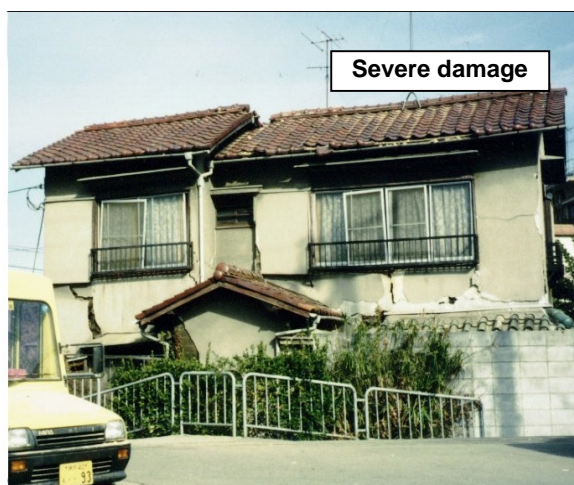
Photo 1: An example of ordinary “severely damaged” buildings and “collapsed” buildings

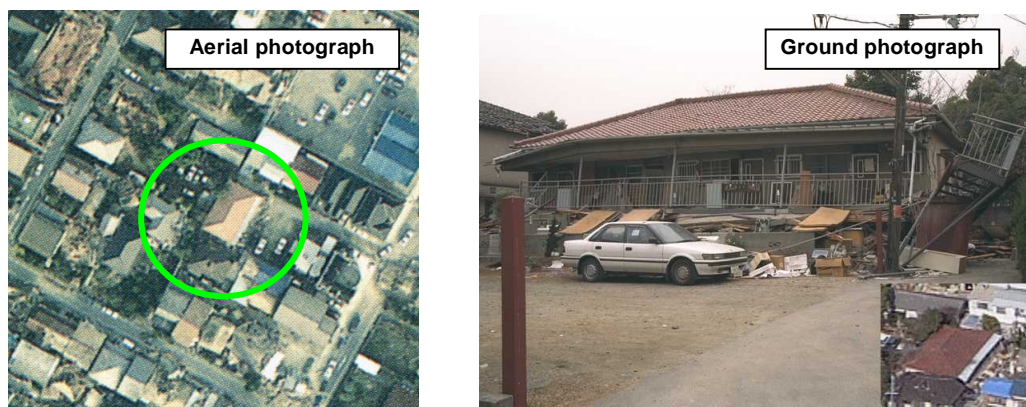
Photo 2: Comparison of an aerial photograph and a ground photograph (this building was not identified to be “collapsed” by all the interpreter since the first story was completely crushed.)

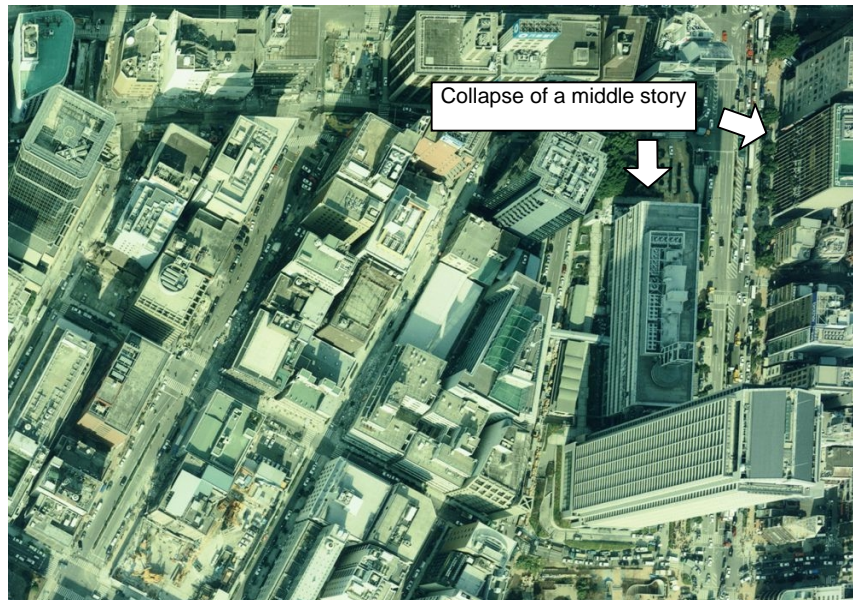
Photo 3: An example of aerial photographs for the non-wooden building area
