## A STUDY ON DAMAGE TO STEEL PIPE PILE FOUNDATION ON RECLAIMED LAND DURING HYOGO-KEN-NANBU EARTHQUAKE

Damage investigation was conducted on steel pipe pile foundations damaged during the 1995 Hyogoken-Nambu earthquake. The investigation site was located about 100m from both north and west quay walls. According to the damage investigation, piles were deformed at two levels. One-dimensional effective stress analysis and soil-pile-structure interaction analysis by a simple spring-mass model considering liquefaction were performed to examine the behavior of the ground and structure during the earthquake. The analytical model was set in detail based on the results of soil investigations, laboratory test and design documents of the structure. According to the one-dimensional effective stress analysis, it is considered that reclaimed decomposed granite soil, "Masado," below the ground water level liquefied. In soil-pile-structure interaction analysis, large bending moments over the full plastic moment appeared around G.L.-6m near the boundary of shear wave velocity in reclaimed layer, and around G.L.-15m, the lower boundary of Masado layer, during the main phases of the earthquake. The

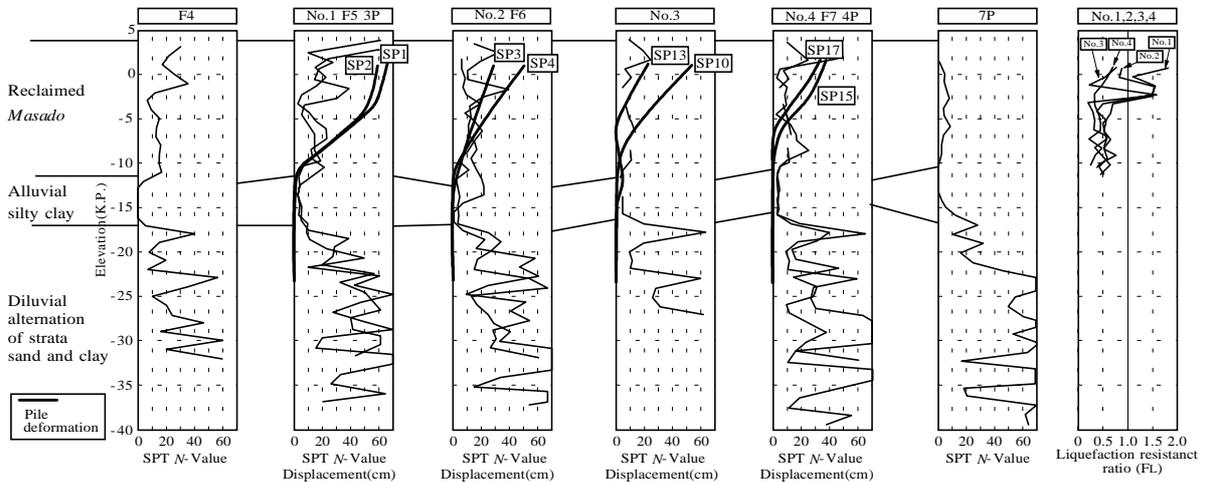
**Figure 2: Soil profiles (East-West section), pile deformations and results of the liquefaction evaluation**

Soil investigations were conducted in 1968 before the earthquake, in 1996 and in 1997 after the earthquake. 15 investigation points in total, indicated in Figure 1. Figure 2 shows the soil profiles and standard penetration test results “SPT *N*-value” for 11 points along the crossbeam direction of the building. From the ground surface (K.P.+3.6 m) to the depth of K.P.-10 m, approximately 14 m in thickness is a reclaimed layer comprising *Masado*, decomposed granite soil. The SPT *N*-values are relatively high at 10 to 30 in the range of K.P.+3.6 to  $\pm 0$  m, which is above the ground water level (K.P.-0.4 m) in the subsurface range. There are also high at 20 to 40

Deformation of piles found by damage investigation, pile SP1 and SP3, are superimposed in the Figure 7. Pile SP1 was deformed at around G.L.-6 m and G.L.-15 m, whereas pile SP3 was deformed at around G.L.-15 m. The computed shear strain of ground was suddenly changes at G.L.-6 m and G.L.-15 m, suggesting a possibility that the piles were damaged at the depth of strain changing when liquefaction occurred.

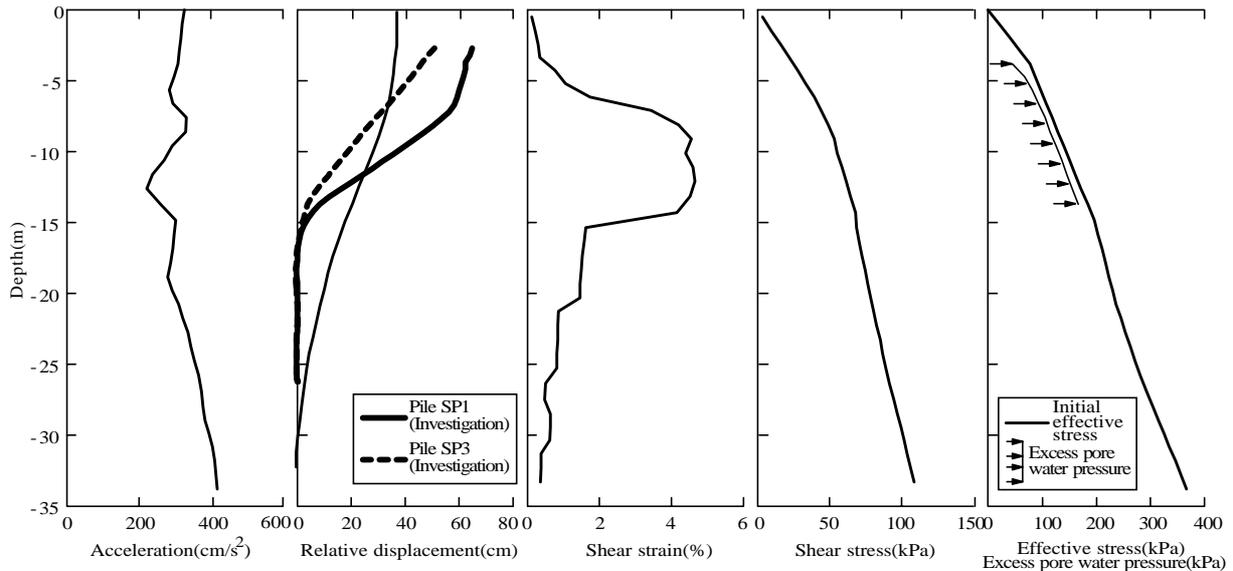
**Figure 7: Maximum response values of ground by one-dimensional effective stress analysis and**

Figure 7 shows the vertical distribution of the computed maximum acceleration, relative displacement, shear strain, shear stress and excess pore water pressure. The excess pore water pressure in the *Masado* layer, below the ground water level, is increased to more than 90 % of the initial effective stress of the ground. Also, the shear strain level exceeded 2% excepting the range from the ground water level to G.L.-6 m, in which the SPT *N*-values are relatively high. Accordingly, it is considered that the *Masado* layer from G.L.-6 to 15m was liquefied during earthquake.

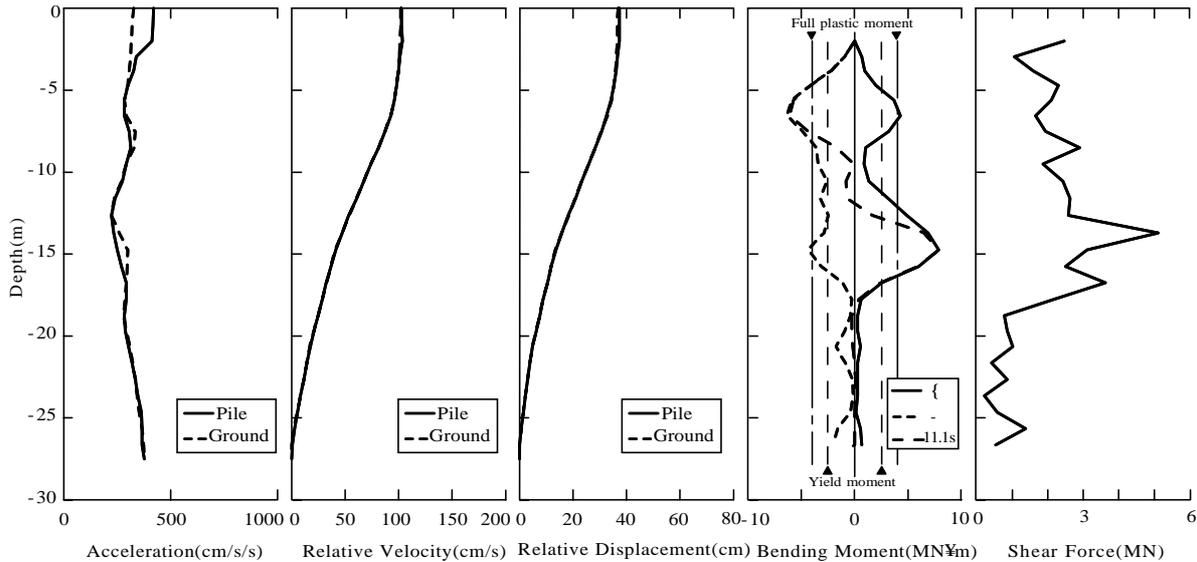
**Figure 9: Maximum response values of pile and ground computed by soil-pile-structure interaction analysis**

Vertical distribution of the maximum response value of pile computed by soil-pile-structure interaction analysis, acceleration, relative velocity, relative displacement, bending moment and shear force, are shown in Figure 9. The bending moment and shear force values represent the collective values for 12 piles of a single frame. Maximum ground response values are superimposed in the Figure 9. Behavior of piles agrees with behavior of the ground excepting the surface layer. It is considered that behavior of piles were mainly controlled by the ground deformation in this case. The difference between the behavior of the ground and those of piles at the surface layer suggests the influence of the inertial force of the building.

The distribution of bending moment at 11.1 seconds, at the time the maximum moment appeared is also shown in the figure for the bending moment. The maximum bending moment at G.L.-4 to -8m and G.L.-15m appeared simultaneously and exceeded the full plastic moment during the main phases. These depths agreed with those piles deformed. The direction of the bending moment were opposite at the upper and lower parts, and these directions agree with those of the moment that may caused the deformation of the piles found in the damage investigation, respectively. It is considered that the failure of piles at the positions of residual deformation occurred during main phases of the earthquake and developed thereafter. The maximum bending stress and shear stress of the R.C. columns were more than three times the allowable stresses. It is therefore considered that the columns also failed in the main phases.
