## PERFORMANCE OF WOOD-FRAME CONSTRUCTION IN EARTHQUAKES

J. Hans RAINER<sup>1</sup> And Erol KARACABEYLI<sup>2</sup>

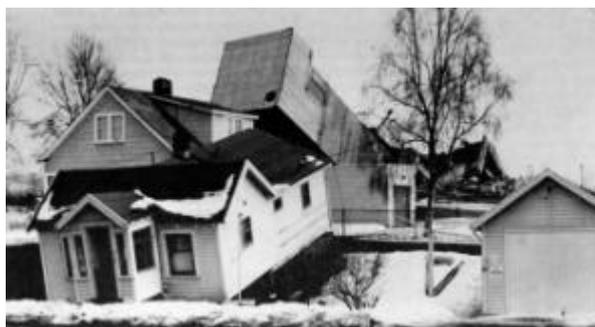
Fig. 2. House in foreground suffered only minor damage though being dropped into an earth slide area. Alaska Earthquake, 1964. Source: Forest Products Laboratory, Madison, WI. US Dept. of Agriculture, 1964.

**Alaska Earthquake, 1964.** With magnitude M8.4 this was one of the largest earthquakes in North America in this century and was characterized by intense ground shaking that caused major landslides in the populated area of Anchorage (Ref. (11)). Both ground settlement and large horizontal and vertical ground displacements caused significant damage to foundations and to the structures supported thereon, resulting in a large number of collapses of buildings and deaths. Unfortunately, no recordings of ground motions were obtained. The performance of wood-frame houses was punctuated by the structural integrity of buildings that literally slid down failed slopes or were otherwise subjected to large ground movements. The box-like wood-frame structures stayed largely intact and “rode out” the earthquake, often coming to rest in an unusable orientation for immediate occupancy! (Fig.2).

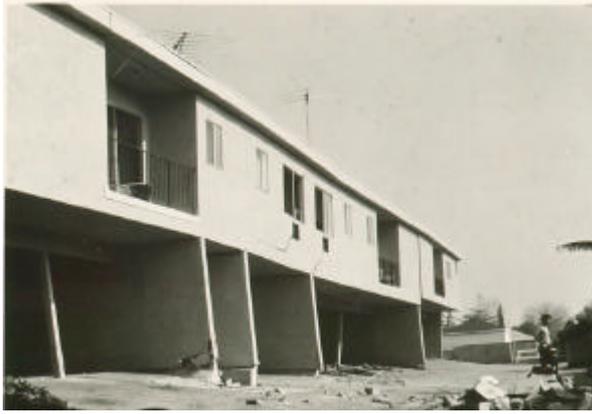
Older wooden houses in the San Fernando area suffered damage ranging from minor to partial collapse. Newer two-storey apartment buildings with large ground-level openings were also severely affected (see Fig. 3). These damage cases can be categorized as follows:

Fig. 3 Failure of supports due to weak first storey. San Fernando Earthquake, 1971.

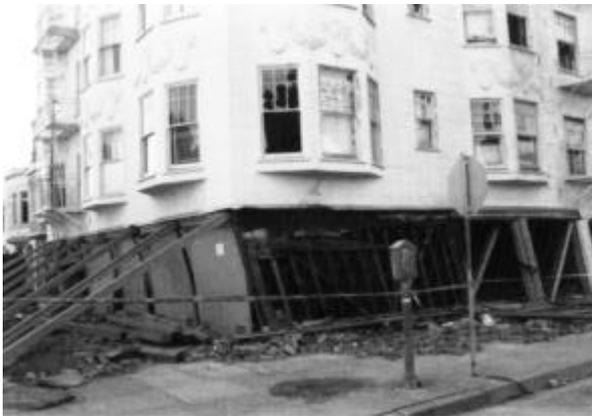
Fig. 4. Almost collapsed wood-frame apartment building, Marina District, San Francisco. Loma Prieta Earthquake, 1989.

A number of older four-storey wooden apartment buildings located on fill materials in the Marina Bay district of San Francisco collapsed onto the ground floor that consisted entirely of garage openings and therefore represented a very weak first storey. The upper 3 storeys, however, stayed intact. Some other buildings of this type nearly collapsed (see Fig. 4). Ground motion amplification of the soft soils at that site also contributed to this damage pattern. Further details can be found in Ref. (5).

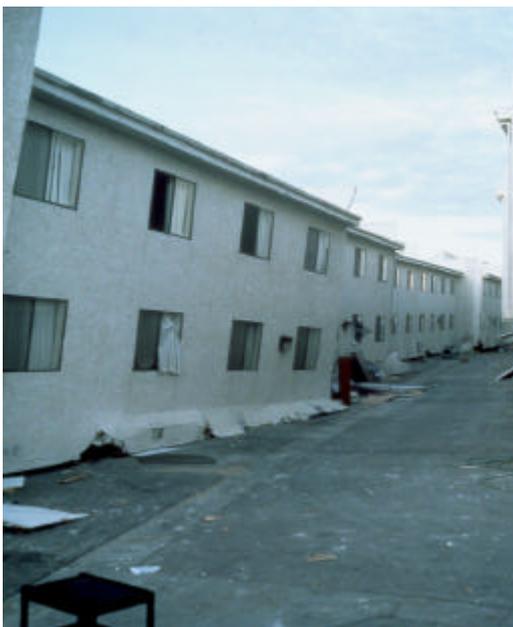
Fig. 5. Collapsed first floor parking area, Northridge Earthquake 1994.

This earthquake again drew attention to a weakness that had already been recognized, practically next door, in the 1971 San Fernando earthquake - the weak first storey in multi-storey wood-frame apartment buildings. Whereas in the 1971 earthquake these weak buildings merely distorted severely but remained standing, in this larger 1994 earthquake a number of ground floors collapsed (see Fig. 5). In one apartment complex 16 occupants were killed. Such collapses are perhaps not surprising when one considers that the horizontal ground accelerations, combined with the vertical accelerations of comparable amplitude, exceeded the nominal horizontal design acceleration of 0.4 g by factors of 2 and more. Four deaths also occurred in three single-family houses that slid down a hillside and collapsed.
