DAMAGE MECHANISMS AND DESIGN LESSONS  
FROM CARACAS

R.I. SKINNER

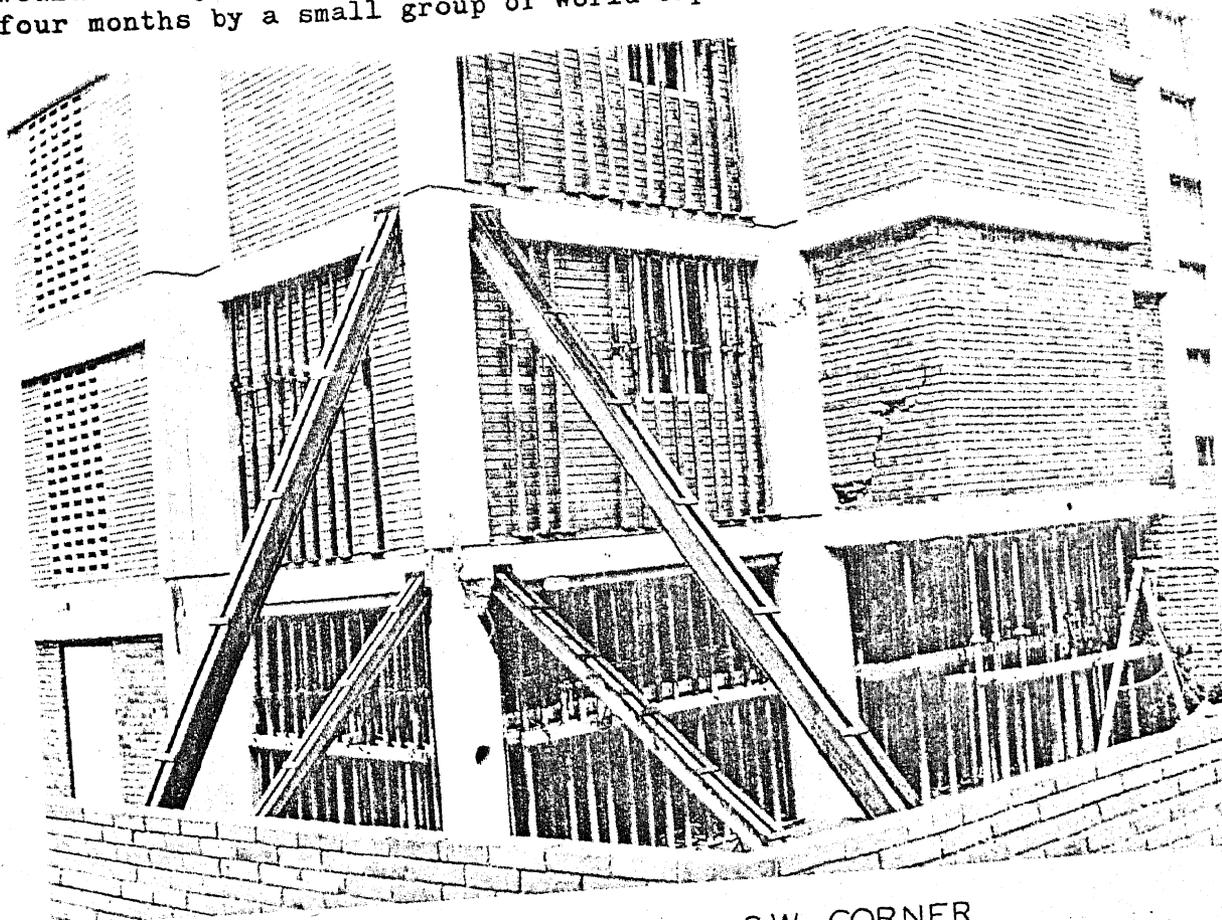
FIG.1. PETUNIA II, S.W. CORNER

The probable sequence of serious damage is as follows. A lurch towards the east caused overturning forces which resulted in tension cracks in the NW corner column and probably the SW corner column. Small tension cracks also appeared on at least one of the intermediate western columns. Later there was a lurch towards the west which crushed the SW and NW columns and caused

small tension cracks in the NE column. Finally there was a lurch towards the south which crushed an intermediate column situated in the southern wall and near the SW corner. In addition to these sudden lurches the building must have swayed from side to side for about three quarters of a minute, causing a progressive increase in the existing damage, Fig. 1. Most of the exterior panel damage was directly associated with crushing failure of the building frame.

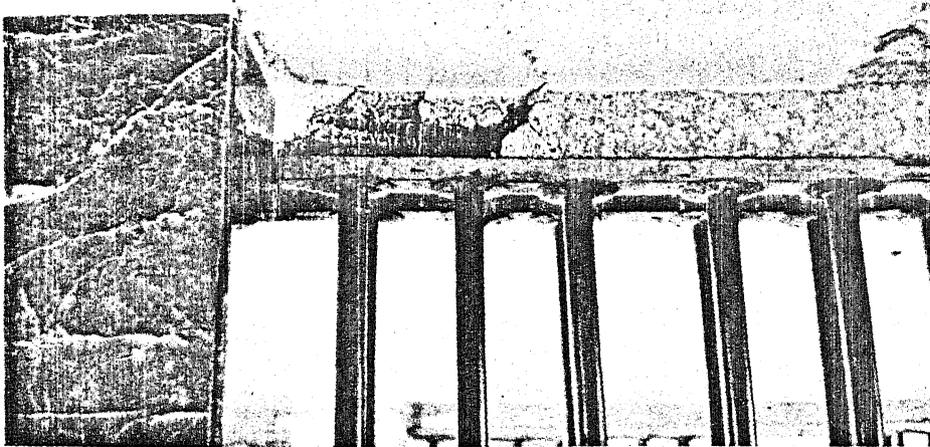
FIG.2 RESIDENCIA UNION, FIRST STOREY

The columns of some buildings remained intact while the beam ends were severely damaged. The slabs between the damaged beam-ends were cracked. The beam damage extended up for six storeys or more. This is to be expected since failure of beams at one level throws additional moments onto the ends of the beams above. In these buildings severe panel damage extends upwards for a greater height than the beam damaged. This damage mechanism requires that the columns are sufficiently strong to damage the beams and panels of several storeys which are giving each other some mutual support. Hence this type of damage is more likely in the direction parallel to the wide faces of the columns. Panels with considerable openings and without column support will increase the likelihood of damage by this mechanism. Two buildings which suffered this beam and slab damage were the Residencia Union and the Blue Palace.

The Blue Palace was constructed in a similar manner to the Residencia Union, Fig. 2, and suffered similar damage. The east-west beams are wide and shallow. The north-south beams are deep and extend about four feet beyond the outer rows of columns to support cantilevered floors. There is very little effective framing of the panels in either direction. The first storey contained a full set of panels. The panels were constructed of high void bricks.

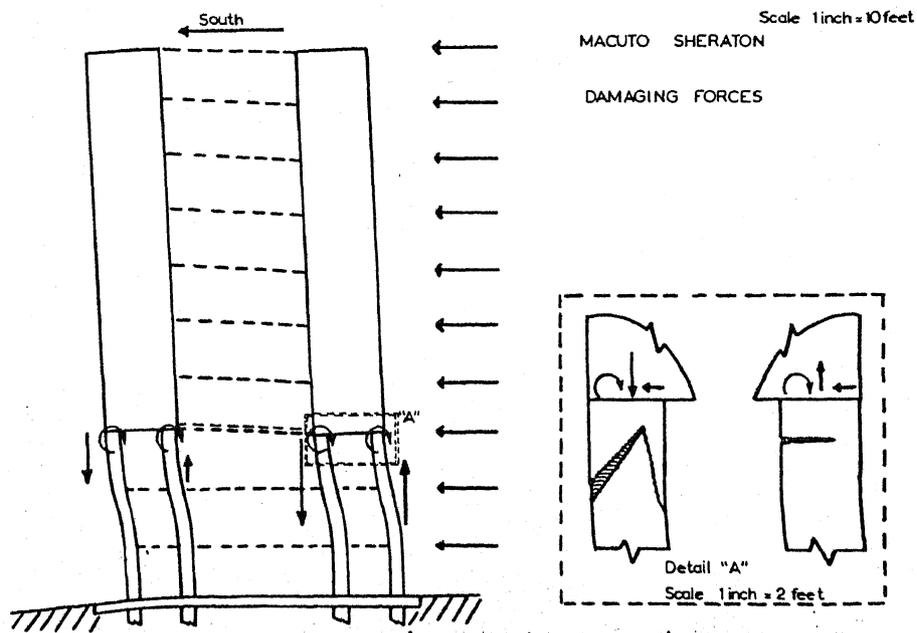
FIG.3 MACUTO SHERATON, DAMAGE MECHANISM

The Macuto Sheraton runs east-west, parallel to the beach. It is a large building of unusual construction, Fig. 3. The cross-section shows two pairs of large columns for the first three storeys with a narrow shear wall rising from each pair of columns for the remaining seven storeys.

When the building lurched to the south, the top and bottom of each triple-storey column suffered very severe end moments since the beams were insufficiently stiff and suffered cracking. Most of the overturning forces at the foot of each shear wall were transferred as vertical forces to the pair of columns below since the shear

resistance of the beam systems connecting each pair of shear walls was inadequate. The second and fourth rows of columns were therefore subjected to very severe moments and compressions as shown in Fig. 3. The northern row of columns shows moment - tension damage and the second shows very severe moment - compression damage. The third and fourth rows from the north show relatively little damage. The lesser damage to the southern rows of columns would be accounted for if the outer rows of piles, particularly the southern row, settled under earthquake shaking and building loads, relieving the overturning forces under the southern shear walls. This settlement is highly probable as the ground settled up to several inches within a few feet of the building, and it is thought that the whole building may have settled about two inches. Hence the component rigidities and the foundation settlement can account for the type of damage suffered by almost every column.

The few exceptional cases of column crushing are probably due to underlying piles with an exceptional resistance to being driven deeper.

Analyses of possible causes for the column failures suggest that the columns failed primarily because of the lack of ductility, a shortcoming aggravated by the increase of axial load and the failure of some of the connecting girders in shear.

The damage to the building emphasizes the importance of considering in design the deformations of the entire structure under the influence of earthquake forces to make certain that all structural elements have compatible ductility and of insuring that enough web reinforcement is provided to develop the flexural capacity of beams and columns.
