THE KOYNA, INDIA, EARTHQUAKES

G. V. Berg^(I), Y. C. Das^(II),
K. V. G. K. Gokhale^(III), and A. V. Setlur^(III)

Synopsis

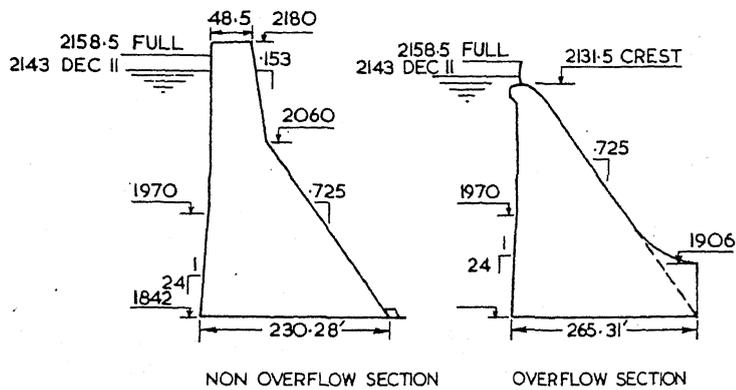
FIG. 3. ELEVATION AND SECTIONS OF DAM
(From Reference 4)

The most important structural damage to the dam was a horizontal crack that appeared in the upstream face of some of the taller monoliths near elevation 2060 feet, at which elevation a break in slope of the downstream face occurs, as shown in Figure 3. Block 18 was the worst affected. Several factors may have contributed to the vulnerability of this particular block. It is the tallest monolith and it is unsymmetrical, the east half of it being overflow section and the west half non-overflow. The west half contains the elevator and stair shaft to the operating galleries, a vertical shaft 14'-6" x 16'-8", which reduced the cross-sectional area at elevation 2060 about 7%. Also, the elevator tower extends 50 feet above the roadway, giving rise to additional bending moment due to the inertia forces in the tower.

The crack was first noticed inside the shaft, where water seeped in around all four sides near elevation 2060, 83 feet below the surface of the lake. Dye released at the upstream face at that elevation took from five to 45 minutes to reach the shaft, depending on where it was released. Faint traces of seepage could also be observed on the downstream face just before sunrise, when the rate of evaporation from the face was slowest. Inspection of the upstream face by means of an underwater television camera revealed that cracks had occurred in other monoliths as well, and it was decided that the lake should be lowered to permit repairs to be made.

The major cracks were repaired by injecting epoxy resin. Holes were drilled into the upstream face at 45° from the vertical to intersect the horizontal crack at distances of two to five feet back from the face. To verify that the drill holes had intersected the crack, compressed air was blown into the holes and its escape was traced at the face of the dam. Epoxy grout was then injected into the drill holes at high pressure, starting with the holes that intersected the crack farthest from the face, and working toward the face. Finally, the surface concrete was loosened in the vicinity of the crack, wire mesh was placed over the face, and the area was patched with gunité. Fine tension cracks also appeared at the upstream face of the taller monoliths above elevation 2060. Polyester repairs are to be made but have not yet been accomplished (June, 1968).

Some of the monoliths are being prestressed. Holes 150 mm. in diameter are drilled from the roadway down through the blocks a distance of 160 feet, i.e., down to elevation 2020, which is 40 feet below the principal cracks. In each 50-foot monolith five holes are drilled near the upstream face and five near the downstream face, all drilled parallel to the face. Cables of 64 parallel wires 8 mm. in diameter are fabricated, bulbs are formed at 3-foot intervals over the bottom 30 feet by inserting spacers between the wires, the cables are placed in the holes, anchored by grouting the bottom 30 feet, and then tensioned to 270 tons, anchored at the top, and grouted for the full length. The blocks being prestressed are the tallest non-overflow blocks, Nos. 15 to 18 and 24 to 26. Blocks in the overflow section are not being prestressed.

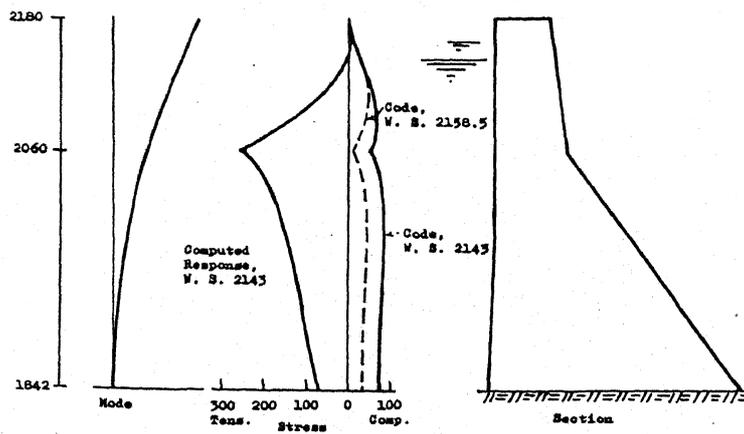
FIG. 11. EXTREME STRESSES AT UPSTREAM FACE

With these approximations one can compute the response by standard normal modes techniques. Figure 11 shows the properties of the first mode of the tallest non-overflow monolith with water to elevation 2143, its elevation on December 11. The response of this mode to the December earthquake, with damping taken to be .05, gives the maximum stresses shown in Figure 11. These are the normal stresses in the vertical direction at the upstream

face, including the effect of gravity on the dam and reservoir, but excluding the effect of vertical earthquake acceleration. For comparison, the figure also shows the stresses computed from the design procedures specified by the Indian Standard (19), using a design acceleration of .05g both horizontally and vertically. The seismic provisions of the Indian Standard for the design of dams are the same as those used by the U. S. Bureau of Reclamation (20). The modal response indicates an extreme tension of 253 p.s.i. at elevation 2060, while the design procedures for .05g acceleration show a compressive stress.

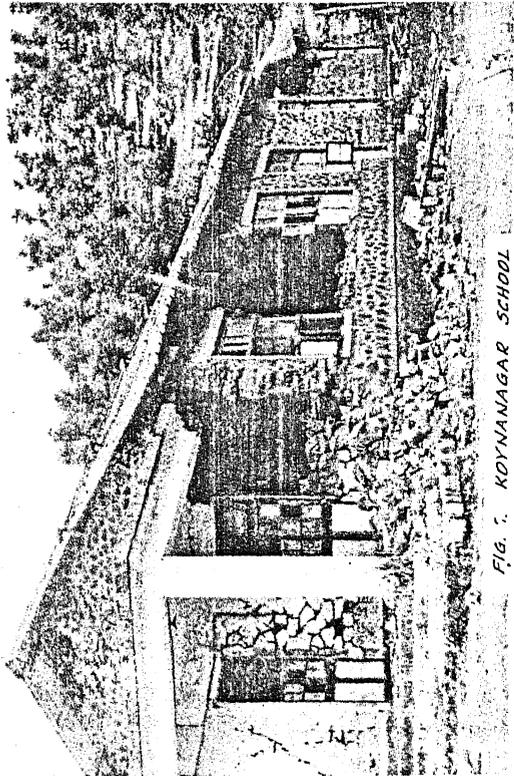
FIG. 7. KOYANAGAR SCHOOL.

The December earthquake demolished much of Koynanagar. Many houses collapsed, and most of the buildings with masonry walls suffered at least partial collapse of some of the walls. Only the corrugated metal shops and warehouses were spared. Figure 7 shows the damage to a school building. The roof was supported by wood purlins on wood trusses which bore on the side walls. Bond beams were not used. In this building, as in most of the buildings of Koynanagar, the extent of the destruction appears to have been largely due to the type of construction. Random rubble masonry is perhaps as susceptible to earthquake damage as any type of construction that can be imagined, and the lack of bond beams increases its vulnerability. There were several buildings in which brick walls remained standing while the rubble walls collapsed.

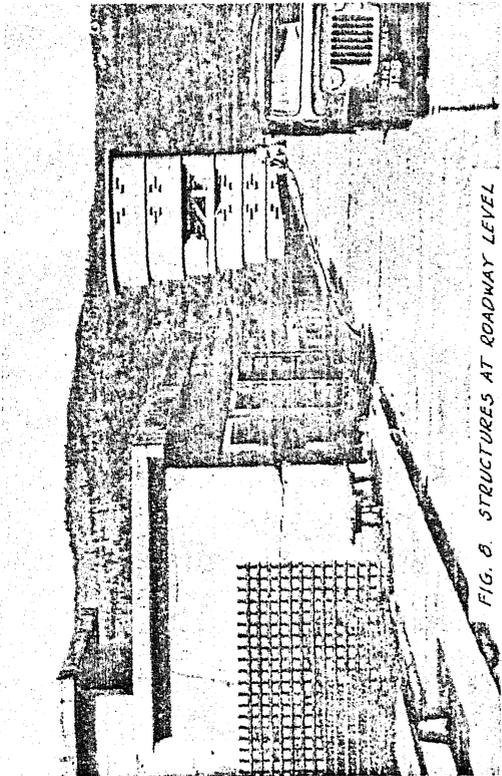
FIG. 8. STRUCTURES AT ROADWAY LEVEL.

The dam suffered structural damage in the December earthquake, both in the body of the dam and in the auxiliary structures at roadway level. The most spectacular damage was found in the tower over the elevator shaft in block 18, just west of the overflow portion. Block 18 is the tallest monolith in the dam. The tower, extending 50 feet above roadway level, was a concrete framed structure with solid concrete block exterior walls. Some of the block walls were dislodged, as seen in Figure 8, the reinforced concrete stairs were cracked and spalled at the landings, and cracks were found in a reinforced concrete shearwall running transverse to the axis of the dam. The gate control house at the other end of the overflow section, seen at the left of Figure 8, was also severely damaged. Its concrete walls were cracked at a horizontal construction joint at mid-height, short reinforced concrete columns between the observation windows on the downstream side were fractured, and diagonal cracks formed in the interior reinforced concrete shearwall parallel to the axis of the dam.
