THE SAN FERNANDO, CALIFORNIA, EARTHQUAKE OF FEBRUARY 9, 1971

P. C. Jennings^I and G. W. Housner^{II}

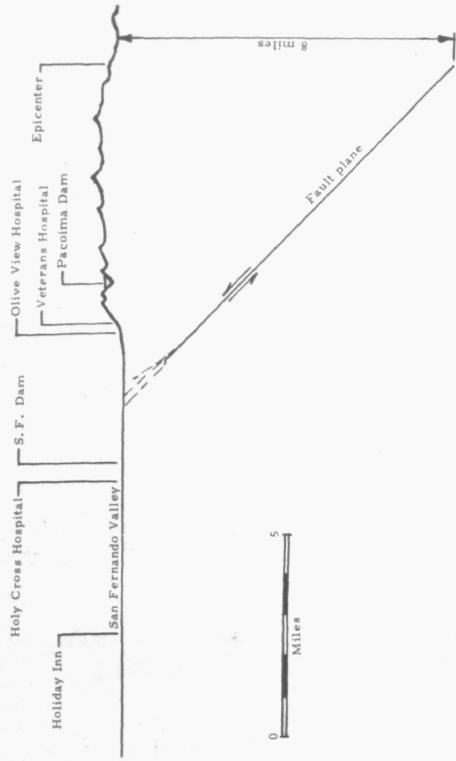
Unlike the more usual California earthquake, which is generated by strike-slip faulting on an essentially vertical fault plane, the San Fernando earthquake was generated on a thrust fault which dipped approximately 45° to the north, underlying the east-west trending San Gabriel Mountains. The hypocenter lay about 8 miles deep, and the

Fig. 2. Vertical Section Showing Fault Plane.

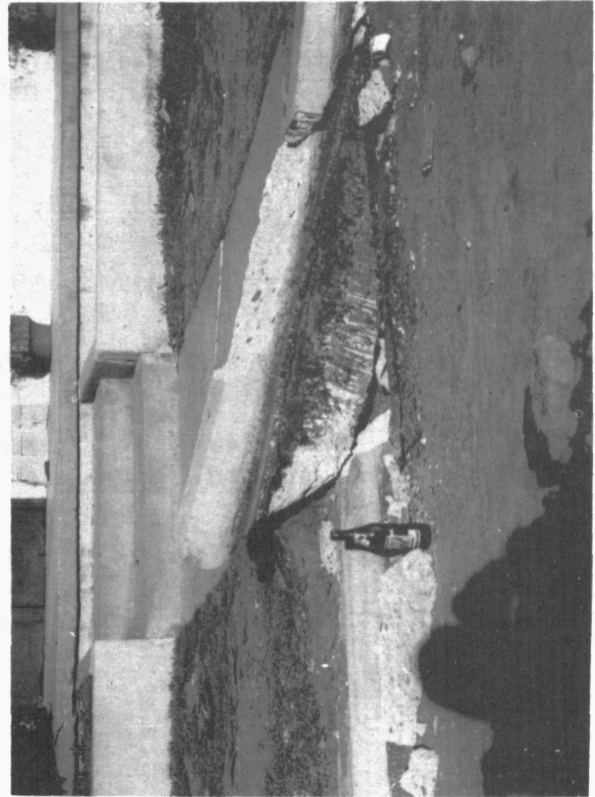
east-west extent of the faulting was approximately 12 miles. At some locations the fault displacements reached the surface of the ground. In addition, a relatively large area of alluvial ground suffered deformation because of fault displacement at depth. A portion of the San Gabriel Mountains was elevated as much as 5 feet by the fault displacement. Numerous landslides were caused on the relatively steep slopes of the mountains and, in addition, there were landslides on relatively shallow sloping alluvial ground in the northern part of the San Fernando Valley.

Fig. 3. Overlap (18 in.) of Fractured Curb in Region of Ground Deformation.

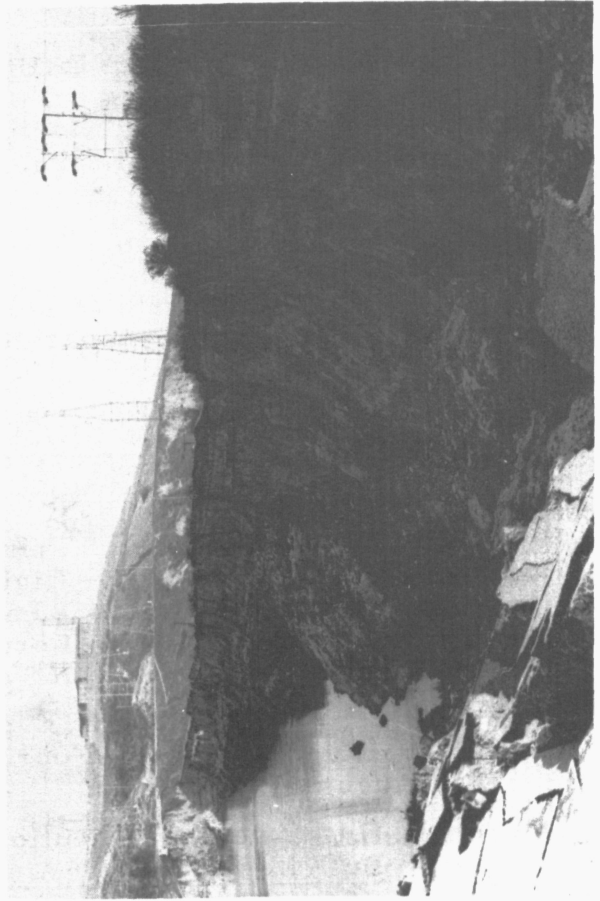
The damage to the San Fernando Dam showed that old dams pose a great hazard in the event of strong shaking. All existing dams should be investigated for earthquake safety and the maximum allowable reservoir elevation under which the dam will be safe should be specified.

Fig. 4. View of Failed Lower San Fernando Dam After the Earthquake.

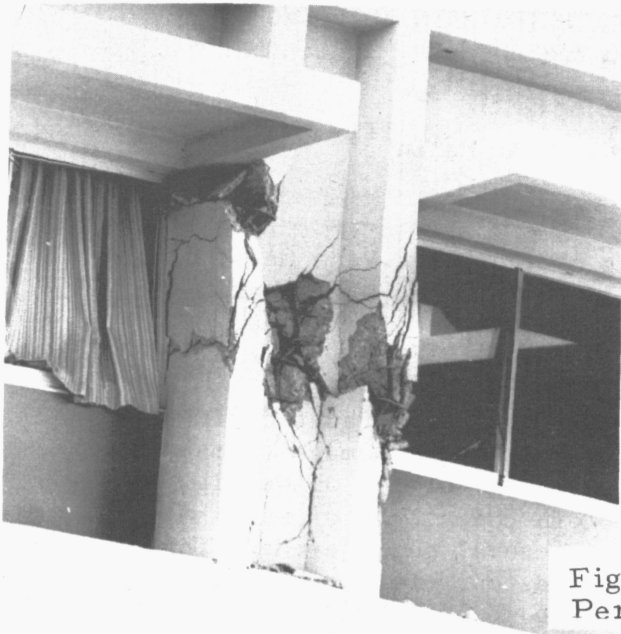
Fig. 5. Second Story Column Fracture of Olive View Hospital.

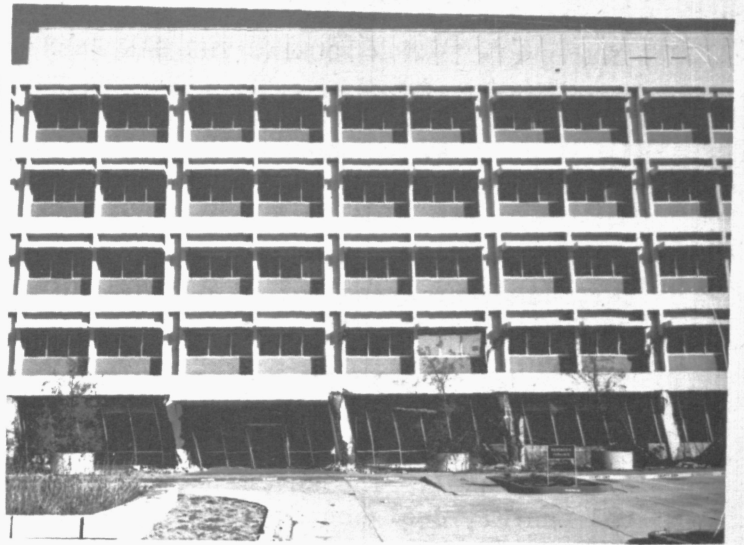
Hospitals. It was a striking fact that in the region of strong shaking, four hospitals were damaged so severely that they could not be used after the earthquake. At the Veterans Administration Hospital a pre-1933 building that had not been designed to resist earthquakes, collapsed and killed 49 persons. The Olive View Hospital, a new \$30 million facility, was so severely damaged by the earthquake as to be almost a total loss.

Fig. 6. Olive View Hospital. First Story Has 2 ft. Permanent Displacement.

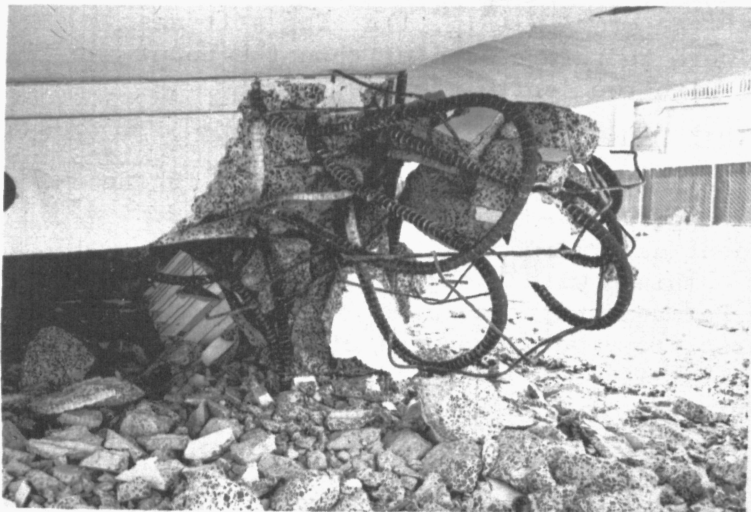
Fig. 7. Collapsed First Story of Psychiatric Building at Olive View Hospital.

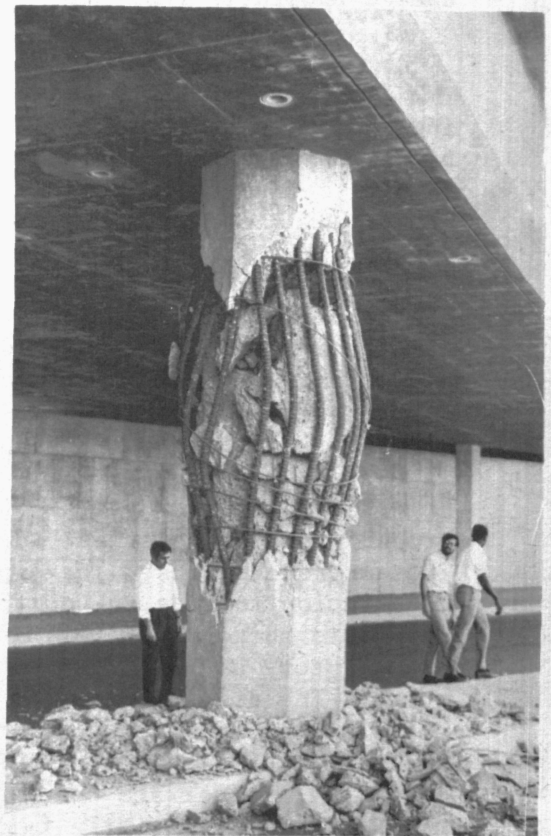
Highway Structures. In the region of strong shaking (25%g or greater) there were 70 bridge structures forming part of the freeway system. Of these, five collapsed and forty others suffered some damage. There was no significant damage to highway bridges where the ground shaking was less than about 25%g. In the central region of the earthquake, permanent deformation of the ground contributed to the damage.

Fig. 8. Fractured Column of Freeway Overpass.

Revisions have been made to the State Highway Department earthquake design criteria. Immediately after the earthquake, the design criteria were increased by over 100%; new and improved details were specified for new bridges; and a program of research was initiated to develop a satisfactory set of design criteria based on modern knowledge. Existing highway bridges were examined for weaknesses which had led to collapse of bridges during the San Fernando earthquake. Where these weaknesses existed, the structures are being strengthened.
