SOIL - STRUCTURE INTERACTION IN THE

MAY 31, 1970 PERUVIAN EARTHQUAKE

Freddy Román, Ph. D.^I

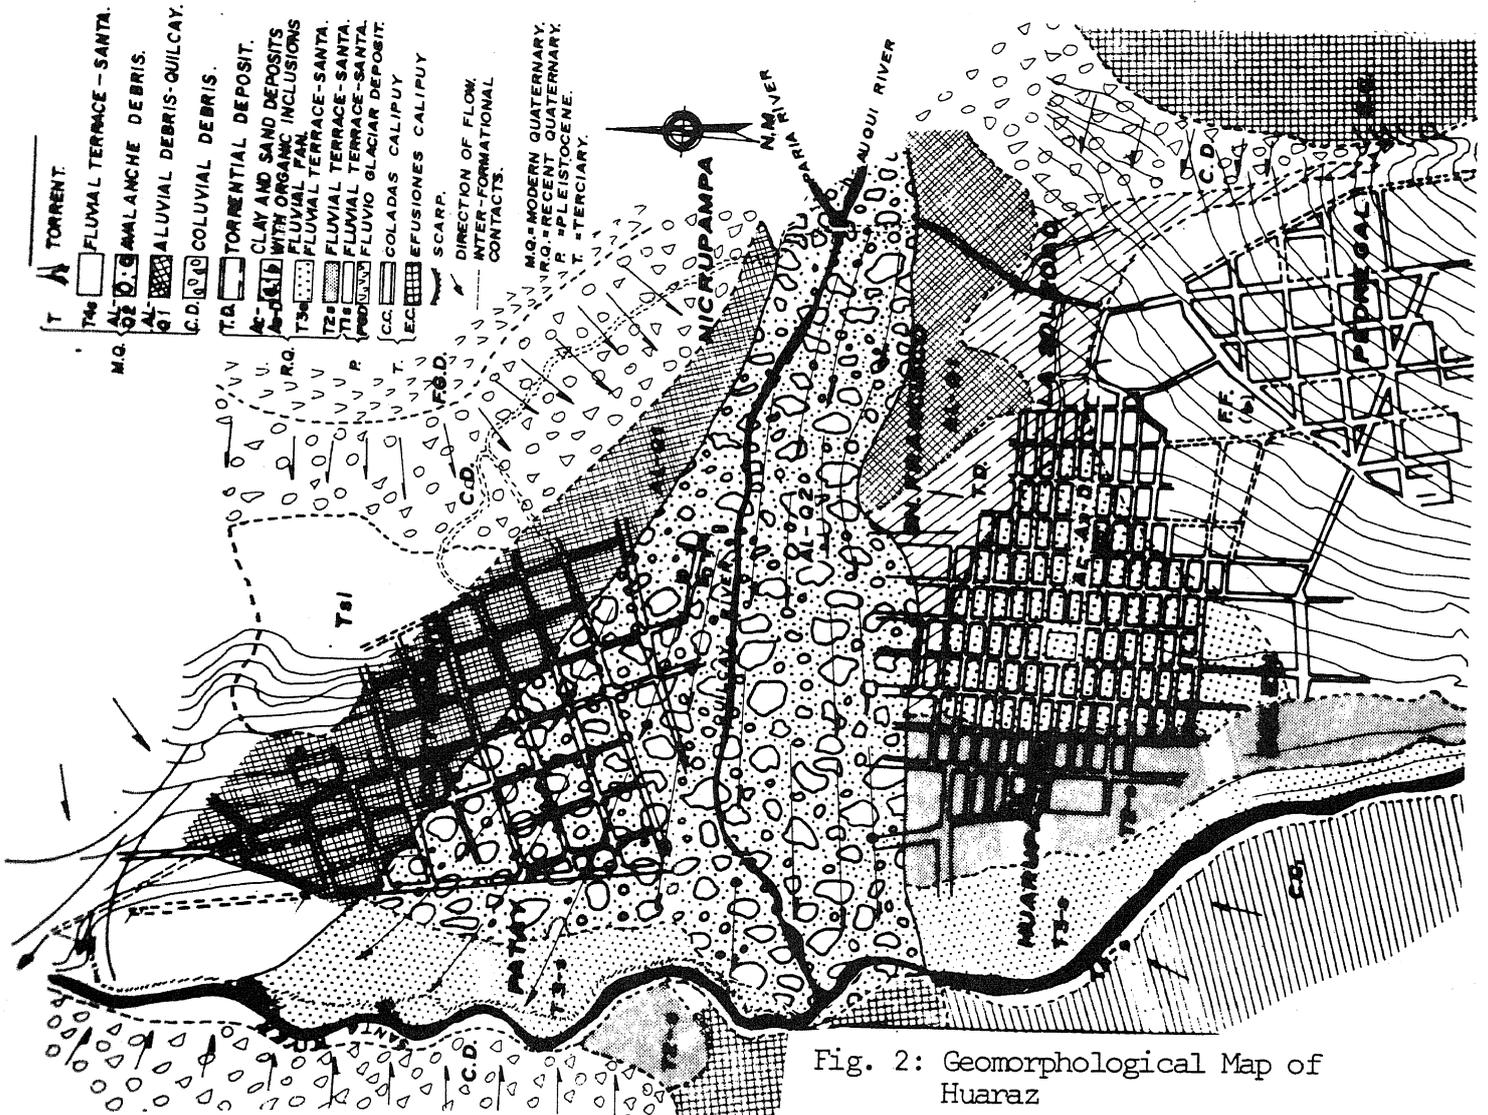
The geomorphological characteristics of the city of Huaraz are given in Fig 2. The urban area is located between the two mountain ranges to the east of the Santa River. Most of it has been formed by torrential action, avalanche debris or coluvial debris proveniente from the higher areas. In particular, it is noteworthy the avalanche cone marked as AL-Q2, which was produced by the debris fallen onto that area in 1941 and originated in the bursting of the natural containment of a glacial lake situated above Huaraz. It is also interesting the area densely populated of Huarupampa which was formed by the temporary damming of the Santa River in recent times and which actually constitutes a lake bed conformed mainly by successive layers of sand, silt and clay. Most destruction occurred in this area.

Fig. 2: Geomorphological Map of Huaraz

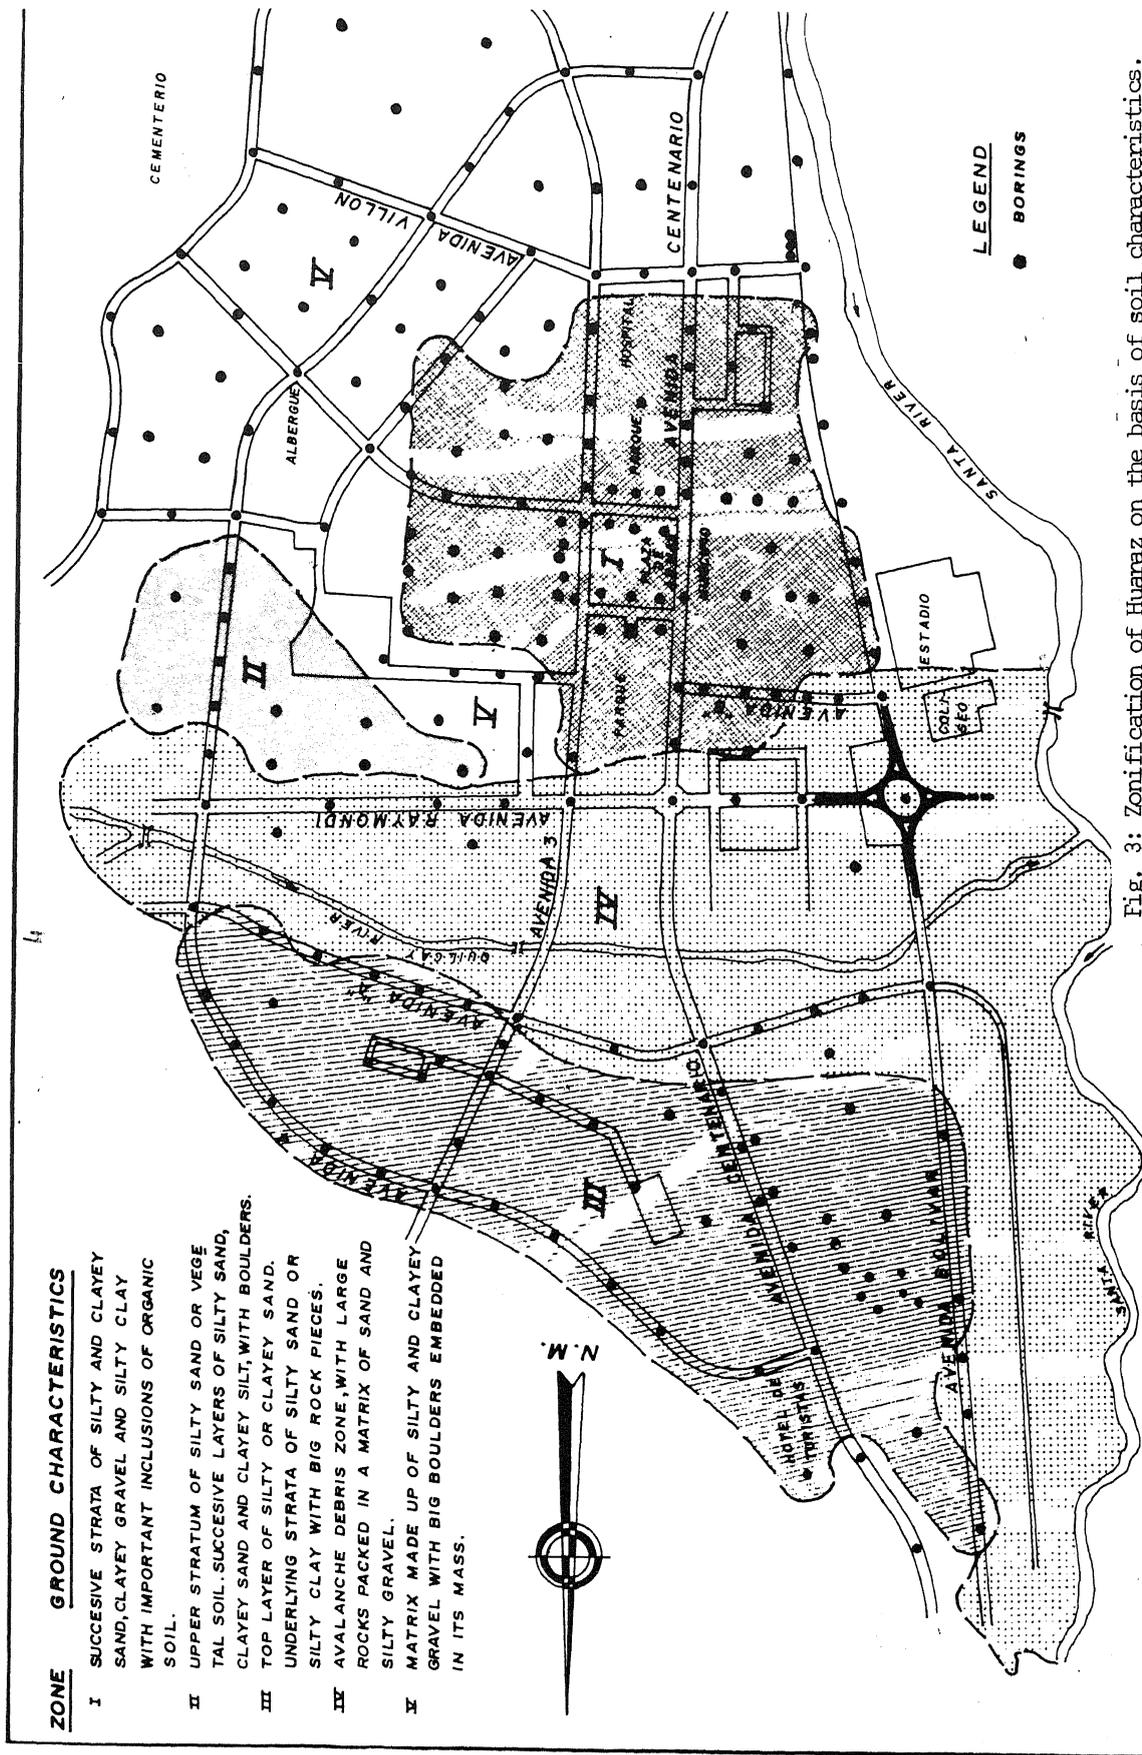
Fig. 3 shows the zonification of the city made on the basis of soil characteristics and Fig. 4 presents the areas where the water table was found at a shallower depth than 3 meters. Zone I corresponds very closely with the area more distressed and where most deaths were recorded. Depths explored were in the order of 10 meters. However, it is estimated that the soft sediments encountered extend to depths as large as 100 meters or more.

Fig. 3: Zonification of Huaraz on the basis of soil characteristics.

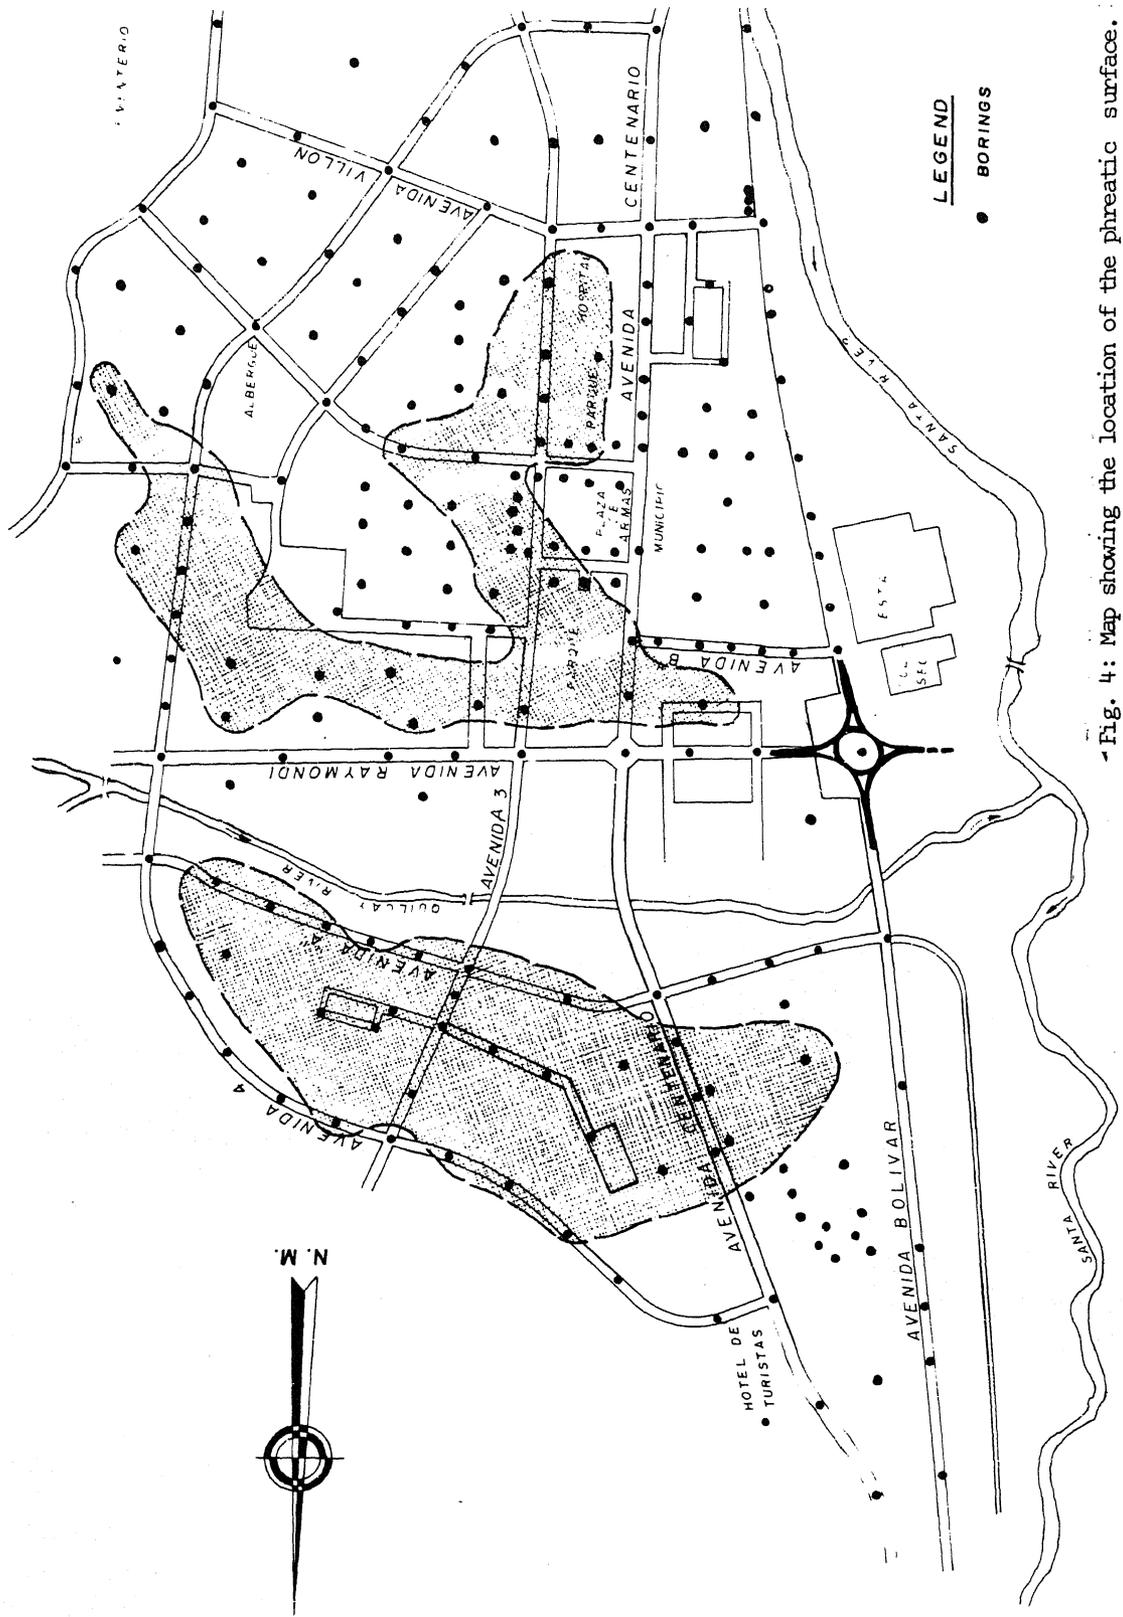
-Fig. 4: Map showing the location of the phreatic surface.
