DAMAGE DURING KINNAUR EARTHQUAKE OF JANUARY 19, 1975
IN HIMACHAL PRADESH, INDIA

S.Singh^I, A.K. Jain^{II}, V.N.Singh^I and L.S. Srivastava^I

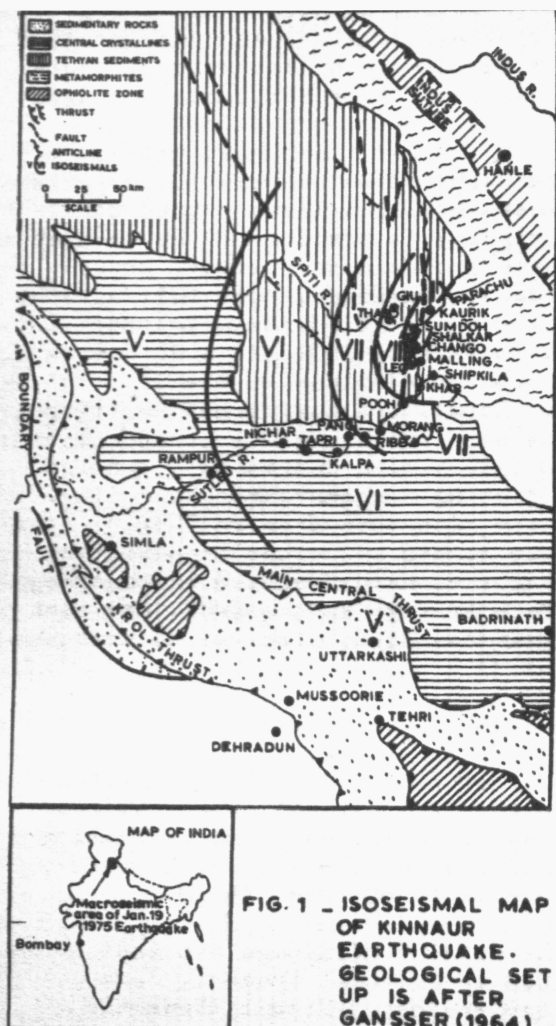
Chango fault (Fig. 1). The N-S trending fault in the meizoseismal area is characterised by the occurrence of thermal springs and gypsum deposits. These evidences show that the area along the Kaurik-Chango fault is active.

A questionnaire for collecting the details of damage was sent to the Post Masters of all the Post Offices in Himachal Pradesh, Jammu and Kashmir and hill districts of Uttar Pradesh. Fig. 1 shows the isoseismal map based on the field observations of the behaviour of buildings and ground, and data collected through the questionnaire. The isoseismal map shows intensities from IX to V. The isoseismals show a general N-S orientation parallel to Kaurik-Chango fault.

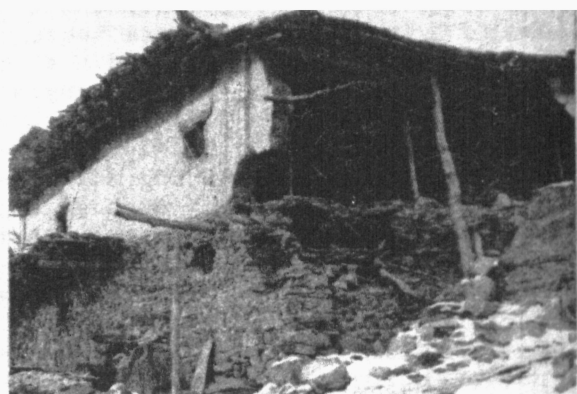
These type of mud houses in most of the villages upto a distance of 100km from epicenter developed wide cracks in the walls and got tilted. These houses from Indo-Tibet border upto Leo village were badly affected, often resulting in collapse of the structure. Extensive diagonal cracks occurred along mortar joints in mud brick walls. Fig. 2 shows complete collapse of E-W cast insitu mud wall of a double storey house at Shalkar. The ground floor is in RRSM in mud mortar.

FIG. 2 - COMPLETE COLLAPSE OF SUNDRIED MUD BRICK WALL OF A DOUBLE STOREYED HOUSE AT SHALKAR. THE GROUND FLOOR IS IN RSM IN MUD MORTAR

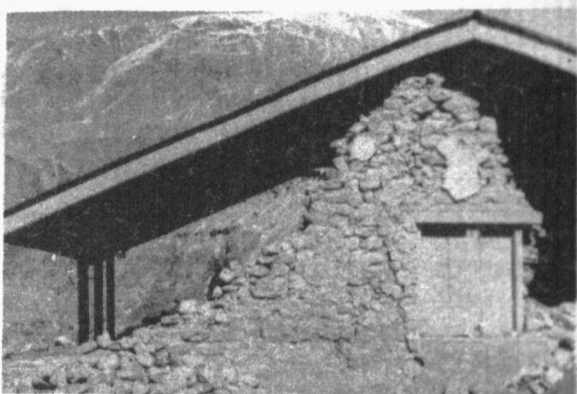
Fig. 3 shows the collapse of gable end wall of a residential house. The wall is constructed in RRSM in mud mortar. The heavy roof is precariously hanging on the partially collapsed wall and the timber posts. Fig. 4 shows a badly damaged double storey house constructed in RRSM in mud mortar. The large boulder rolling down from left and seen below

FIG. 3 - DAMAGE TO GABLE END WALL OF A RSM HOUSE IN MUD MORTAR. ROOF IS SEEN HANGING ON PARTIALLY COLLAPSED WALL AND TIMBER POSTS

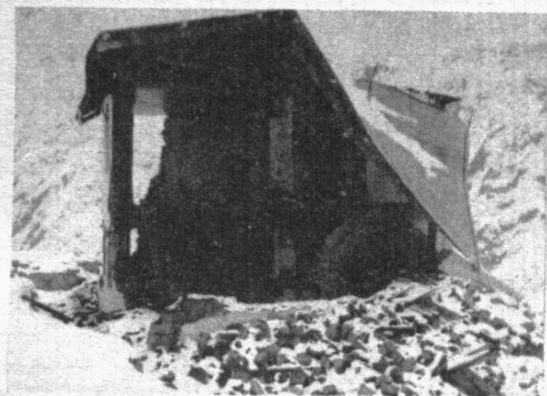
the collapsed roof caused severe damage to the building. Fig. 5 shows heavy damage to the stair case well of a double storeyed building in DSM in mud mortar. Several cracks developed in this building. Fig. 6 shows the collapse of gable end wall in a house made of RRSM in mud mortar. Movement of the roof resulted in tilting and dislocation of sewage ventilation pipes. However, an interior wall reinforced by timber having X-bracking did not collapse. Several buildings with heavy roof and timber trusses resting on walls in RRSM in mud mortar collapsed completely. Complete collapse of such a building is shown in Fig. 7.

FIG. 4 - DAMAGE TO A DOUBLE STOREY ROADSIDE HOUSE NEAR SHALKAR. IMPACT OF LARGE BOULDER ALSO CAUSED SEVERE DAMAGE.

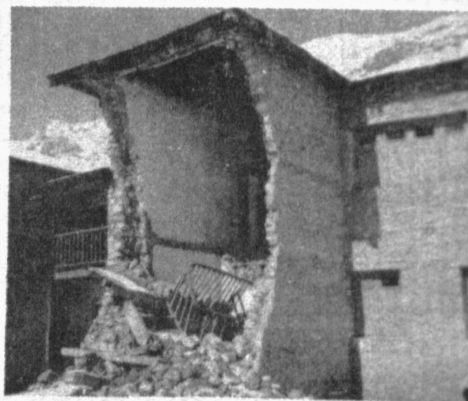
FIG. 5 - COLLAPSE OF STAIRCASE WELL IN A DOUBLE STOREYED HOUSE OF DSM IN MUD MORTAR AT LEO

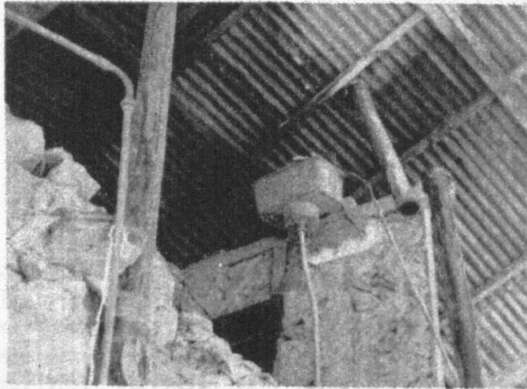
FIG 6 - COLLAPSE OF GABLE END WALL IN A HOUSE AT LEO - AN INTERIOR WALL REINFORCED BY TIMBER HAVING X - BRACING DID NOT COLLAPSE

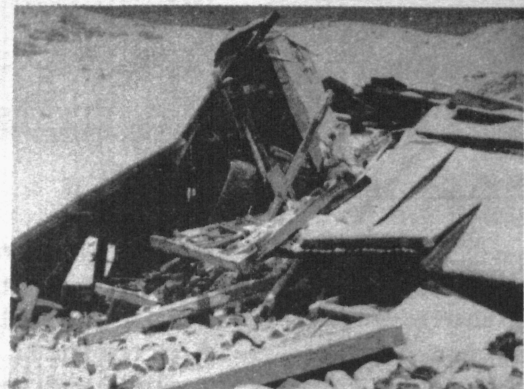
FIG.7 - COMPLETE COLLAPSE OF A BUILDING IN RRSM IN MUD MORTAR AT LEO

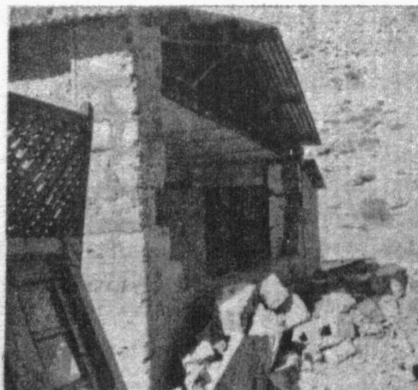
Fig. 8 shows the collapse of the gable end wall made in hollow concrete block whereas the columns and corrugated iron sheet roof resting on steel trusses did not suffer much damage.

FIG.8 - COLLAPSE OF GABLE END WALL MADE OF HOLLOW CONCRETE BLOCKS NEAR SUMDOH

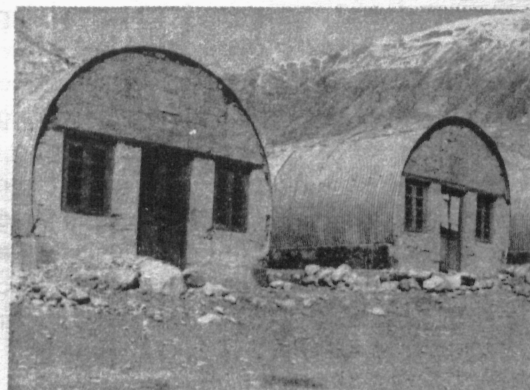
These constructions, even when very close to the epicentral region did not suffer much damage and withstood the shock very well. Fig. 9 shows cylindrical sheds of corrugated iron sheets which suffered no damage except for developnment of cracks on the side walls near Sumdoh. Fig. 10 shows barrack type houses which suffered no damage.

FIG.9 - CYLINDRICAL SHEDS OF CORRUGATED IRON SHEETS WHICH SUFFERED NO DAMAGE EXCEPT DEVELOPMENT OF MINOR CRACKS ALONG SIDE WALLS

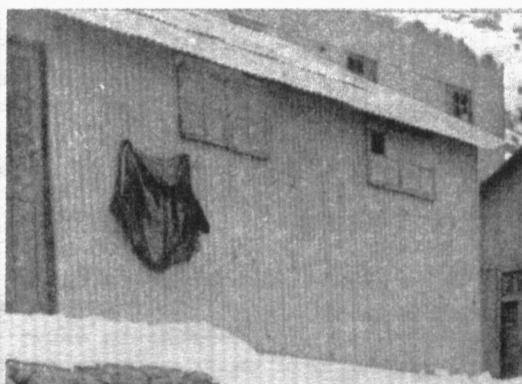
FIG.10 - UNDAMAGED HOUSE MADE OF CORRUGATED IRON SHEETS NAILED ON TIMBER FRAME WITH SLOPING ROOF

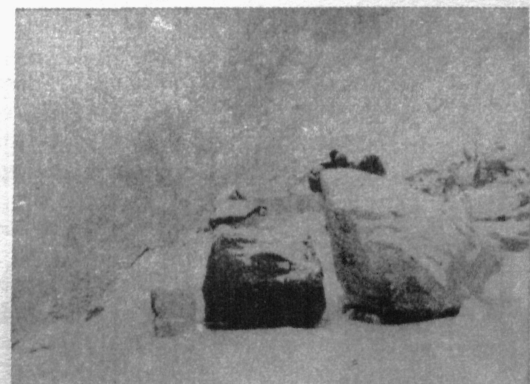
Stone masonry retaining walls were washed down at many places with the land slides. Falling of huge boulders and landslides caused considerable damage to the Hindustan-Tibet highway. A portion of the damaged highway is seen in Fig.11. The earthquake produced very strong ground motion resulting in fissures in the ground, landslides, rock falls and avalanches. Thick succession of glacial moraine at Kaurik developed wide and extensive fractures from a few centimeters to 100m and a downthrow of ground towards west was noted upto 100m. Landslides in the area continued for several days along steep hill slopes. Dislodging and shifting of boulders at the crest of hill slopes were quite common. A major landslide filled the right bank of Parachu valley with debris upto a height of 60m and blocked the flow of water creating a reservoir behind it. After six days the water impounded in the reservoir started flowing from the left bank. Loosening of rocks along joints and other pre-existing discontinuity surface and movement along them have resulted in changing the seepage outlet in some of the surface springs in the area. One such natural spring in limestones near shalkar ceased to flow due to readjustments in limestone along joints.

FIG.11 - LARGE BOULDERS FALLEN ON ROAD PAVEMENT. PART OF THE ROAD DAMAGED DUE TO LANDSLIDE IS SEEN IN THE BACKGROUND
