## DAMAGE OF STRUCTURES DUE TO THE 1974 IZUHANTO-OKI EARTHQUAKE

### SYNOPSIS

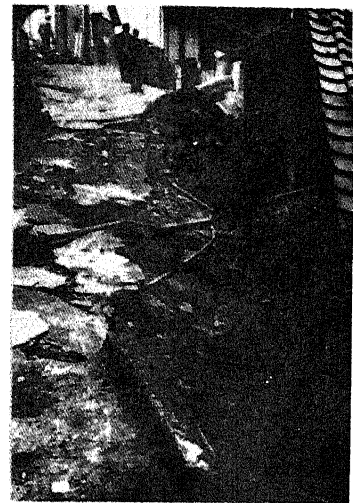
Photo 1. Crack in the ground caused by collapse of retaining wall (Iruma)

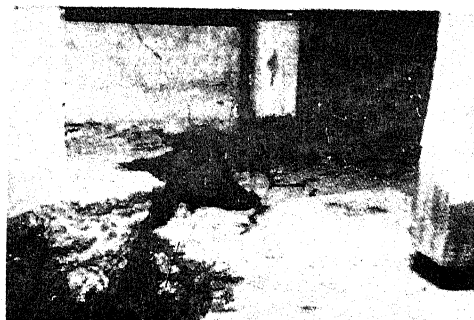
Most of the houses just above the fault were heavily damaged. The shear failure of continuous footing, slipping down of wooden column from boulder foundation, torsion of whole structure and movement or falling down of roofing tiles were observed in them. This type of failure were observed at Irozaki district. (Photo 2, 3, 7)

Photo 2. Fault occurred at the ground under the wooden house (Irozaki)

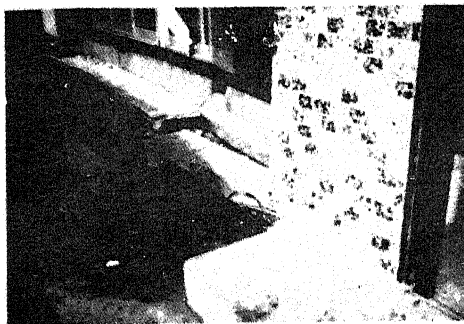
Photo 3. Collapse of footing caused by fault (Irozaki)

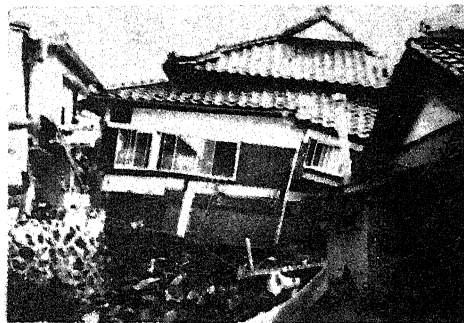
At Iruma district, the houses are built on the sand leveled with retaining wall. Due to the vibration of the earthquake, the surface of the sand slid with the foundations of the structure, and the houses were destroyed. Especially, the structures whose retaining walls and foundations were not constructed solidly were heavily damaged. (Photo 4, 5)

Photo 4. Destroyed house caused by collapse of retaining wall (Iruma)

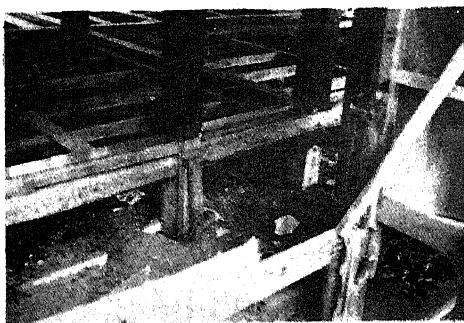
Photo 5. column slipped down from boulder foundation (Iruma)

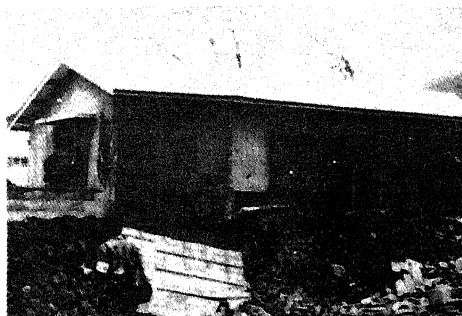
Mixed structures which consist of wooden and reinforced concrete block or masonry were built here and there. In most of these structures, the failure occurred due to the difference of rigidities between wooden part and the other. The superannuated wooden houses were also heavily damaged as observed in the other earthquake.

Photo 6. Damage of wooden house with reinforced concrete block wall (Iruma)

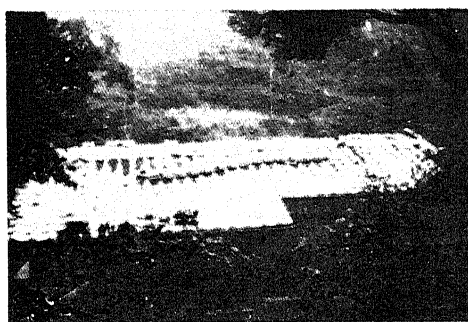
Photo 7. Movement of ridge roofing tile of wooden house (Irozaki)

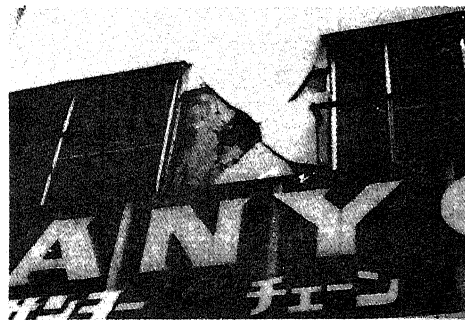
Photo 8. Crack of mortar finish on metal lathed steel structure (with ALC interior finish) (Shimoda)

It seems that the damages of main structure of steel constructions would be slight at such a scale of earthquake, being designed and constructed according to the standard design manual and standard specification of construction. However, the serious consideration to the design of non-structural member such as finishing material is seemed to be important from a viewpoint of the security of the lives of peoples and the estates. The steel structure should be carefully designed to have not only the strength but also the rigidity which does not exceed the deformation capacity of the interior and exterior finishing materials.

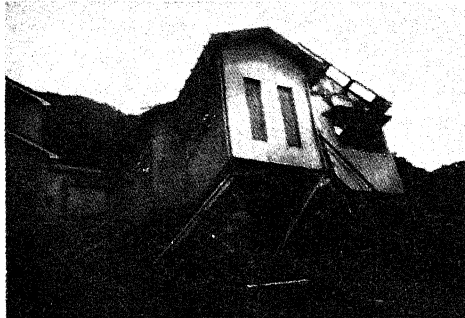
Large spanned steel structure for green house at Irozaki district, were slightly destructed in main structure except the destruction of finishing materials such as glasses. Two or three storied apartment house and store house with mortar finishing walls were many at Shimoda district. Most of these structures were damaged of exfoliation of finishing mortar. (Photo 8) And some cases of rupture and laxity of braces were observed. In the case of light gaged steel structure, the representative destruction was observed in the detached house with pilotis at Shimogamo district. (Photo 9)

Photo 9. Completely destroyed house caused by destruction of light gauged steel structure at the first floor (Shimogamo)

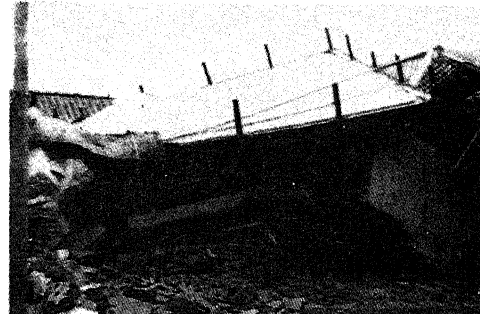
Most of these structures which were heavy and massive, and still more, were designed with no aseismatic consideration were completely collapsed. The reinforced concrete block structures designed with aseismatic consideration were not damaged.

Photo 10. Damage of reinforced concrete block house (Iruma)
