DAMAGE TO A REINFORCED CONCRETE HOTEL BUILDING DUE TO THE OHITA EARTHQUAKE OF APRIL 21, 1975

Masahide Tomii^I and Koji Yoshimura^{II}

SYNOPSIS

Information about the damage to the K. L. Hotel building, damaged beyond repair during the 1975 Ohita earthquake, is given and the principal cause of the damage is presented.

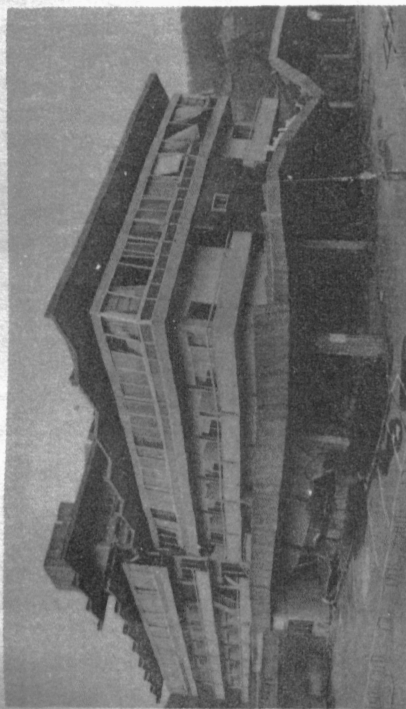
Damage to the building caused by the earthquake was massive (Fig.5 and 6), however most of the severe structural damage was concentrated in the

Fig.5 - South and East Sides of the K. L. Hotel
after the Earthquake

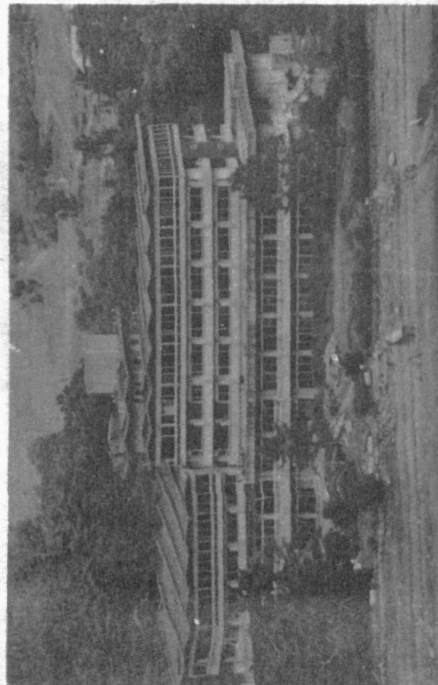
Fig.6 - North Side of the K. L. Hotel
after the Earthquake

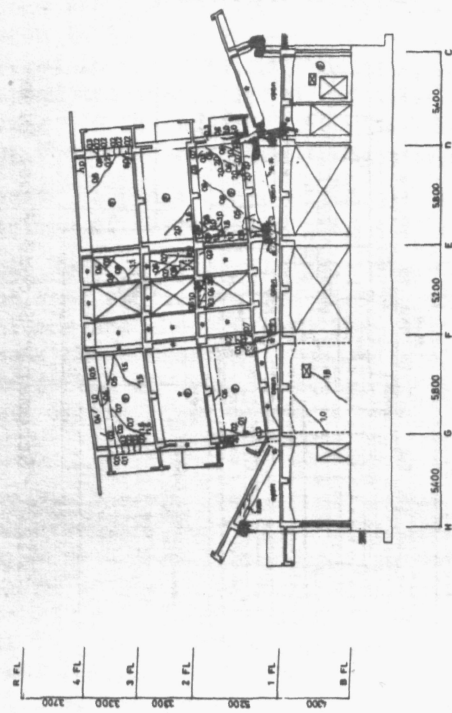
East Section (Figs.7~11): Figs.7 and 8 show the structural damage to Sections B-B and C-C, respectively. Numbers in the figures represent the crack width in mm. It is seen from these figures that the most severe damage occurred in the first story, where columns and shear walls completely collapsed and some interior columns punched through the slabs (Figs.9 and 10). Damage to the upper three stories and basement in this section was moderate but they were damaged beyond repair except for the basement.

Fig.7 - Structural Damage to Section B-B (West Elevation)

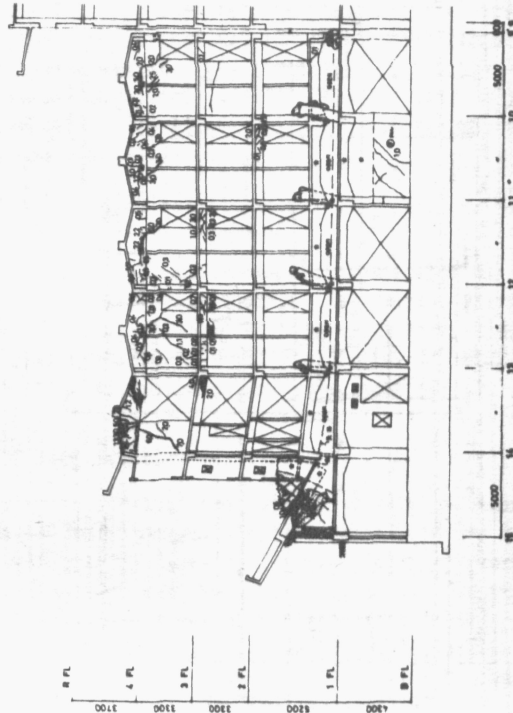
Fig.8 - Structural Damage to Section C-C (North Elevation)

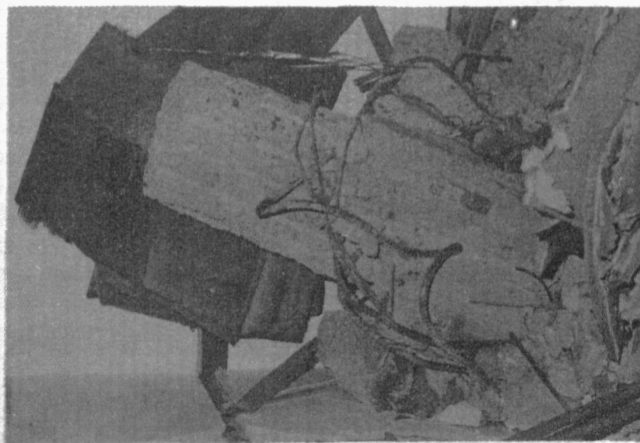
Fig. 9 - Detail of damage to the interior long-column at coordinates F-12 in Fig. 8. Note that top of the column punched through the second floor slab.

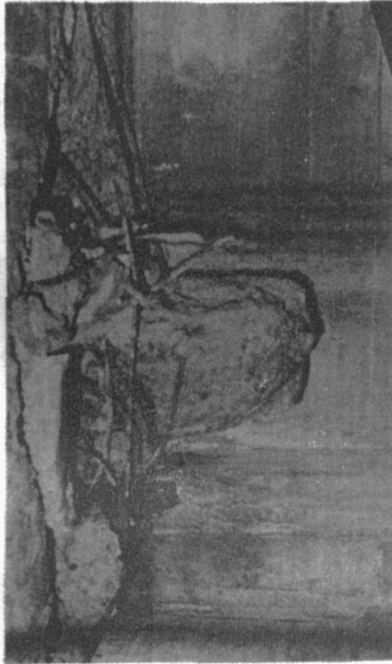
Fig. 10 - Damage to the first story interior long-column at coordinates D-11. Bottom of the column punched through the first-story slab.

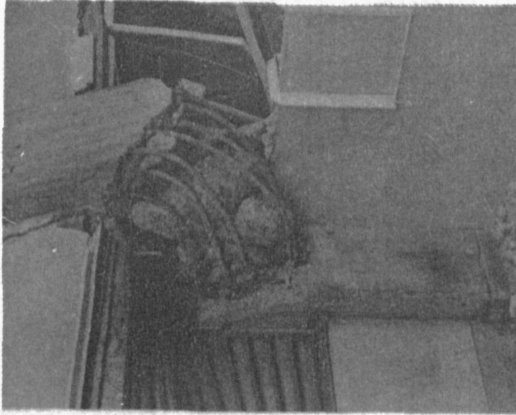
Proportioning and Detailing of Members: The shear-force reinforcement for columns and shear walls, although permitted by the 1962 AIJ Standard, was inadequate. Such lack of adequate shear resistance capacity and ductility in shear walls and columns was one of the main factors in the severe structural damage (Figs.11 and 14).

Fig. 11 - Detail of damage to the exterior short-column at coordinates C-13 in Fig. 8

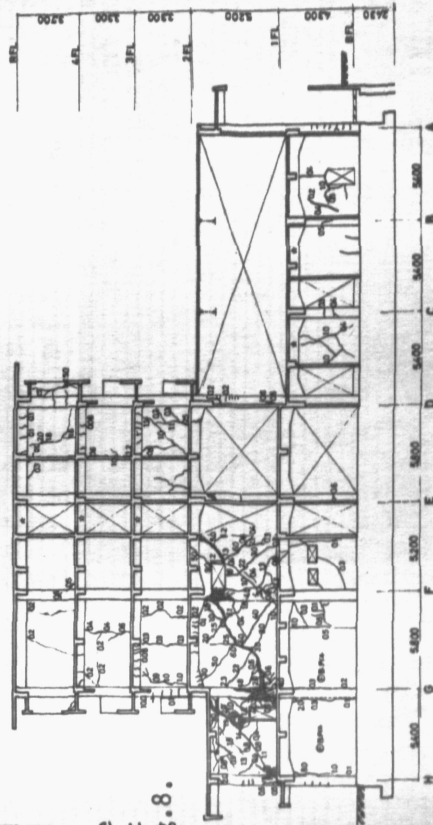
West Section (Figs.12~14): Fig.12 shows the typical structural damage to the west section. This section suffered moderate damage to the first story columns and shear walls above the basement, and as the result of this, the upper three stories leaned slightly to the northwest. Figs.13 and 14 show the detail of typical damage to the top of the interior column and shear wall of the first story.

Fig. 12 - Structural Damage to Section D-D (West Elevation)

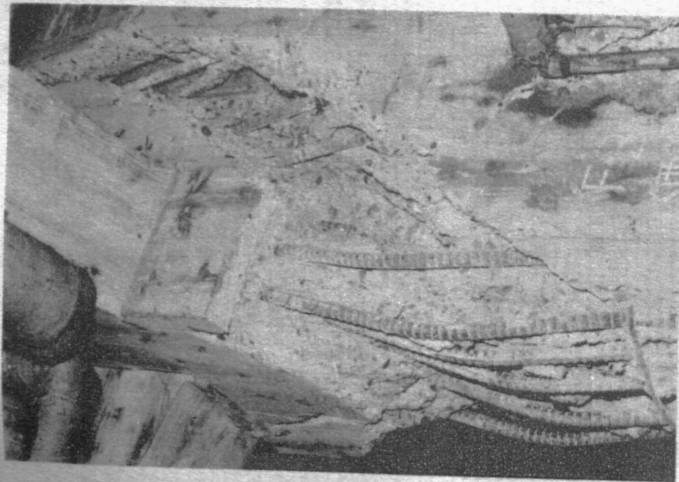
Supervision of Works: Stirrup-ties could not be seen at the top of interior long-columns which suffered severe damage (Fig.13). The main cause of the damage that occurred in the long-columns of the first story was the lack of these stirrup-ties at the top of the interior columns.

Fig. 13 - Detail of damage to the top of the interior long-column of the first story at coordinates F-3. Note that few ties can be seen.

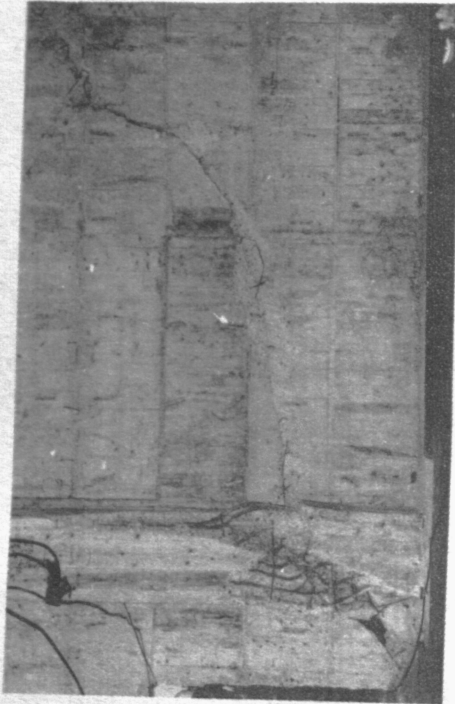
Fig. 14 - Cracked shear wall

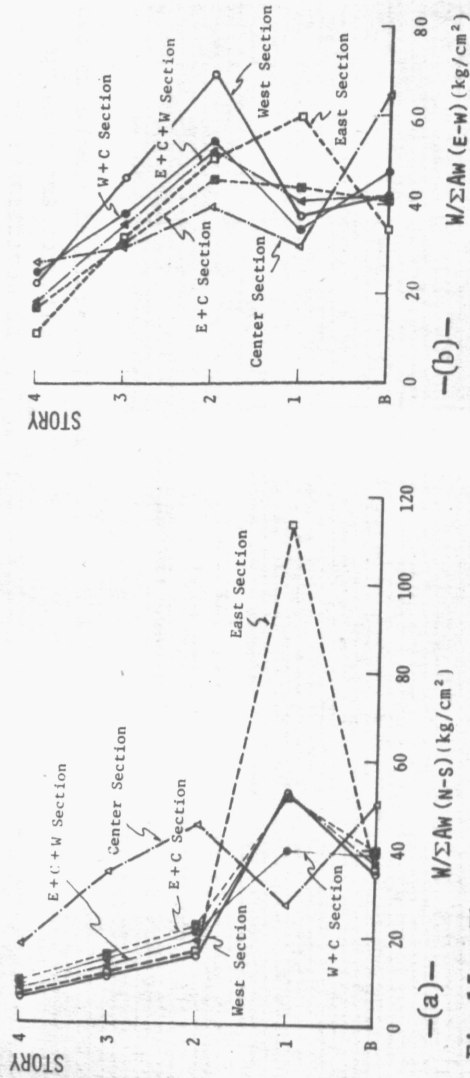
Selection of Structural System: On the first story, though the uncracked framed shear walls carried 90 per cent of the storied shear forces, the ratios of $W/\Sigma A_w$ in N-S direction of the east and west sections were fairly greater than the ratios in other stories, especially the ratio of the east section was remarkably large (see Figs.15(a) and 15(b)). This fact shows that large stresses are induced in the shear walls during earthquakes. Moreover, there were many short columns whose shear forces were large on the first story of the east section. Such discontinuities in stiffness and strength were one of the reasons for the damage of this building.

Fig. 15 - The ratios of $W/\Sigma A_w$ for each section. W denotes the total of dead plus live loads of the upper stories and ΣA_w denotes the lateral cross-sectional area of the framed shear walls in the direction under consideration.
