EFFECTS OF THE KYZYL-KUM EARTHQUAKES
ON APRIL 8 AND MAY 17, 1976

S.V.Poliakov*, A.I.Martemianov**, A.M.Zharov***,
L.Sh.Kilimnik, V.S.Novikov***, D.A.Alekseenkov****

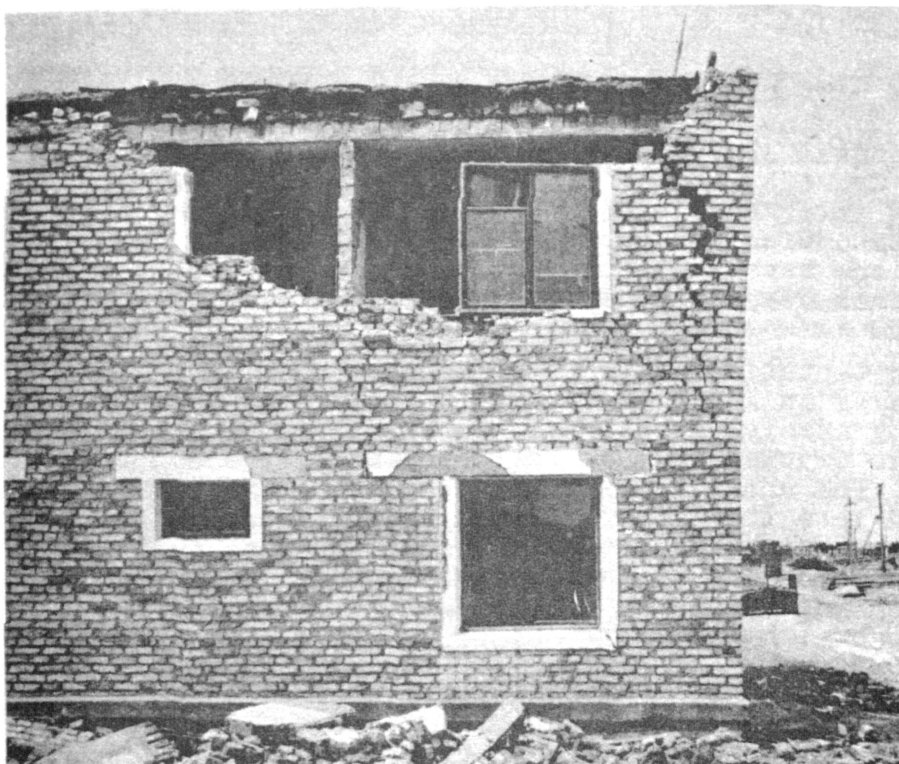
Fig 1

After the April 8 earthquake the brickwork buildings suffered severe damage. Most typical destructions were falling out of portions of external walls (Fig.1), diagonal cracks in wide interfenestrations, shear of floor slabs, damage of wall corners on the second floor, inclined cracks in internal wall, disintegration of brickwork and falling out of bricks from walls above door openings. In all buildings failure of parapets, chimneys, falling out of gable walls and infilling brickwork at the loft level were observed. In some cases lintels and brickwork over them on the upper floor fell out.

A great majority of damage in brickwork buildings was due to poor cohesion between mortar and brick. As the test data obtained by the Institute ISMiS, Academy of Sciences of the Georgian SSR, show, the cohesion was within 0.09 - 0.33 kg/sq.cm despite fairly high grades of mortar. One of the reasons for the above mentioned damage was poor quality of brick-laying workmanship.

- Fig. 1 Collapse of a brick masonry wall of a two-storey dwelling.
- Fig. 2 Damage of the end wall of a two-storey large-panel building.
- Fig. 3 A section of a four-storey large-panel building facade.
- Fig. 4 Collapse of structures of the two-storey school with a reinforced concrete frame.

With regard to the question of Prof. Keightley, we wish to state that the character of damage of two-story brick buildings in the township of Gazli resulted from high intensity of the earthquake and lack of antiseismic precautions, as the regional seismicity was considered to be 5.

Greater damage of upper stories is typical of such buildings because the decrease of gravity load on the walls (as compared with the first stories) results in lower masonry resistance to major tensile stresses and shear forces. The similar damage could be seen in Tashkent after the earthquake in 1966.

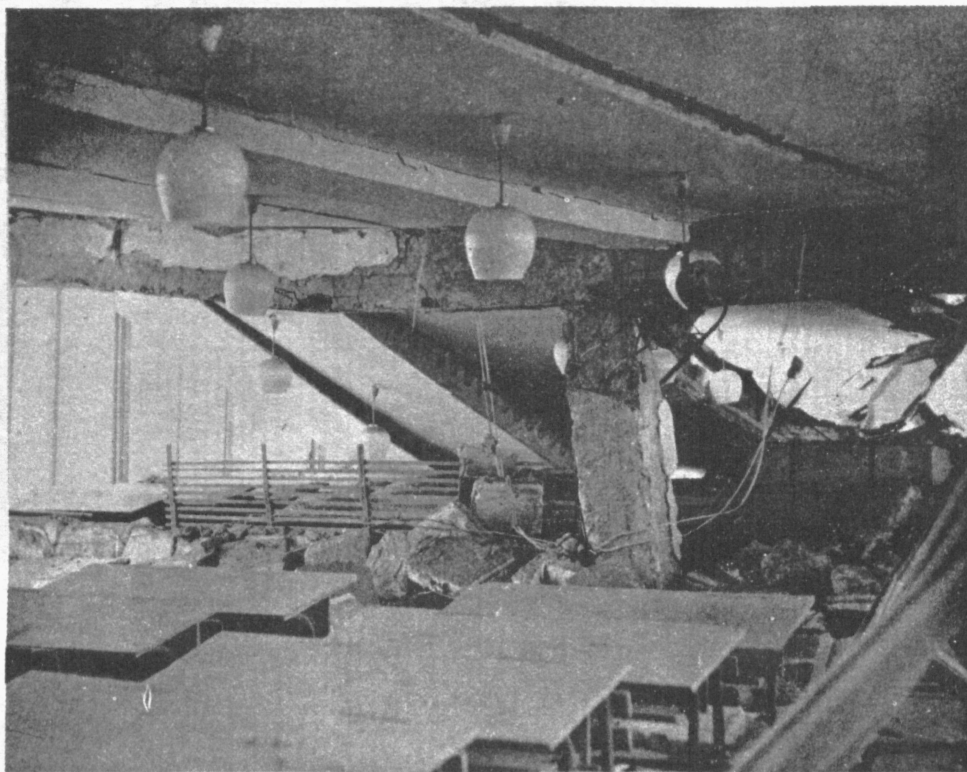
Fig 4

After the May 17 earthquake all the load-carrying and enclosing structures of the school were severely damaged or collapsed. The lap-frame joints reinforced had horizontal and sloped cracks, in a great many connections concrete came down partly and reinforcing bars buckled. Structural and technological defects of workmanship in erecting the frame such as interruption of frame concreting at the column top level which did not ensure solidity of the structure, absence of coupling of column and girder reinforcement and inadequate (from the view point of earthquake resistance) confined reinforcement, produced more adverse effects during the second quake.

As a result of failure of connection zones and concrete crushing in columns at a height of 30-50 cm under the girder in a few classrooms and near the staircase roof slabs collapsed (Fig. 4). In fact, all the partitions in the building were damaged and many failed. Girders reinforced with portal bracing suffered not so severely as before damage being in the form of vertical and sloped cracks. However in the lower joints of bracing with columns cracks and spalling of encasing concrete were observed. Ruptures of pipes of heating and water-supply systems in the school were reported. Walls of the assembly hall, partitions in particular, were damaged by horizontal and sloped cracks, reinforced concrete columns being damaged severely.

After the April 8 earthquake the major structures of the school were restored: part of the frame joints was reinforced by metal laps, under the most damaged girders in the span portal bracing of steel rolled shapes were installed, and in corners channel brackets were placed which increased the frame effect of the system. Brick and gypsum-cast partitions were made with reinforcement. Brick walls of the assembly hall were erected anew, at the floor levels aseismic belts were provided to make the structure earthquake resistant.
