STUDY OF REINFORCED CONCRETE BUILDINGS DAMAGED DUE TO THE MIYAGIKEN-OKI, JAPAN, EARTHQUAKE OF JUNE 12, 1978

Shizuo Hayashi*1, Yoichi Morishima*2, Akira Wada*3 and Seiji Kokusho*4

SYNOPSIS

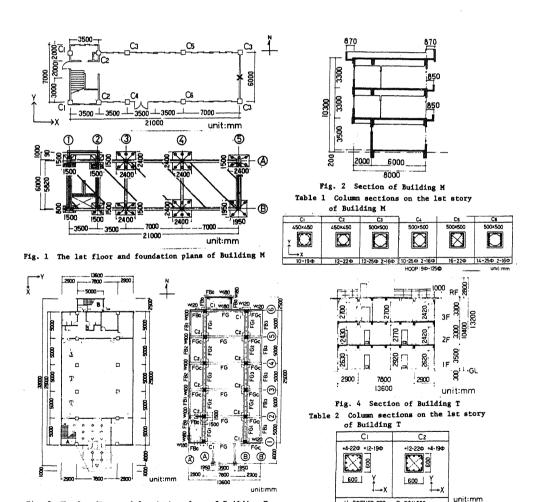
Fig. 3 The 1st floor and foundation plans of Building T

Building T: This was built in 1964. The plan, section and columns on the 1st story are shown in Fig. 3, 4 and Table 2. Floor slabs projected over from the column line A or B in E-W direction, and there was no foundation at the tips of the cantilever beams. Shear walls were located only arround a staircase of the north side.

The building was inclined toward southeast due to shear failure of columns on the lst story.
