SOME LESSONS FROM THE MARCH 14, 1979 EARTHQUAKE IN MEXICO CITY

Enrique del Valle (I)

Summary. Some of the problems caused by a severe earthquake, $M_s = 7.6$, that occurred on March 14, 1979 near the coast of Guerrero, but which affected --- mainly Mexico City, are described.

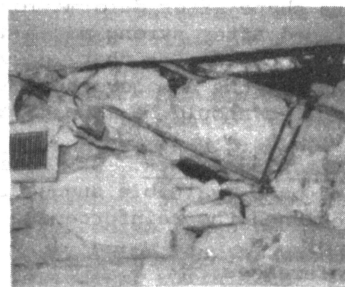
Fig. 8 shows another case where lateral walls were diagonally reinforced to resist seismic effects but were placed on a plane not coincident with the frame. Here the strength of the walls was not enough and the diagonal reinforcement was damaged.

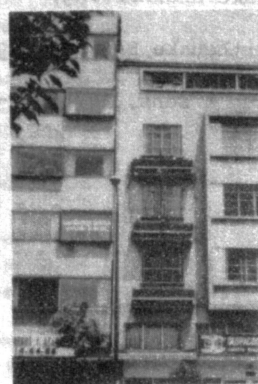
Fig. 9

Pounding between adjacent buildings in some cases was due to the combined effects of excessive flexibility of structures and differential settlement of buildings. Figs. 9 and 10 show how the separation between two buildings was reduced considerably due to settlement of the short building, causing that one fourth floor column of the tall one resulted with damage. Fig. 11 illustrates a similar case where adjacent walls were seriously damaged due to pounding with the neighbouring buildings. Here partition walls in the short direction were badly cracked due to excessive flexibility combined with null separation between them and the structure; reparation of this building is described later.

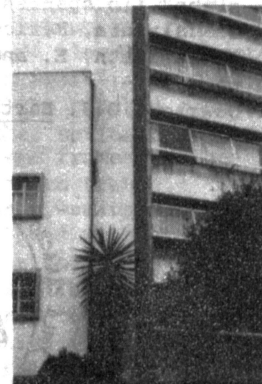
Fig. 11

The first one was illustrated in fig. 11. It was mentioned with

regards to pounding with adjacent buildings due to insufficient seismic gap. It had mainly non structural damage in the partition walls of the short direction; however, a column of the fourth floor had failed as shown in fig. 20. It is one of the condominium apartment buildings that was being repaired by each tenant without studying the structure as a whole. Plan of the typical floor is shown in fig. 21. The structure consisted of flat slab floors and concrete columns; it is supported on friction piles. Due to the insufficient depth of beams the frames were very flexible causing pounding with the neighbours, therefore, it was decided to increase lateral stiffness by means of diagonal steel members infilled in three of the frames of the transverse direction combined with column reinforcement using steel angles and lattice, as shown by fig. 22. Longitudinal walls were also reinforced using wire mesh and plaster. Fig. 23 shows period measurements of the building taken before and after strengthening, evidencing the increase in lateral stiffness that will eliminate most of the pounding problem with neighbours.

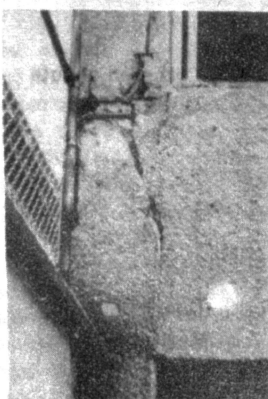
Fig. 12

Deep facade beams, when spandrels are incorporated to the resistant structure, increase frame stiffness due to reduction of column lengths. This produces two effects: a larger force than that assumed in the analysis neglecting the increase in stiffness is absorbed by facade frames and shear failure of the columns becomes possible. Vibration periods are also reduced and this may lead to a higher earthquake response. Figs. 12 and 13 show damage to the columns of a twelve story building where this happened. As there is an architectural current in Mexico that tends to use this type of elements, it has been necessary to include joint effects in the frame analysis to take into account zones of very large moment of inertia at the ends of the columns.

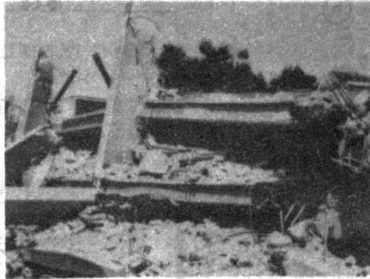
Fig. 16

The worst case of damage was the total collapse of three school buildings of a private university (figs. 14 to 17) located far away from the

zone where most damage occurred, fig. 1. The buildings were three stories high, constructed in 1961 approximately, therefore they had survived several strong motions that affected the city since that time. Seismic forces were resisted by rigid frames; however, due to architectural reasons, the beams of the longitudinal direction were connected to the beams of the transverse direction rather than to the columns, transmitting seismic effects to them through torsional action on transverse beams. fig. 19.

It is well known, at present, that torsional failures are brittle and should be avoided; however, it is difficult to explain the failure from this single point of view. Cumulative damage due to previous movements might have contributed largely to the collapse, as the structure had several cracks that were studied in several occasions before the 1979 earthquake, and recommendations were made in order to strengthen the structure; however, this was never made. Estimated periods of vibration in the longitudinal direction are larger than 1.5 sec (very long for a 3 story building) and a large response due to soft soil conditions might have also contributed to the failure. Three identical buildings remained standing, fig. 18, 19 but severely damaged; they were demolished without opportunity to make some field studies on them. The time at which the earthquake occurred was certainly fortunate in this case, as two hours later the buildings would have been completely occupied.
