REPAIR AND STRENGTHENING OF BUILDINGS DAMAGED BY EARTHQUAKES

By: J. Kuroiwa^I and J. Kogan^{II}

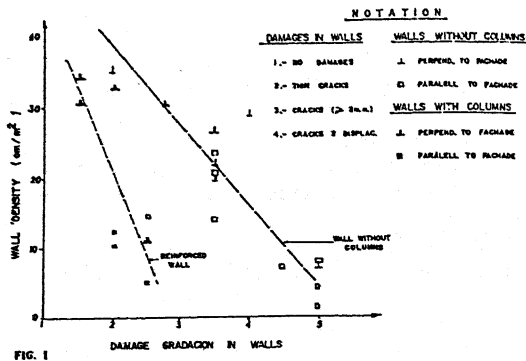
FIG. 1

The results of the damage survey of brick houses are given in Fig. 1. This illustration shows how effectively the reinforced concrete columns reduce damages. It also demonstrates the influence of wall density, especially in the non-reinforced houses. When the wall density was very low (less than 5 cm/m^2), damages in doors and windows also were found.

Fig 1 also suggests the strengthening method employed for brick houses which is to add rectangular reinforced concrete columns with their longer dimension parallel to the direction of the lower wall density. First, the walls and part of the foundation are cut. After placement of the reinforcing bars, fresh concrete is poured, creating monolithic structures. The system is complemented by the use of tie beams. (See photo 1).

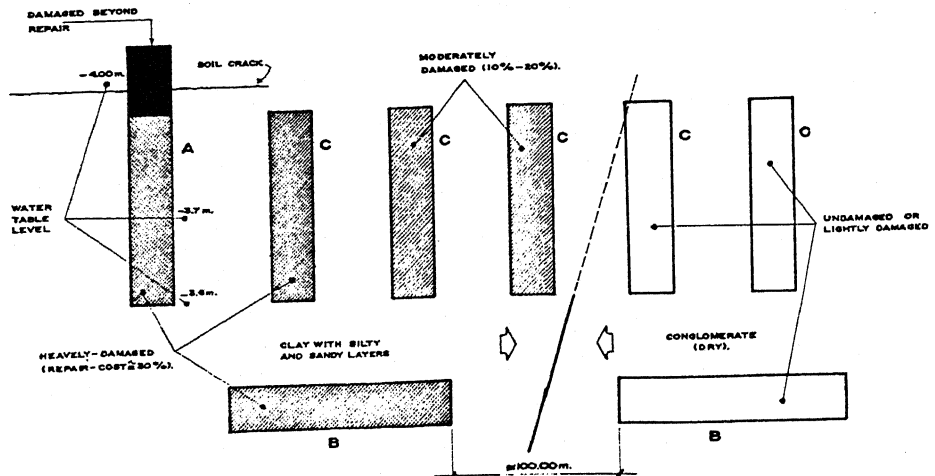
FIG. 2

A clear microzoning effect was observed in an area of very erratic soils about 300 m by 500 m on the campus of the Peru Police Academy. (see Fig. 2). A portion of a 3-story R.C. building was damaged beyond repair. The rest of that building, other 3-story building, and two one-story buildings suffered heavy damages. Identical types of buildings located only about 200 m. away were practically undamaged during that earthquake.

CAMPUS OF THE PERU POLICE-ACADEMY
(SHOWN - PARTIALLY). LA CAMPAÑA-CHORRILLOS

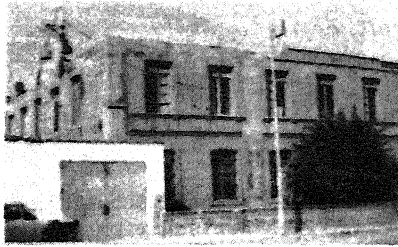
Photo 1. Brick building.
Note that from the post to
the left has been reinforced

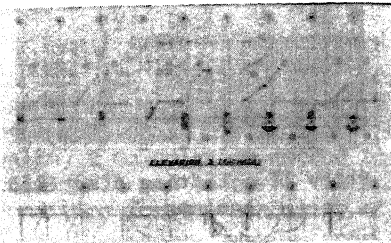
Photo 3. Plotting of damages

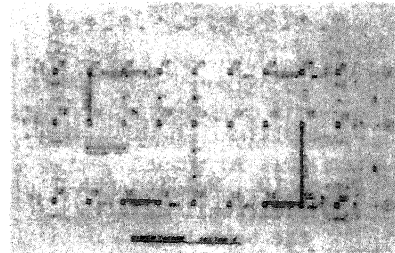
Photo 4. Note the 6 shear
walls added to the building

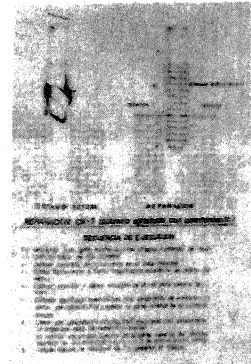
Photo 7. Example.
Details to repair
a column

- Structural details were designed with the aim that the original structures and the new elements would form a monolithic system through the use of epoxy and welding of the reinforcing bars. (See photos 7, 10, 12 & 13).
- Budgets were prepared based on technical specifications.
- Inspection was carried out during construction.

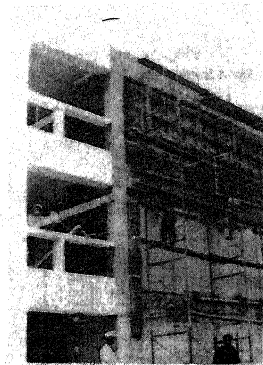
Photo 13. Shear wall
Note that the left
end and the top are
filled separately with
dry concrete

- When R.C. shear walls longer than 4-5 meters and about 3 m. high were built inside a frame, cracks appeared in the border of the shear walls due to the concrete retraction. To solve the problem, 3" bands were leveled on the top and side borders. Then dry concrete was poured and compacted (see photo 13).
- Simple methods had to be developed, in cooperation with the contractors, to lift the settled columns. (See photo 11).
- Epoxy resin is very expensive in Peru. To make efficient use of it, simple tests were conducted. Concrete cylinders (those used for compression tests) were cut along their diameters and stuck together.
