# DESIGN SEISMIC COEFFICIENT IN SEISMIC COEFFICIENT METHOD AND ACTUAL EARTHQUAKE DAMAGE

Shunzo Okamoto<sup>I</sup>, Choshiro Tamura<sup>II</sup> and Katsuyuki Kato<sup>III</sup>

This paper mainly takes up the Miyagi-ken-oki Earthquake of 1978 which caused much damage to facilities and structures designed based on earthquake-resistant design methods, and describes the relations of damage, earthquake motions and design seismic coefficients in regard to bridges and dams.

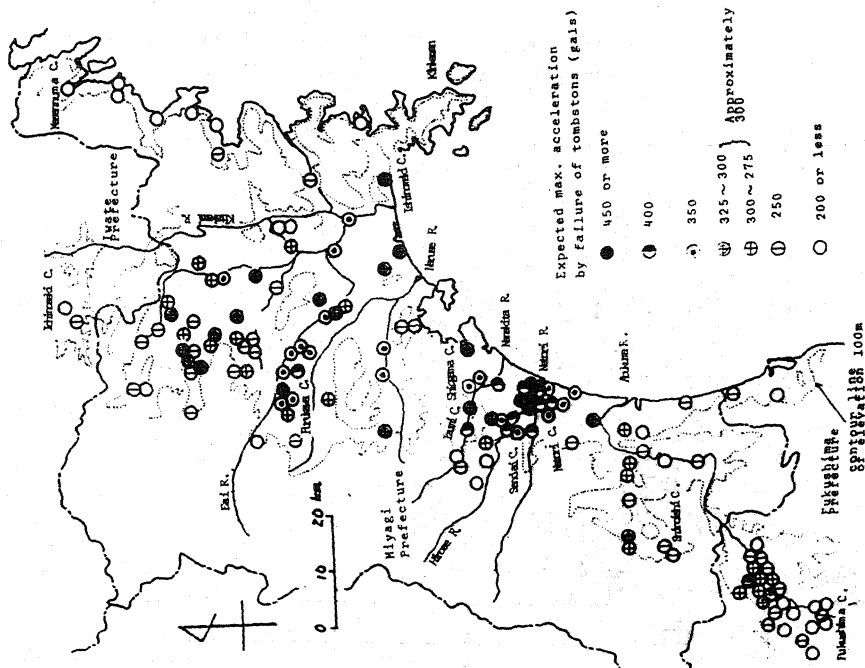
Fig. 3 is an example of distribution of acceleration estimated from surveys of gravestones toppled in the earthquake. Points of 250 to 300 gal

are large in number in districts about 100 km distant from the aftershock area center, and these roughly agree with the previously-mentioned values of maximum accelerations at diluvial ground. In districts such as the vicinity of the mouth of the Natori River where there was heavy damage to bridges, levees and houses, it is seen that there is a correspondence with the high accelerations estimated from overturning of gravestones — 400 to 450 gal or even higher. In general, it is known that heavy damage occurred to structures in areas of alluvial ground overlying diluvial tableland.

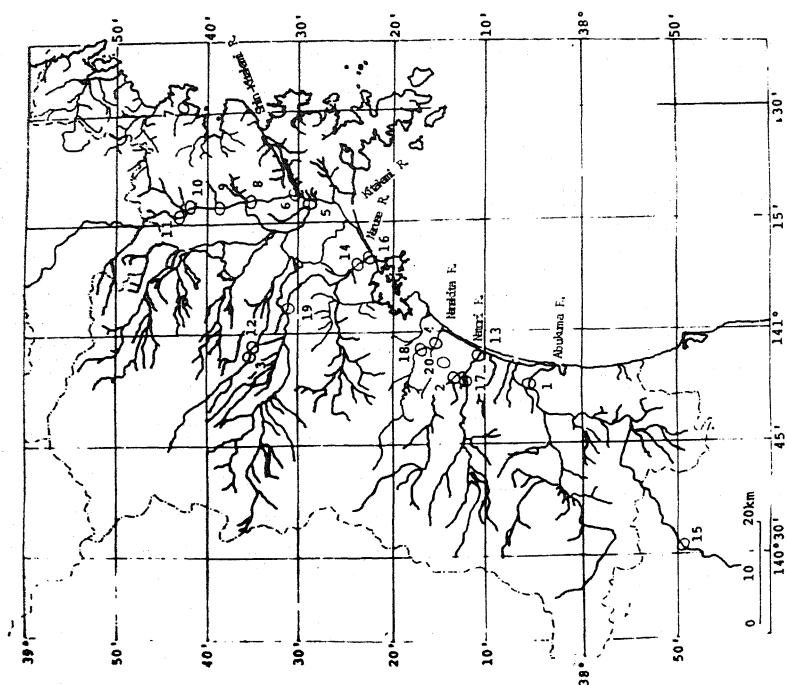
Major cases of bridge damage are listed in Table 1 with the locations of damaged bridges shown in Fig. 4. The numbers in Fig. 4 correspond to the bridge numbers in Table 1. These bridges have been designed for earthquake resistance by the seismic coefficient method, and except for two bridges which had been completed very recently, the values of  $k$  were  $k_H = 0.2$  with  $k_V$  one half of  $k_H$ . At the four exceptions 0.22, 0.24 and 0.25 had been taken for  $k_H$  because of ground conditions and height of piers.

The damage to bridge pier bodies in the table consisted of roughly horizontal or slightly diagonal cracks thought to be due to shearing and bending deformation, buckling of main reinforcement and tilting in case of massive reinforced concrete bridge pier bodies, cracking in case of relatively flexible rigid structures and wall-type structures, and movement and crushing at construction joints of concrete in case of non-reinforced concrete bridge piers. Foundations were pile foundations, and well or caisson foundations reaching down to bearing layers through soft ground of thickness of ten and several meters.

At some of steel bridges buckling of members such as cross beams and sway bracing occurred near supports, while at bearing parts breaking of joints between web plates and cover plates, buckling of web plates and twisting deformation of cover plates were seen, and pins of shoes also failed. At one steel through truss bridge there were breakages of top chord members, and judging by the condition of the ruptured surfaces, it is surmised that fatigue had been fairly advanced.

At reinforced concrete and prestressed concrete bridges there were many cases of shoes breaking and girders moving while there was a number of bridges where cracks occurred near fixed bearings at ends of girders.

In both reinforced concrete and steel bridges, it appears that either damage consisting of failure of fixed bearings, pull-out of anchor bolts, and breaking of concrete around bolts, or damage to girders near fixed bearings occurred in most cases.

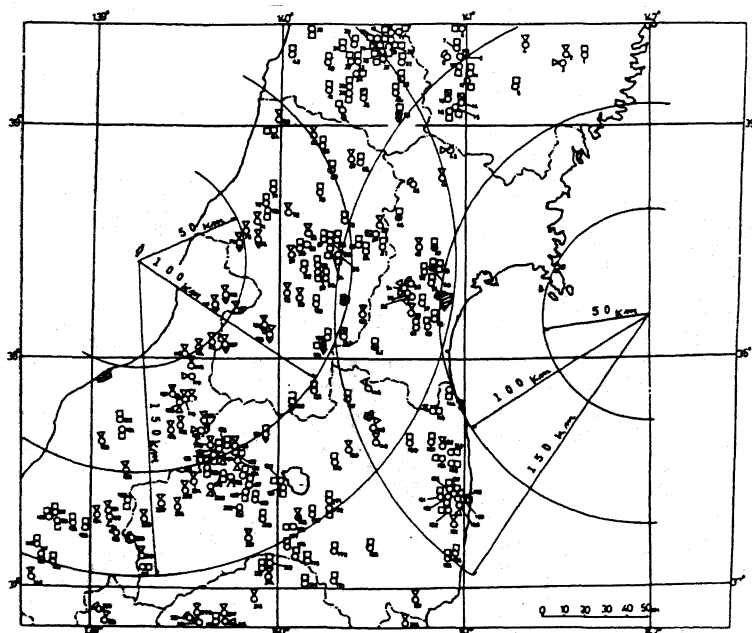
Fig. 5 shows the locations, types and whether or not damage was suffered with regard to dams (as of 1978) 15 m or higher in an area approximately 150 km north and south of the epicenters of the Miyagi-ken-oki and Niigata earthquakes. The marks  $\circ$  and  $\bullet$  in the figure indicate locations of dams with the latter denoting changes or damage occurring in the Miyagi-ken-oki Earthquake. The mark  $\blacktriangle$  denotes change or damage occurring in the Niigata Earthquake. The marks  $\nabla$ ,  $\nabla$ ,  $\square$ ,  $\square$ ,  $\triangle$  and  $\triangle$  indicate dam types, they being concrete gravity dam, hollow concrete gravity dam, fill dam, combination of fill dam and concrete dam, arch dam, and multiple arch dam, respectively.

In the case of the Miyagi-ken-oki Earthquake, there were no dams within a radius of 100 km from the aftershock area center. The only dam suffering real damage to its body was a 24-m high earth dam at a distance of 160 km, with damage at other dams being slight such as temporary increase in leakage.

At the time of the Niigata Earthquake, concrete gravity dams of height 15 m or more located within a radius of 100 km from the aftershock area center were those listed in Table 2, and these were designed with  $k_H$  as 0.12. As shown in the table, changes occurred at three dams all of which had heights of 40 m or more. Of these three, the dams No. 110 and No. 76 indicated temporary changes in leakage. At No. 111, leakage from grout pipes occurred, and further, there was leakage from joints of blocks and repair works were carried out to stop the water. Changes occurred at dams other than these three in the Niigata Earthquake, but all were of the
