ON THE DAMAGE AND CAUTION TO WOODEN HOUSES
BY RECENT EARTHQUAKES IN JAPAN

Gorozo Iizuka^(I)

SUMMARY

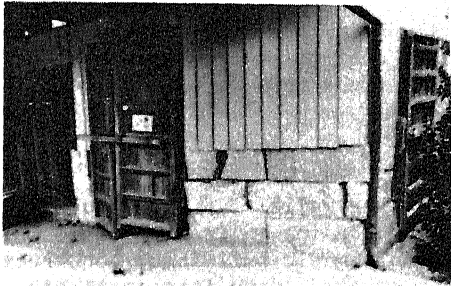
Foundation An adequate construction of the foundation of a building can be effective to reduce damage of the upper structure in the case of earthquakes. From this point of view, foundations made of stone or concrete-block are not desirable even for wooden houses, because they loosen during an earthquake as shown in Photo.1. Continuous concrete foundations are apparently useful, among which the reinforced concrete foundation beam is the most preferable.

Photo.1 Tree layers of tuffaceous stone was apparently disadvantageous against earthquake.

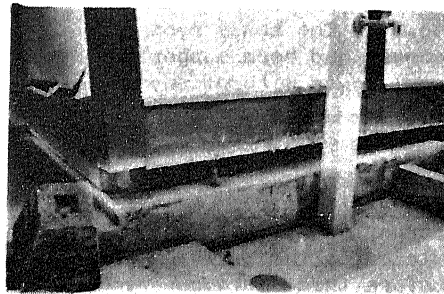
Photo.2 An anchorbolt was not nutted up to the sill due to lack of its projection. The sill lifted up.

It should also be noticed that, an anchorbolt has to resist not only against base shear but also turn over of the building caused by the earthquake(Photo.2).

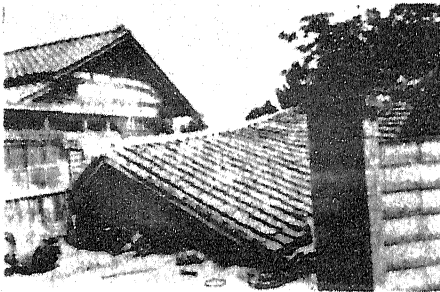
Roof tile is the most preferable material not only for architectural design but for other performances as well as the status symbol of a conventional Japanese residence. However, the only disadvantage of this material is to make a building at the top, and instable in the case of earthquake as shown in Photo.3. It weighs 2 to 4 times more than other roofing materials, and the center of gravity in a house of tiled roof is estimated 20-25 % higher than that of metal roof.⁽¹⁾ One of the solutions for this conflict is, for instance, to use lighter material such as metal sheet shaped like clay tile.

Photo.3 The heavy roof of this warehouse had been supported by several posts without any wall.

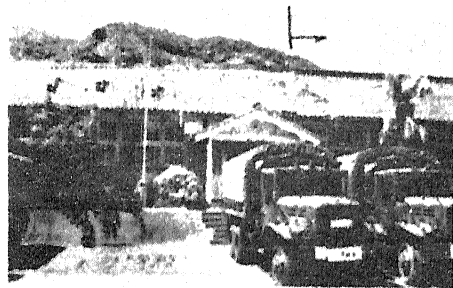
Stability of the roof tiles during earthquake is closely concerned with the rigidity of the roof trusses, purlins, as well as rafters(Photo.4). To avoid severe vibration of the roof during the event, bracings in vertical and horizontal plane among roof trusses are necessary.

Photo.4 Remarkable difference of the damage of roof tiles is caused by the rigidity of the roof structure.

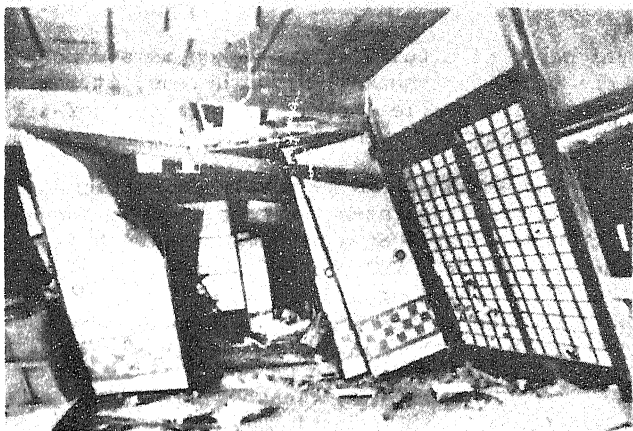
(1) Lack of the necessary shear bearing walls or of the 'in-plane' rigidity of a frame. Especially, the absence of effective structural partitions in a house is apparently disadvantageous for lateral forces.(Photo 5.)

Photo.5. Scarcely any useful wall can be seen inside of this house. Lintels and hangwalls were helpless to avoid large inclination.

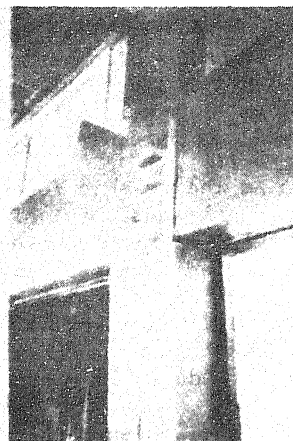
Photo.6. Zig-zag crack at the notch of the column

Traditional construction and contemporary improvements In the case of a Japanese traditional (or conventional) houses, bearing walls are scarce by its nature. Intergration of outdoor and indoor life is a character of the nation. Resisting mechanism of such an instable building is that, posts and deep beams are consisting an imperfect rahmen frames. Adding to this reason, the role of the lower tie among columns (Ashigatame) should be emphasized. To ensure this mechanism, columns should be large enough in cross-section, which can not always be expected in contemporary wooden houses.(Photo. 6.)

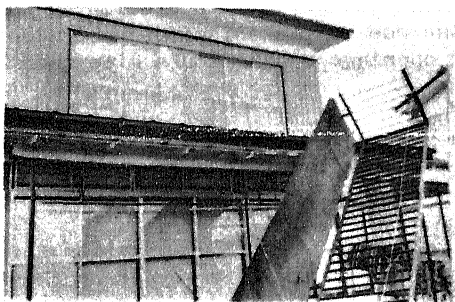
As the seismic force applied to an object is generally proportional to its weight, each part of a building receives lateral forces in accordance with its weight. Consequently, heavier parts of a building should be constructed stronger than lighter elements. Injuries of unexpected parts of a building sometimes are caused by behinding the above mentioned principle. Examples which could be seen in the recent earthquakes are the rain-shutter box, the steel balcony(Photo.7), as well as the thick tiled wall introduced in Photo.8.

Photo.7. A steel balcony tumbled off the upstairs. It had been screwed only to the wall upstairs.

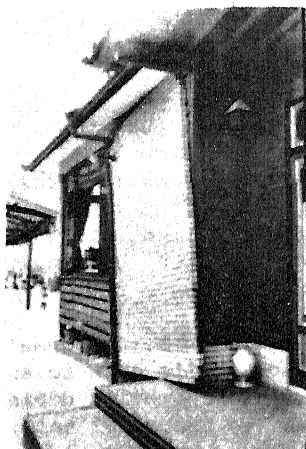
Photo.8. A tiled wall slipped out due to the poor connection to the sheathing.....
