ENGINEERING IMPLICATIONS OF THE BUCHAREST COMPUTING CENTER COLLAPSE

Glen V. Berg (I)

SUMMARY

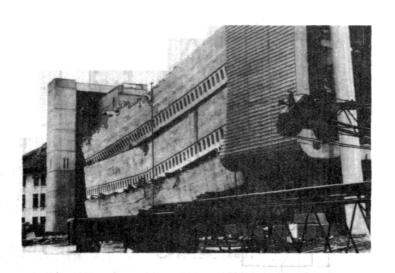
Fig. 2. Collapsed building.

The computing center was a three-story reinforced concrete structure of striking architectural design. Fig. 1 shows the building before the earthquake. It was a flat plate building with service towers at either end housing the stairwells, elevators, etc., and a main building in between. The central building was structurally separated from the service towers. The service towers remained intact, but the central building collapsed, as shown in Fig. 2.

The third factor, and the most crucial, was the lack of a second line of defense. Once a column failed, there was no other structural component to come to the rescue. A second line of defense is not mandated by any building code of which I am aware. The ATC-3 recommendations address the issue in a provision for non-redundant systems which provides "The design of a building shall consider the potentially adverse effect that the failure of a single member, connection, or component would have on the stability of the building and appropriate design modifications shall be made to mitigate this effect."

In a sense, the Bucharest computing center was an extreme example of the soft ground story—a source of much grief in one earthquake after another. We ought now seriously to consider our building codes in the light of this disaster and decide whether earthquake engineering is well served by continuing the double bonus our codes now offer as an incentive for selecting flexible, unbraced structural systems.
