DAMAGE ANALYSIS OF OIL STORAGE TANKS FOR
OFF MIYAGI PREFECTURE EARTHQUAKE OF JUNE 12, 1978

by S. Yamada^I, T. Oda^{II}, K. Yoshida^{III}, S. Yamamoto^{IV}, K. Kawano^V, T. Shibuya^I

SUMMARY

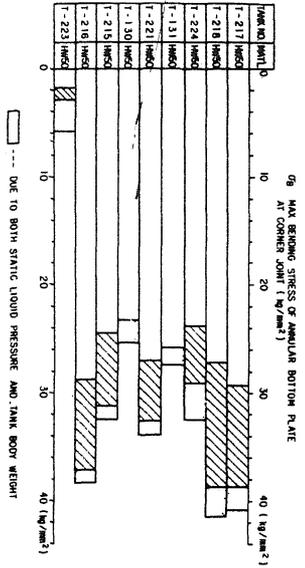
Fig.1 Bending Stress at Annular Bottom Plate Joint owing to Static Liquid Pressure, Tank Body Weight, Thermal Load and Circumferential Uneven Settlement just before Earthquake

- 1) The bending stresses just before the main shock at the annular bottom plate perimeter joint of the nine tanks analyzed for various loads were as shown in Fig. 1. It can be seen that the range of maximum bending stress analyzed in the annular bottom plate at the joint with the shell plate of each tank was predicted to be 24 thru 42 kg/mm², except for tank T-223 which had a low level of contents. From this, with the exception of tank T-223, it can be said that the stress amplitude for loads and conditions such as uneven settlement and thermal stress is rather small compared with stresses caused by static liquid pressure plus the tank body weight.

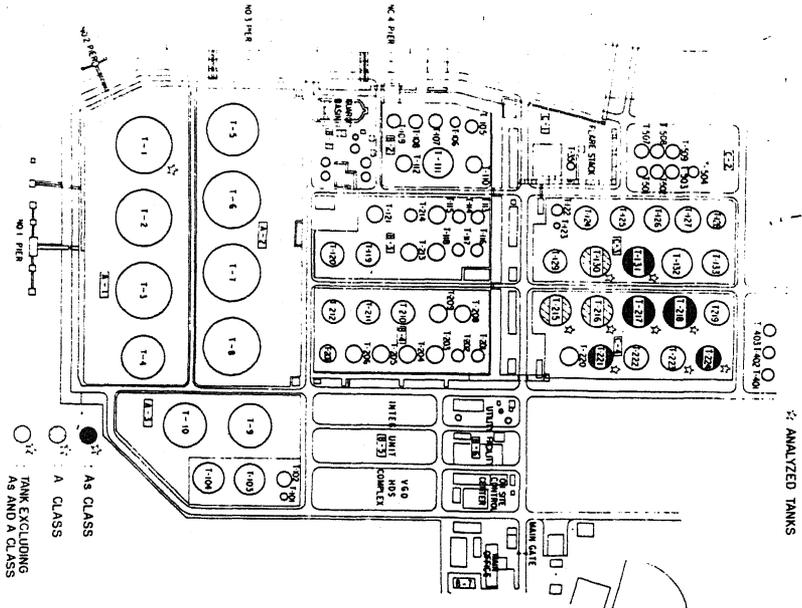
Fig.3 Tanks with High Tensile Steel HW50 Annular Bottom Plate and classified as As and A Classes, considering Corrosion of Annular Bottom Plate

- 2) The maximum stress and the maximum stress range under seismic conditions at the annular bottom plate at the joint with the shell plate have the relationship shown in Fig. 2. These results are mapped in the plot plan of the refinery as shown in Fig. 3. The A_S class in the figure are defined as those with maximum stress (σ_B) exceeding the yield stress (σ_y) and the maximum stress range ($\Delta\sigma_B$) exceeding twice the yield stress under seismic load conditions. The A class are defined as those with maximum stress exceeding the yield stress and the maximum stress range not exceeding twice the yield stress.

- 1) The possibility of abnormal characteristics in response and amplification against the earthquake in the C-3 and C-4 areas where the damaged tanks were concentrated as shown in Fig. 3 were studied by response analyses on the basis of data obtained from physical tests made on the site. However, it was found that no abnormal ground motion attacked these areas.

- 5) Stress analyses were performed by assuming an input horizontal acceleration of 0.3 G, referring to the acceleration recorded during the earthquake on the ground surface near the refinery. The results revealed that the tanks that were damaged, T-217, T-218, and T-224, and the tanks that developed penetrated cracks, T-131, and T-221, were classified as A_s class, defined as those with both maximum stress exceeding

yield stress ($\bar{\sigma}_y = 50 \text{ kg/mm}^2$) and maximum stress range exceeding twice the yield stress under seismic load conditions. The main reason that calculations for these tanks resulted in high stress values is considerations were made for corrosion in the annular bottom plate.

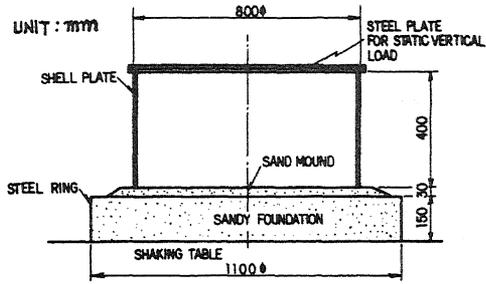
Fig. 4 Tank Model for Shaking

- 3) To study the phenomena of tank settlement under ground motion, model tanks placed on sand mounds were shaken on a shaking table as shown in Fig. 4. It was observed that the tank shell bottom settled quickly into the sand mound along the perimeter uniformly as shown in Photo. 1 when horizontal acceleration reached some critical value. Also, it was observed that the critical value became smaller as the static vertical load at the tank shell bottom became larger, and that as the distance between the tank shell and the outer edge of the sand mound became shorter, the settlement occurred easier. Qualitatively, this explains the reason why tank settlement occurred along the perimeter during the earthquake.
