DAMAGES OF OIL STORAGE TANKS FOR
OFF MIYAGI PREFECTURE EARTHQUAKE OF JUNE 12, 1978

SUMMARY

This report presents the investigation of the damages caused to the oil storage tanks by the Off Miyagi Prefecture Earthquake of June 12, 1978. As a result of the investigation, the damages of the oil storage tanks were classified into the following five basic categories:

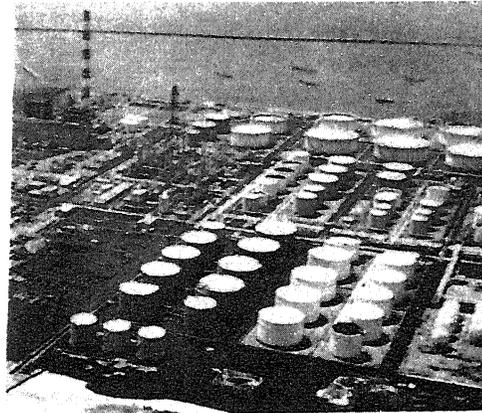
These tanks failed at the annular bottom plate along the inside fillet weld toe at the corner joint with the shell plate as shown in Photo. 2 and Fig.3, and the contents flowed out and covered the refinery area as shown in Photo. 1. Measurements made of the annular bottom plate thickness after the earthquake revealed that the thickness of the annular bottom plates in these tanks decreased by corrosion.

Photo.1 Oil Spill from Three Damaged Tanks Covering Site of Tohoku Oil Sendai Refinery

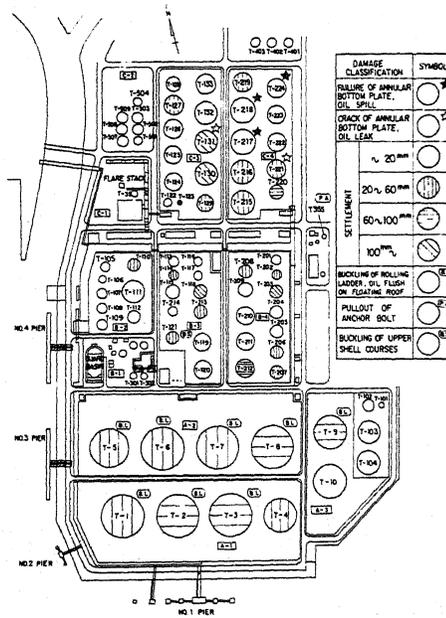
The layout of the cylindrical steel tanks in the Tohoku Oil Sendai Refinery and the damages are as shown in Fig. 2. Typical features of the damage are as follows:

These tanks settled an average of about from 100 mm to 140 mm along the perimeter similar to the settlement shown in Photo. 3. Also, because of the settlement, the annular bottom plate deformed so much that an acute angle was formed with the shell plate as shown in Fig. 4. In addition to these tanks, T-118 and T-203 (11,300 Kl) settled an average of more than 100 mm along the perimeter as shown in Fig. 2.

Fig. 2 Plot Plan of Oil Storage Tanks in Tohoku Oil Sendai Refinery

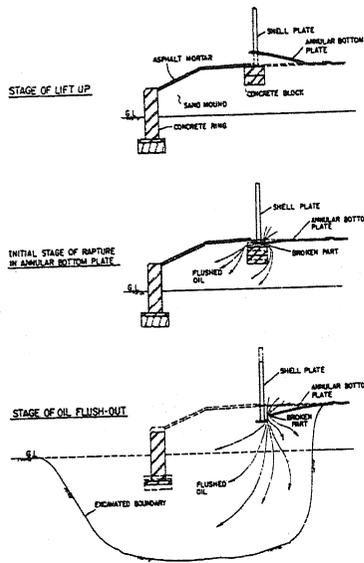
Fig. 3 Damage of Annular Bottom Plate (Tanks T-217, T-218 and T-224)

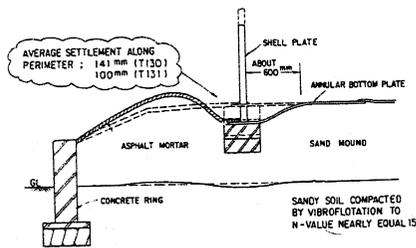
Fig. 4 Feature of Settlement (Tanks T-130 and T-131)
