ANALYSIS OF INSTRUMENTAL AND MACROSEISMIC
OBSERVATIONS OF BUILDING BEHAVIOUR IN
ZHALANASH-TIUP EARTHQUAKE, MARCH 25, 1978

Zhunosov T.Zh., Vypriazhkin Yu.A.,
Boochatskiy E.G.

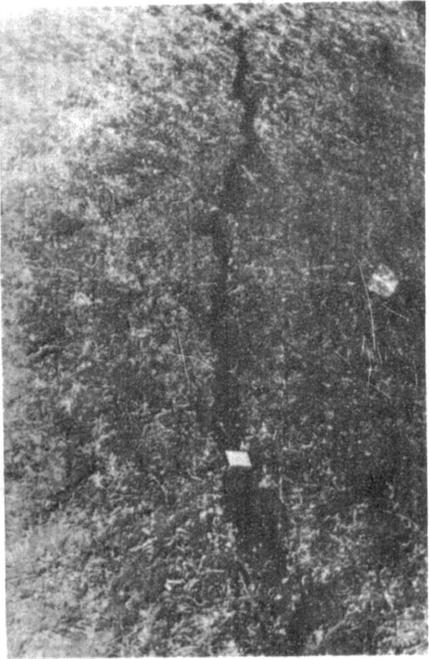
Figure 1

To evaluate the earthquake intensity, statistical processing of the macroseismic damage observation data on different-type buildings was carried out on the basis of the MSK-64 scale [1]. The earthquake intensity depended on the area relief. In Toghuz-Bulak dwellings on hills were maximally damaged, and numerous ground cracks opened up to 15cm in width (Fig.1). The widths of crack openings in some building foundations were the same of those in the ground.

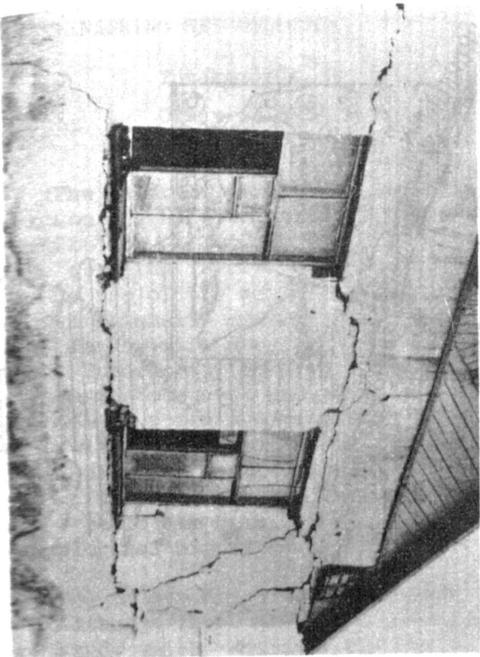
Figure 3

Buildings of the second subgroup had timber or reinforced-concrete floors. Most of them got series damages corresponding to degree III and in individual cases to degree IV. For instance, the obstetrical dispensary building got damages of degree IV (Fig.3): numerous widely-open through cracks formed in the walls; the building corner bulged from the wall plane; some longitudinal walls were broken away from cross-walls; floor slabs displaced 5cm relative to the walls. The building was considered to be unfit for service.
