# DAMAGE TO PORT STRUCTURES BY THE 1978 MIYAGI-KEN-OKI EARTHQUAKE

Setsuo NODA<sup>I</sup> and Satoshi HAYASHI<sup>II</sup>

## SUMMARY

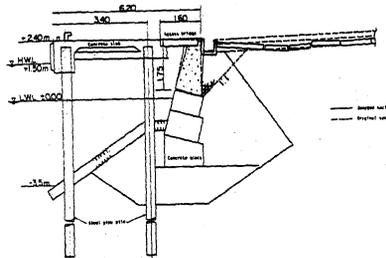
F-9 Yuriage -3.5m Wharf

except the retaining wall behind the wharves. Fig. 9 shows the -3.5 m Wharf in Yuriage fishing port, which had been constructed in front of the gravity quaywall. It was supposed that the steel pipe pile resisted against the horizontal force through the access bridge during the earthquake. The same state happened at Ohte Wharf in Ishinomaki port. Judging from these facts, it was confirmed again that the steel pipe piled wharf was very tough against earthquakes.

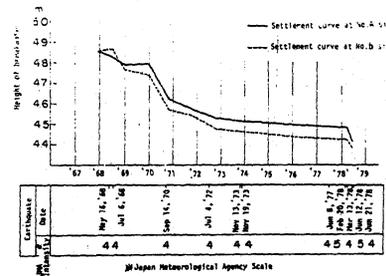
F-11 Settlement Curves of Breakwater

A 38 meter high composite breakwater consisting of a rubblestone mound and concrete caissons in Fig. 10 was subjected to strong ground motions during the earthquake. Maximum accelerations of 350 Gals and 170 Gals were recorded at the crest and on the rock foundation, respectively. As this breakwater was made to protect the port against tsunami, 0.2 of seismic coefficient for stability of concrete caisson was applied and 0.1~0.2 for rubblestone mound in due consideration of the dynamic behavior of the structure. According to the settlement curves of the crown in Fig. 11, it was suffered 5~7 cm of very slight settlement by this earthquake but did not lose its function.
