THE FEBRUARY 4, 1976 EARTHQUAKE IN GUATEMALA CITY AND
VICINITY: ENGINEERING FIELD REPORT

RAUL HUSID^I

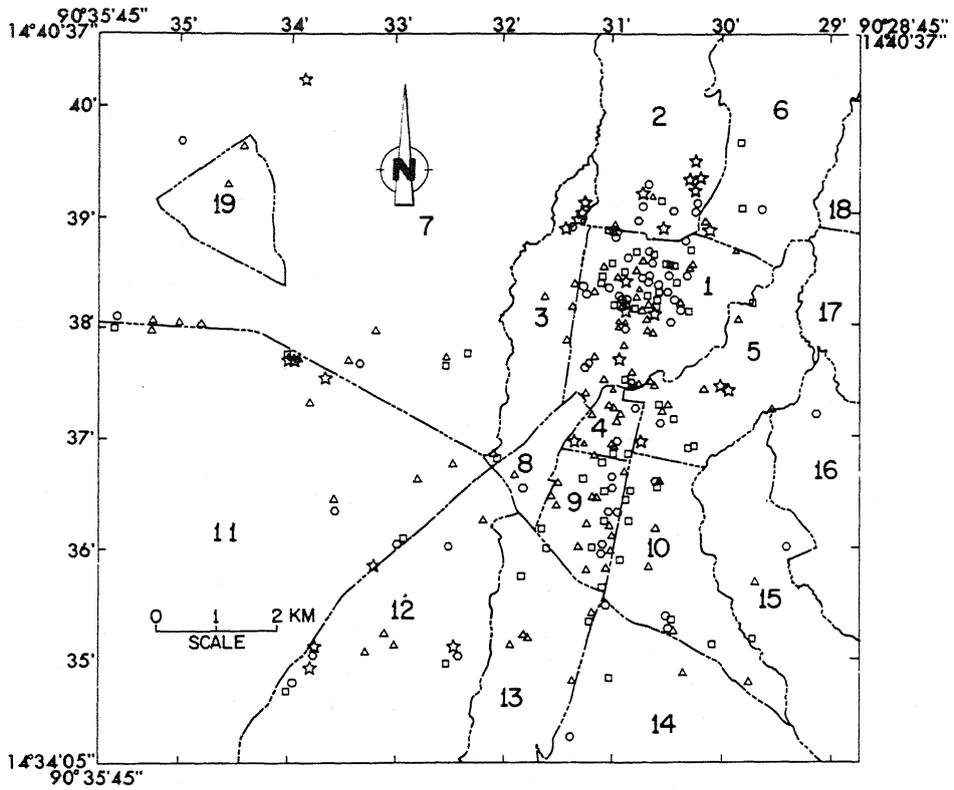
FIGURE 1
INDIVIDUAL DAMAGE RATIO MAP FOR GUATEMALA CITY

Figure 1 shows a map of Guatemala City and D. R.'s for more than 260 individual structures, using a uniform five-point damage scale. The damage estimated from individual D.R.'s and from the MMI's do not show a good agreement.

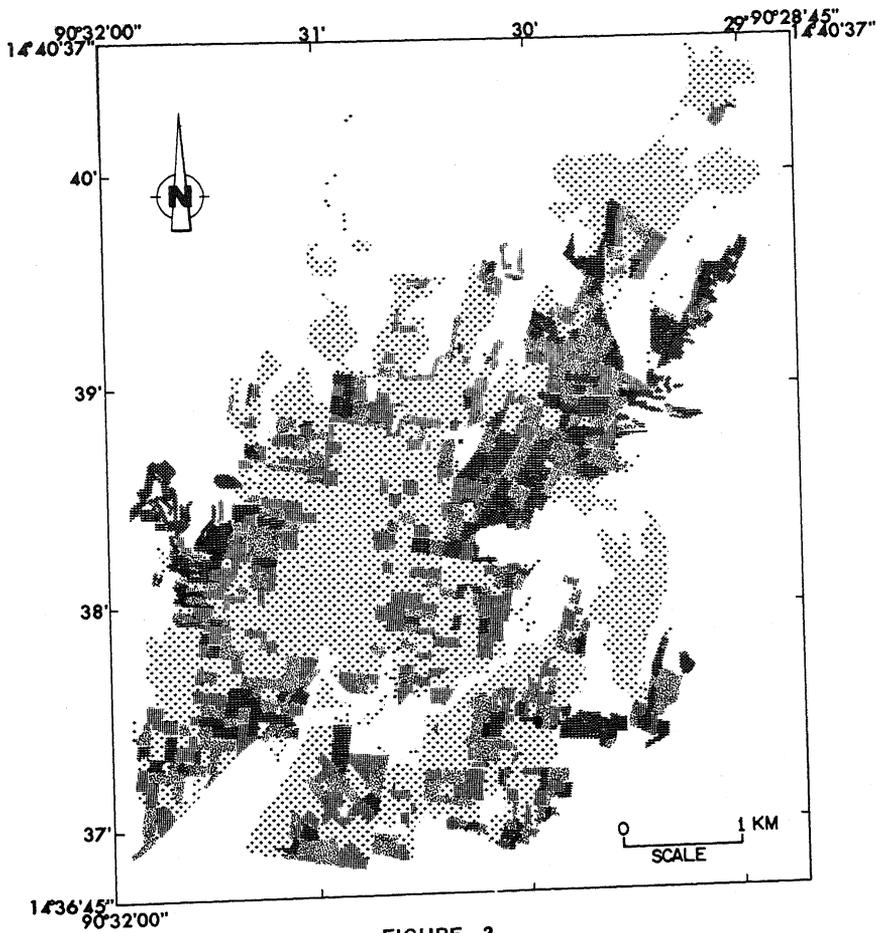
FIGURE 2

Fig. 2 shows a detailed block-by-block distribution of average D.R.'s

DETAILED AVERAGE DAMAGE RATIO MAP FOR ZONES 1 THROUGH 6 FOR GUATEMALA CITY

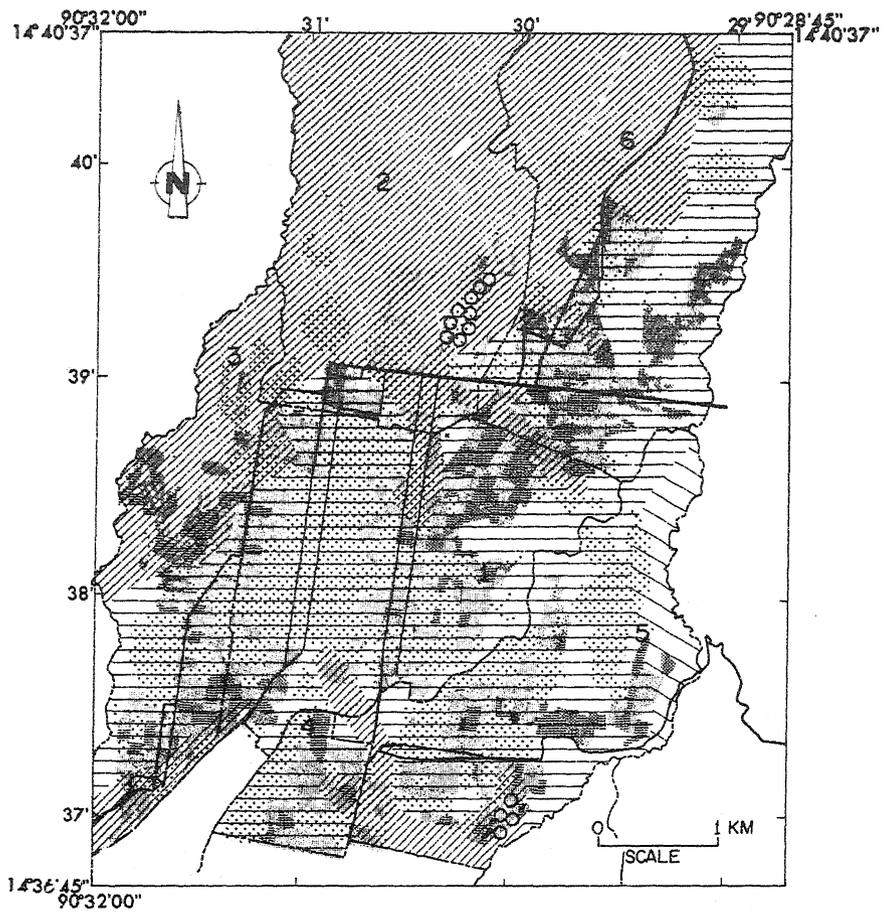
FIGURE 3
 DETAILED AVERAGE DAMAGE RATIO MAP & INTENSITY DISTRIBUTION
 FOR ZONES 1 THROUGH 6 FOR GUATEMALA CITY

for six zones in Guatemala City. Fig. 3 gives the same information superimposed on the MMI map.

Differences between the damage estimated from D.R.'s and the MMI's are obvious from Fig. 3. The Intensity map appears to be rather generalized in its representation of damage and is, in some cases, in conflict with the D.R. map. As an example, Zone 1 was assigned predominantly intensity VII; and Zone 2, predominantly intensity VIII. The D.R. data yield a larger number of adobe buildings with D.R.'s > 0.80 in Zone 1 than in Zone 2.

The results of this investigation clearly show that in urban areas particularly, where significant building damage occurs, intensities should be carefully assigned on the basis of the best damage-survey information available. Estimation of damage ratios for individual buildings is recommended when time and personnel for the task are available, because information of this type greatly improves the data base for the determination of damage versus intensity-of-ground-shaking relations used in earthquake-loss studies.
