EARTHQUAKE IN THE "SCHWÄBISCHE ALB"/GERMANY
SEPTEMBER 3, 1978

Dr. Max Hintergräber, Axel Jungmann
Kraftwerk Union AG, Erlangen, Germany

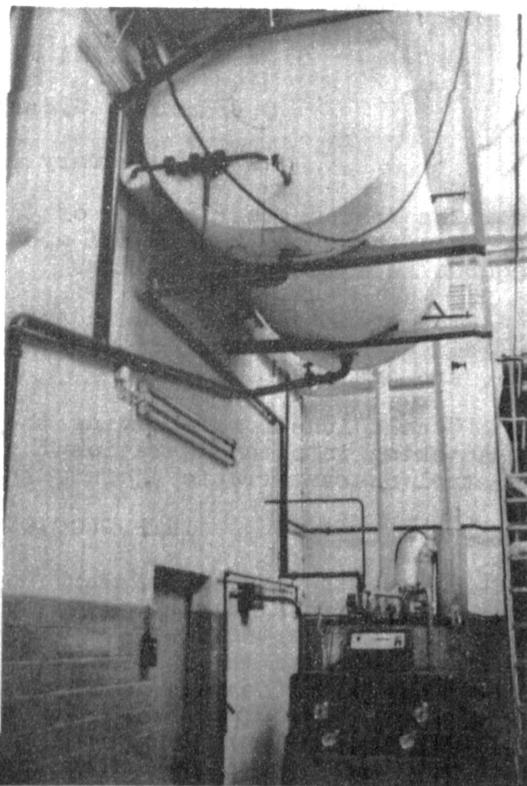
Fig. 1
Feedwater tank

Representing the characteristics of the effects to mechanical components one example is given in Fig. 1 and 2. The water-filled vessel which is mounted on a sectional

steel frame approx. 4 m above the floor remained undamaged (picture 1) although the piping was rigidly connected to the building wall. At the points where both the horizontal steel sections are embedded in the wall it can be seen that the mortar has been loosened from the wall. In this case the filling of the mounting holes with mortar was the only fortuitous measure for taking horizontal forces. Features which would have implied possible movements of the vessel are not to be recognized. Likewise the connected lines remained unimpaired.

Undamaged components
in the same building
(situated 3 km far
from the epicentre)

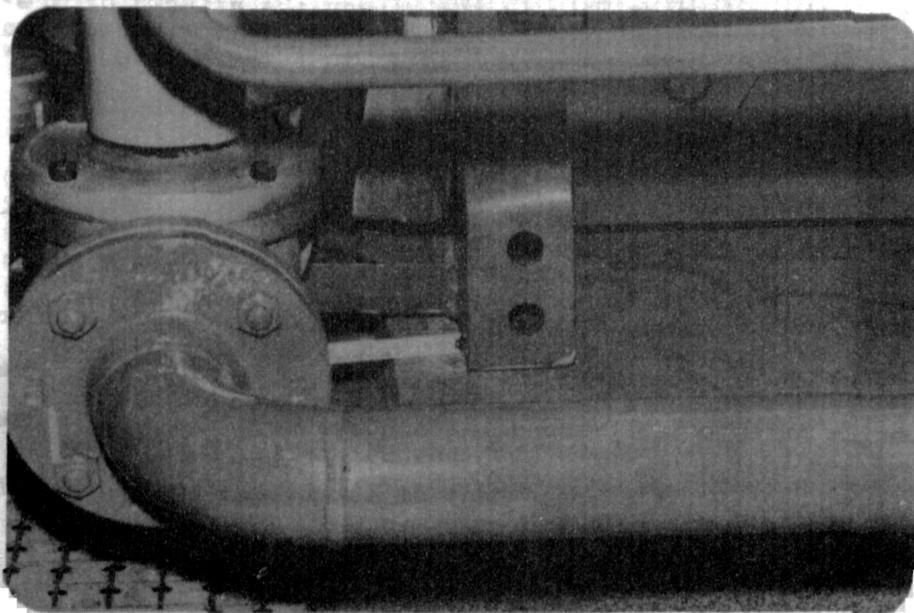
In the same boiler house which has been considerably damaged the heating boiler is installed. The boiler itself has an operating weight of approx. 33 t and an operating pressure of 12 bar. During the earthquake the plant was not in operation.

The support of the boiler (Fig. 2) consists of an approximately 10 cm high concrete base on which the boiler stands without any mounting arrangement. An anchor or device against horizontal or vertical forces is not present.

The boiler was displaced 2.5 cm in one direction as a result of the earthquake stresses (Fig. 2). Damage which would have impaired the functionability of the plant in some way or other (e.g. flange leakages etc.) had not occurred. Neither could any effects be established on the flanged burner of the boiler which represents the largest excentric mass of the vessel.

Fig. 2
Heating boiler (30 Mp)
foundation displace-
ment of 2.5 cm
