DAMAGE OF REINFORCED PRECAST CONCRETE PILES
DURING THE MIYAGIKEN-OKI EARTHQUAKE OF JUNE 12, 1978

Hideaki KISHIDA^I
Toshikazu HANAZATO^{II}
Shoichi NAKAI^{III}

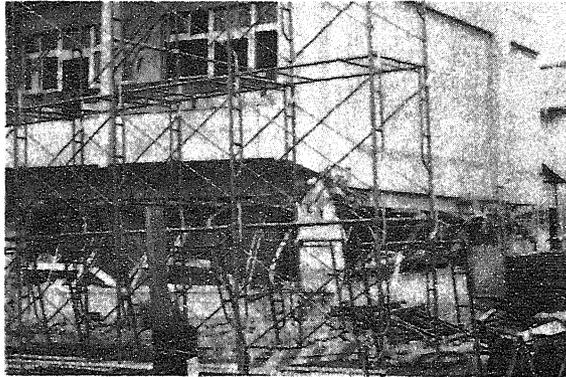
Fig. 1 The collapsed Maruyoshi building

The Maruyoshi building was a reinforced three-storied building located at Oroshi-machi of Sendai City. The superstructure of the building was collapsed as shown in Fig. 1. After the collapsed superstructure was removed, the foundation beams and pile caps were investigated. Some cracks were observed at the foundation beams and the typical one is shown in Fig. 2. The location of the observed cracks are shown in Fig. 3. Based on the results of the observation, the excavation of the piled foundation was carried out to investigate the damage of the pile shafts. Plan of the pile caps, foundation beams and location of piles are also shown in Fig. 3.

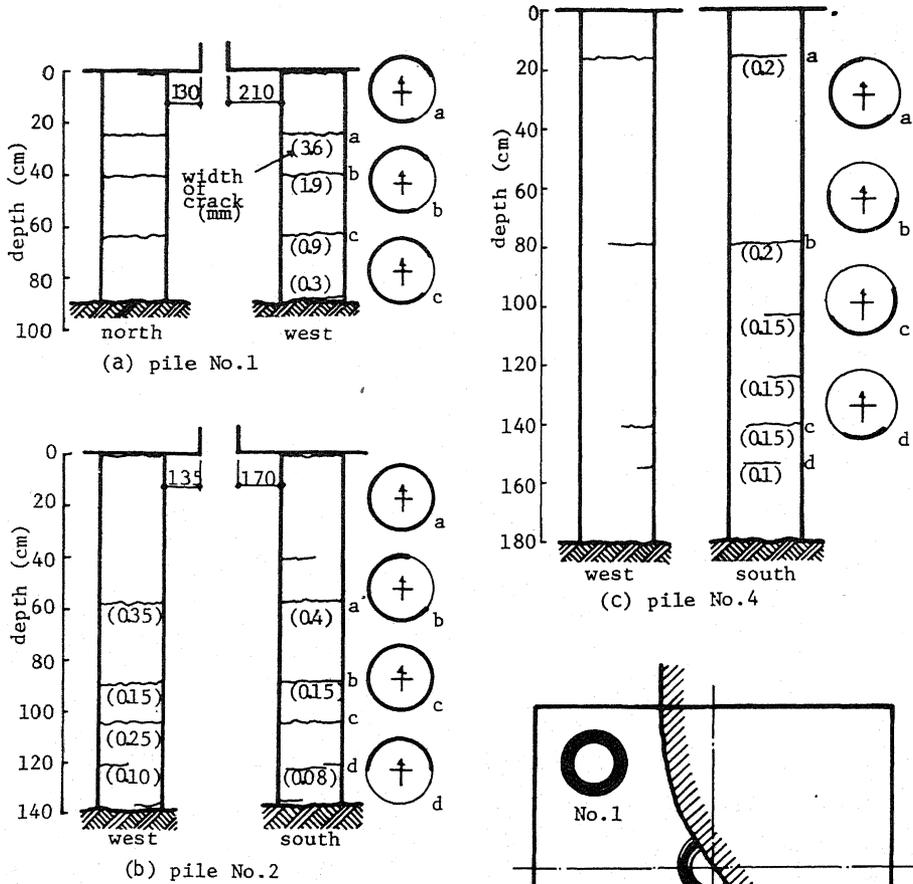
Fig. 7 Details of cracks in the pile shafts

Cracks were found at the pile shafts of the all observed piles, and the close up view of the pile shaft of No. 1 pile is given in Fig. 6 indicating visible cracks. The width and location of cracks in No. 1, No. 2 and No. 3 piles are shown in Fig. 7. All cracks occurred in a circumferential direction of the pile shafts, and no cracks were found in a diagonal direction of the pile shafts.

These piles were driven piles, and tensile stresses might caused the cracks at the pile shaft. The cracks due to tensile stresses usually occurs at an overall circumference of the pile shaft. The places of cracks at the circumference of one pile shaft were brought together at one plane.

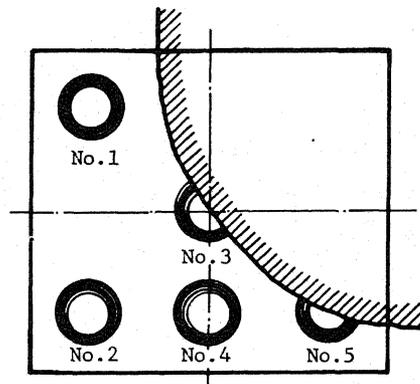
Fig. 8 Position of all cracks in the observed five piles

The position of all cracks in the observed five piles were marked in black color as can be seen in Fig. 8.

The time of occurrence of the cracks were checked by investigating the neutralization of the concrete in the pile shaft using phenolphthalein. The result indicated that these cracks did not occur during pile driving. Considering the position of cracks in Fig. 8 and the phenolphthalein test results, these cracks seemed to occur during the earthquake.

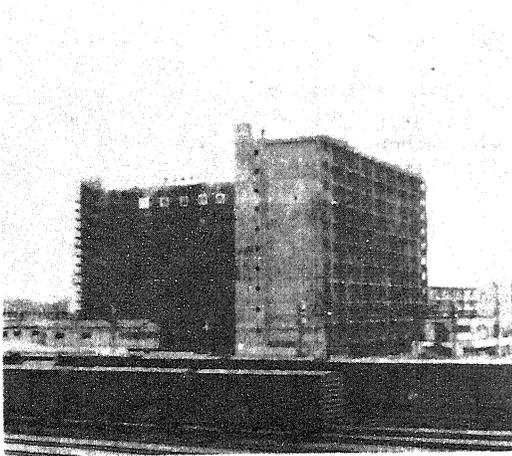
Fig. 9 The Sendai municipal apartment house

The autoclaved high strength concrete piles caused a severe damage at the Sendai municipal apartment house. The eleven-storied superstructure shown in Fig. 9 tilted and the piles were completely crushed as can be seen in Fig. 10. The detailed report of the damage of the piled foundation and the reconstruction of the apartment house is published in Nikkei architecture (1979).

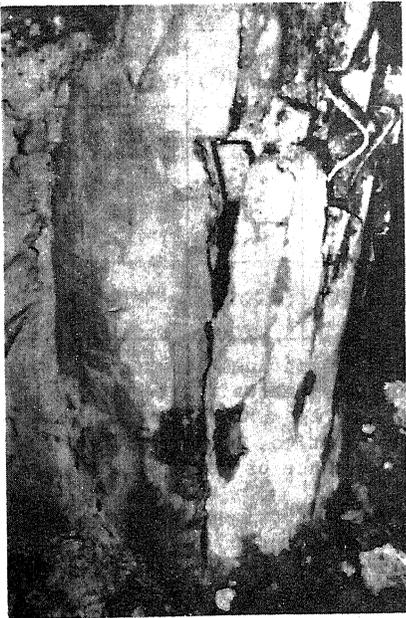
Fig. 10 Crush of the autoclaved high strength concrete piles

The principal features of the damaged pile are the followings: (1) the materials of the pile shaft are reinforced precast and/or prestressed concrete piles, (2) the cracks due to bending moment are found at the pile shaft, and (3) the material of the heavily damaged pile is autoclaved high strength concrete having little ductility.

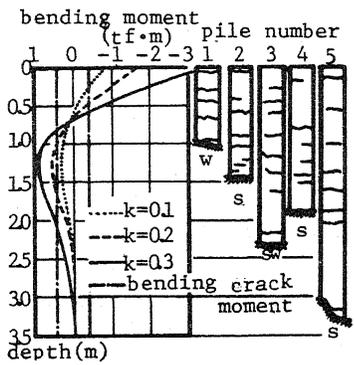
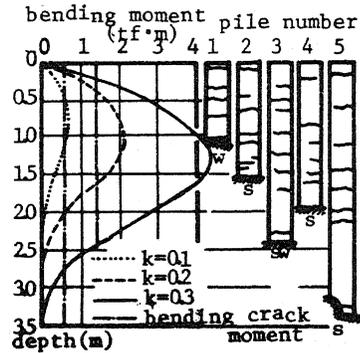
Fig. 12 Calculated bending moment and observed cracks at the pile shaft

Based on the proposed method by the authors (1977), the bending moment occurred at the pile shaft were calculated applying the horizontal load at the top of the pile. The vertical design load is 20 tf per a pile, and three horizontal loads that are 2 tf, 4 tf and 6 tf were used for calculation. These loads are equal to 0.1 ($k = 0.1$), 0.2 ($k = 0.2$) and 0.3 ($k = 0.3$) times the vertical design load respectively. The maximum horizontal acceleration at the site seemed to be about 300 gals, and the bending moment calculated by the horizontal load of $k = 0.3$ seems to be approximately equal to the one occurred during the earthquake.

The calculated and the investigated results are shown in Fig. 12, in which the broken line means the bending crack moment (0.44 tf-m) of the pile shaft. In Fig. 12, the most of the observed cracks are placed at the part of the pile shaft where the calculated bending moments for horizontal load of $k = 0.3$ are more than the bending crack moment of the pile shaft. Fig. 12 also indicates that the calculated bending moment for horizontal load of $k = 0.1$ are less than the bending crack moment of the pile shaft.

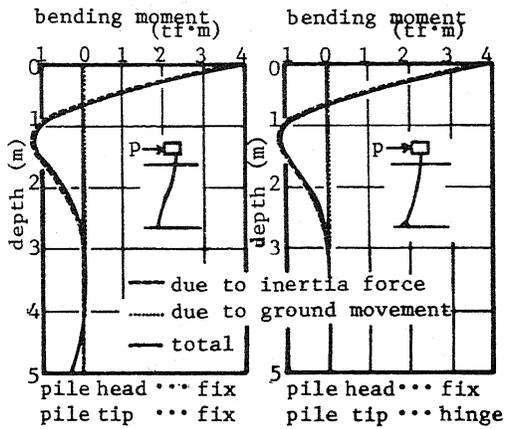
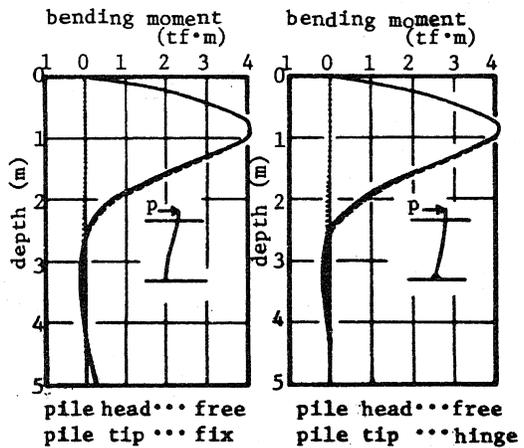
Fig. 13 Calculated moment referring to ground movement

The fundamental period of the ground was assumed to be 0.2 sec. The bending moment at the pile shaft caused by the forced deformation of the pile shaft was calculated assuming the linear spring connection between the pile shaft and the ground. The calculated results indicates that the moment caused by the ground movement are much smaller than the moment caused by the inertia force of the superstructure as can be seen in Fig. 13.

acceleration of ground surface = 300gal
 displacement of ground surface = 0.39cm
 inertia force at pile head P = 6 tf
