THE CHARACTERISTICS AND ANALYSIS OF DAMAGES OF SINGLE STOREY
R.C. INDUSTRIAL BUILDINGS DURING THE TANGSHAN EARTHQUAKE

Wang Zuang Sun^I Ju Ming Chuan^{II}
Chen Zhong^{III} Tung Wei Ming^{II}

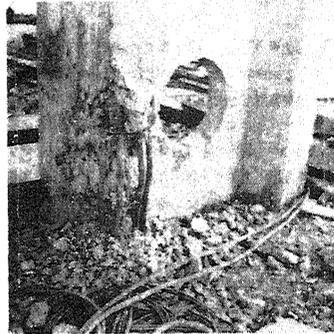
Photo 2

Generally, columns are stepped in factory buildings for travelling of the overhead crane. The main members for resisting lateral seismic load are these columns in single storey factory buildings. Except at 11° intensity, for few such buildings with heavy roof construction, breakage appears on the bottom portion of these columns. For the rest intensities, damages are not very serious. From 8° up, 0.2mm residue visible cracks appear on bottoms of the columns with their widths increase with the intensity. Based upon tests made on models, if ductility factor, μ , lies between 2 and 3, the width of the residue cracks is about 0.1—0.2mm. It is deduced that in the 8° intensity regions, seismic force acting on the columns might exceed its yielding strength. In 10° intensity regions, owing to unreasonable arrangement of column bracings, columns of a few buildings are damaged seriously with their main reinforcement buckling, protecting cover of concrete spalling off (Photo 2).

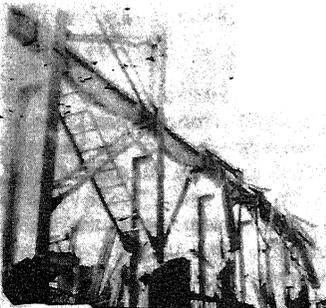
Damage often occur seriously at the junction where stepped columns change their sectional areas. Statistics shows that whenever inertia of the upper section differs the lower section by more than 5 times, damage would occur and would be on the increase with the ratio. Photo 3 shows a typical example of certain factory building with columns broken on its upper section. Owing to the fact that a crane of heavy class is provided in that factory, inertial of the lower section is made 10 more times than its upper. Calculation shows that under horizontal seismic load, yielding strength of the lower section is 2 more times more than its upper, thus bottom of the upper section arrived at the plastic stage earlier during earthquake. Thus, ductility of the whole building is decreased, causing downfall of the roof. Damages on the junction between spans with different heights are caused by the

higher mode of vibration during earthquake. Analysis has been made on 204 buildings with spans of different heights. Results show the larger the difference in height, the higher the internal stress induced by the higher mode, which coincides basically with the marco damages observed.

5. Strength and ductility of the columns should be carefully enhanced, especially the junction between stepped columns. Moreover, junction between high and low spans should be carefully designed, where stepped columns are to be used.

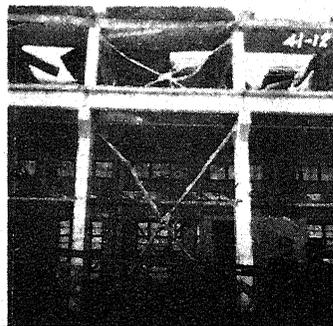
Photo 4

Bracings between columns are the important members to withstand longitudinal seismic load. From 8° on, various signs of damages appeared on them (Photo 4). Analysis indicates that whenever buckling appeared on those cross bracings made by steel angles after earthquake, the bracings worked in the elastic-plastic stage with a ductility factor of about 3-4. Moreover, observation on large amount of earthquake damages shows that if cross bracings between columns are made strong, generally, serious damages would happen on the joints. On the other hand, if the bracings are not strong, buckling would happen on themselves.
