PROGRESS REPORT OF RESEARCH WORKS IN BRIDGE EARTHQUAKE ENGINEERING
AT THE PUBLIC WORKS RESEARCH INSTITUTE, JAPAN

Eiichi KURIBAYASHI^I and Toshio IWASAKI^{II}

SUMMARY

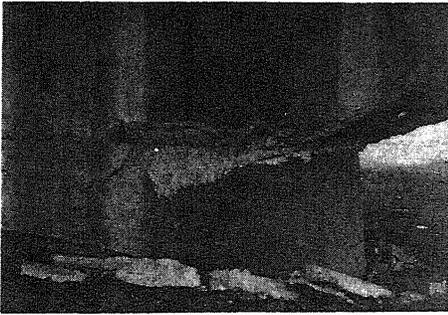
Due to the earthquake (the epicentral distance to the bridge is $\Delta = 120$ km), all of the nine pier columns sustained damages. Piers 1 through 4 cracked horizontally at the column bases and surface concrete pieces separated heavily from the columns near the bases. Piers 5 through 8 had similar damages near the haunches which connect columns and beams. Pier 6 which has the lowest free height sustained the severest cracking at both sides (see Fig. 6). Concrete pieces separated at the haunch and reinforcing bars buckled. Near the haunch number of reinforcing bars as well as concrete sectional area change rapidly.

Fig. 6 Failure of Pier 6, Sendai Bridge

5) In view of the damages to pier columns at Sendai and Yuriage Bridges which were recently constructed according to the current specifications, it is recommended to consider ductility of pier columns when designing short reinforced concrete columns. In this respect further experimental and analytical researches are necessitated, and seismic specifications should include an appropriate regulation on ductility of columns.

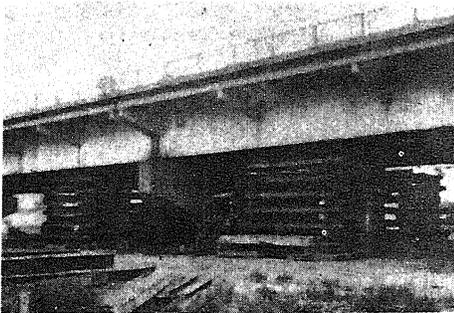
Fig. 7 Temporary Frame Supporting Girders near Pier 6, Sendai Bridge

Fig. 7 shows temporary frame works supporting the girders near Pier 6. Since the bridge is very important, damaged piers were repaired without stopping traffic even for a short time. Fig. 8 illustrates an example of permanent repairing work at Pier 6. The thickness of added concrete was 50 to 70 cm, and vertical reinforcing bars were fixed by epoxy adhesive into the well foundation and lateral bars were fixed to the columns. Moreover, chemical resin was placed into small cracks. It took only one month to

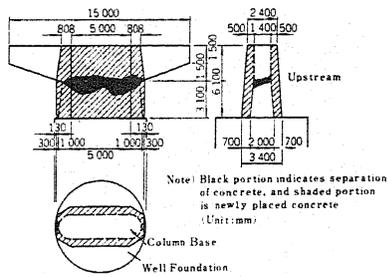
Fig. 8 Damage and Repair Work of Pier 6, Sendai Bridge

completely repair the all damages to this bridge.

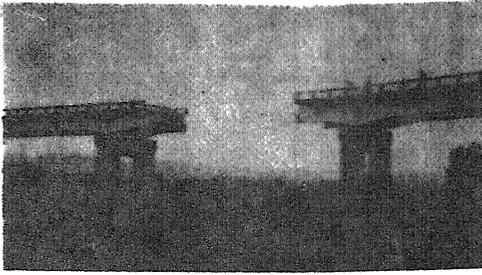
Kin-noh Bridge — Kin-noh Bridge, completed in 1956, is on National Highway No. 346, and crossing over Kitakami River. The superstructures of the bridge are single-span steel plate girder, 5-span simply supported steel trusses, and 9-span Gerber-type steel plate girders from the left to right. The total length and the width are 575.5 m and 6.0 m, respectively. Sub-structures are RC columns on caisson foundations for the truss span, and RC columns on footing foundations with RC piles for the Gerber plate girder span. Soils are of soft silts and sands, and a firm sand layer exists approximately 30 m below the ground surface. During the June earthquake one girder of this bridge fell down (see Fig. 9). This Kin-noh Bridge is only one bridge which completely fell down during the June Earthquake.

Fig. 9 Fall of a Suspended Girder, Kin-noh Bridge (During the Earthquake of June 12, 1978)

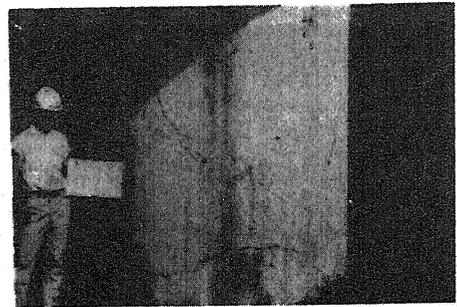
Fig. 13 Cracks at Pier 1, Yuriage Bridge
