EXCAVATION AND RESPONSE ANALYSIS
OF A DAMAGED RC PILES BY LIQUEFACTION

T. Nishizawa (I)
S. Tajiri (II)
S. Kawamura (III)

SUMMARY

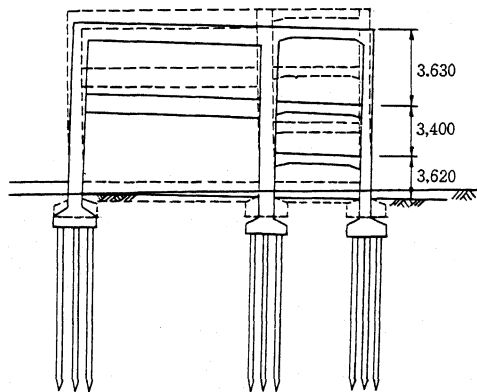
Fig.2 Section of the Building

In 1964 Niigata earthquake the building was settled and inclined as shown in Fig.2 due to the damages of the piles caused by the liquefaction of subsoil. The maximum settlement was 1.3m. Underground pipings and the like were also damaged, though the upper structure itself was slightly damaged. After the earthquake the building was jacked up and supported by the H-shaped steel piles newly driven. It was used till recently.

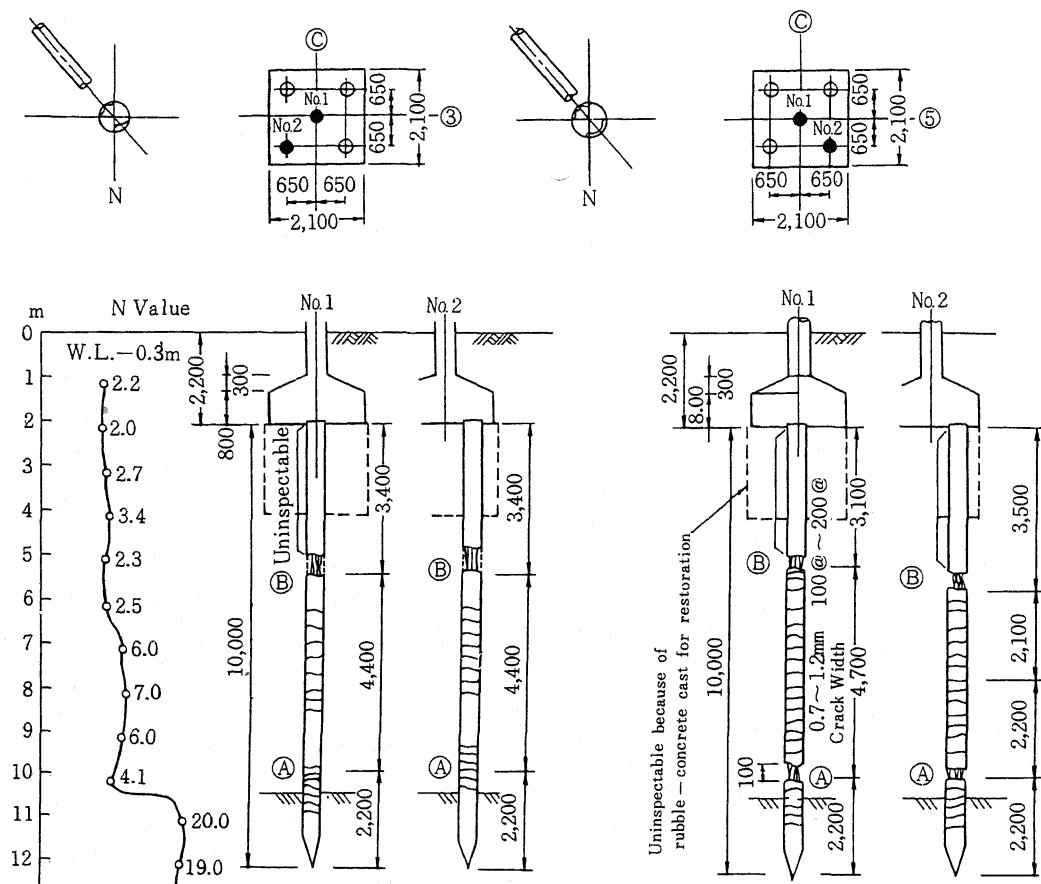
The damage on the piles is shown in Fig.4 and Photo 2. Most severely damaged parts are around 2.2m from the tip and around 3.1~3.5m from the bottom of the footing. On both parts concrete was crushed and spalled along the length of 10~20cm. Axial reinforcing bars and spiral shear-reinforcing bars were exposed and a little rusted. Ring cracks were found along the whole length, whose widths were 0.7~1.2mm and the pitch was 10~20cm. As the subsoil 2m thick just under the footing was replaced by rubble concrete, damage of the piles around there could not be inspected.

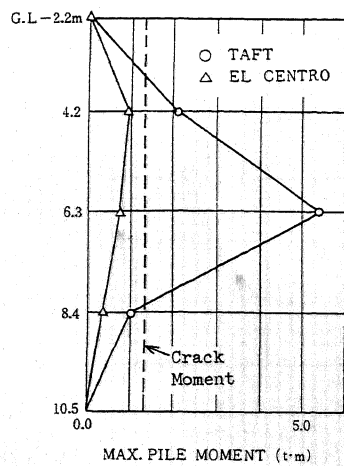
Fig.11 Bending Moment of a Pile

Linear and nonlinear maximum response accelerations are shown in Fig. 9. In the nonlinear response the amplification ratio is less than that of the linear response, and the mode is also varied from the linear one. The hystereses of the shear spring of the free soil at the third layer from the bottom are shown in Fig.10, where cyclic degradation of stiffness and strength is clearly noticed. The bending moment of a pile is shown in Fig. 11. The value for TAFT exceeded the crack moment to a large extent, which corresponds to the actual damage.

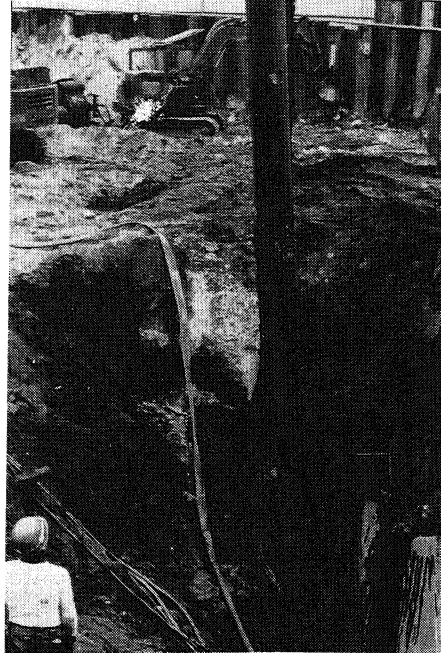
Photo 1 Pile just Pulled off

Excavation of piles was done after demolishing and removal of the upper structure and footings. Steel casing with water jet at its head was pushed down to the pile tip enclosing the piles. After the circumferential friction was cut the piles were pulled off by wire, taking care that the piles were not damaged by the work. Photo 1 shows the pile just pulled off. Total 4 piles were excavated whose locations are shown in Fig.1.

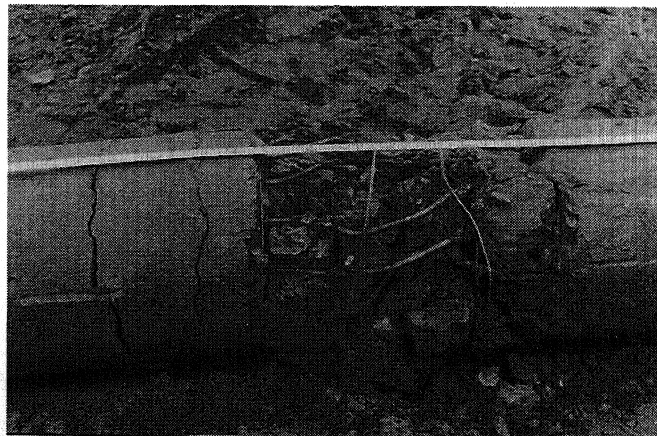
Photo 2 Damage of a Pile

It is noteworthy that the severe damage of concrete crush buckling of bars was found not only around the maximum moment point in the case of hinged pile head but also near the pile tip where the stiffness of the soil layers suddenly increased. It might be possible that the large bending moment was generated also at the boundary of soil layers as the displacement of the pile was restrained in the stiff soil. It is difficult to judge whether the ring cracks were due to the earthquake or construction works.
